U.S. Department
of Transportation
**Federal Railroad
Administration**

RR 19-02 | February 2019

THERMITE HEAD-DEFECT REPAIR WELDS AT THE EASTERN MEGA SITE

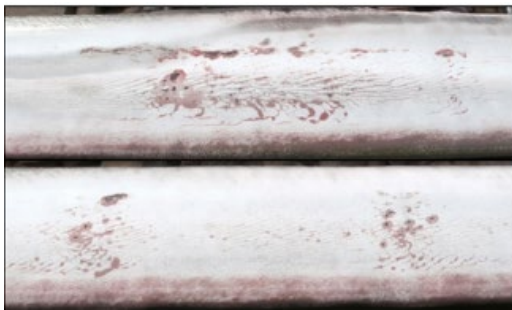
- All eight thermite head-defect repair welds had surface rolling contact fatigue (RCF) and minimal metal flow at the heat-affected zones (HAZ).
- Supplier B's low rail welds showed small amounts of shelling or pitting near the HAZ. Supplier A's low rail welds showed a greater amount of shelling or pitting throughout the weld material, as well as the HAZ.

Figure 3 shows two welds, one from each supplier, installed on the low rail of each curve at the eastern mega site. Supplier B's thermite head-defect repair weld installed on the low rail shows minor RCF throughout the whole weld and HAZ, and minor pitting only in the HAZ. Supplier A's thermite head-defect repair weld installed on the low rail shows an increased amount of RCF throughout the weld material and HAZ; however, the pitting is seen not only in the HAZ, but also in the weld material location.

Figure 3. Head-Defect Repair Weld Installed on the Low Rail: Supplier A (top) Supplier B (bottom).

- Periodic preventive grinding was conducted on these test welds, which has kept the RCF and the metal flow from the soft HAZ regulated.
- There were no weld failures.

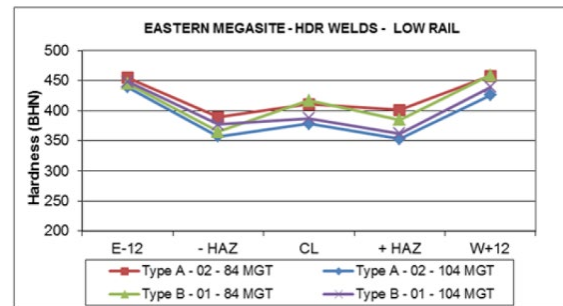
Figure 4 shows the surface hardness values that were also measured at five locations for each weld. These included parent rail on either side of the weld, at approximately 12 inches from the HAZ; within both HAZ; and at the centerline of the weld itself.

The hardness values measured at the centerline were slightly lower than those of the parent rail, which is head-hardened premium rail. As expected, the hardness results measured in the HAZ were lower than those measured for both the parent rail and the welds.

Figure 4. Post-Grind Hardness Measurements are Shown with the Data Taken at 84 MGT and 104 MGT. Type A Refers to Low-Rail Welds from Supplier A and Type B Refers to Supplier B.
