**Federal Railroad
Administration**

Joint Bar Failure Study—Field Investigation

1. AGENCY USE ONLY (Leave blank)		2. REPORT DATE June 2019		3. REPORT TYPE AND DATES COVERED Technical Report April 2016
4. TITLE AND SUBTITLE Joint Bar Failure Study—Field Investigation			5. FUNDING NUMBERS DTFR53-10-D-00002 Task Order 18

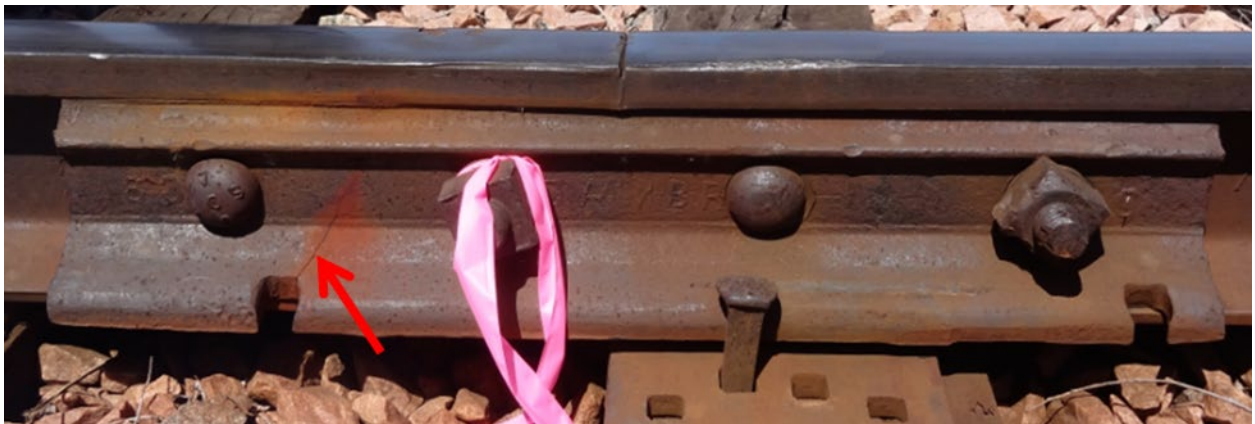
Figure 3. Full Quarter Break on a Long Toe (Angle) Bar

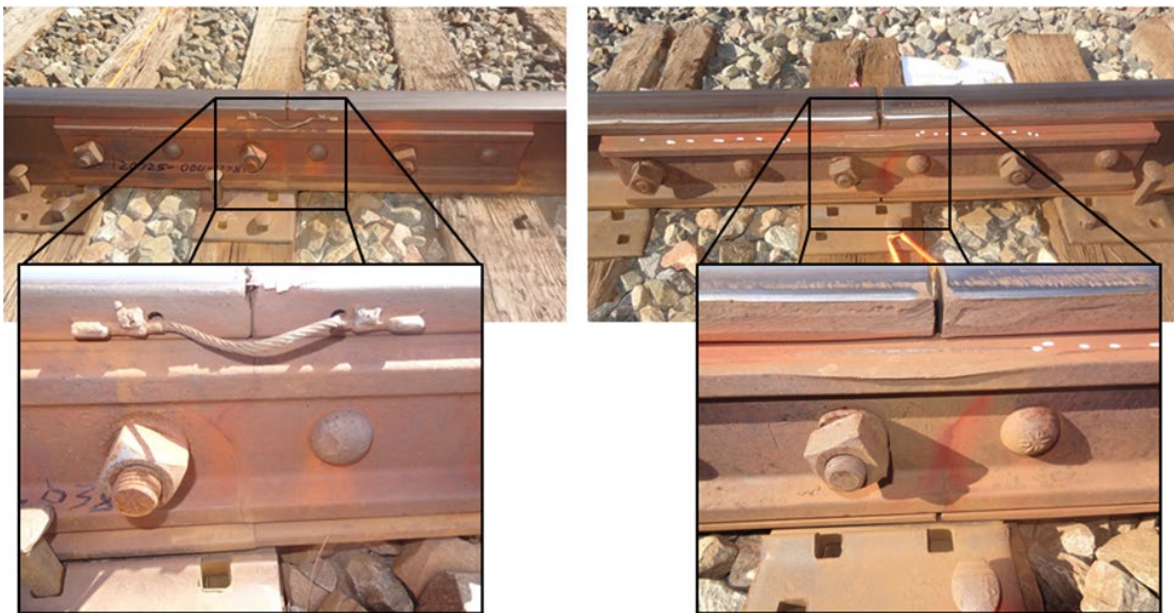
The photograph a) in [Figure 7](#) below shows the unusual full center break with the “Y” shape pattern. This defect occurred on a field side bar. The photograph b) shows the unusual partial bottom center crack with the “Y” shape pattern. The crack occurred on a gage side bar.

a) Full Center Break with Unusual Pattern

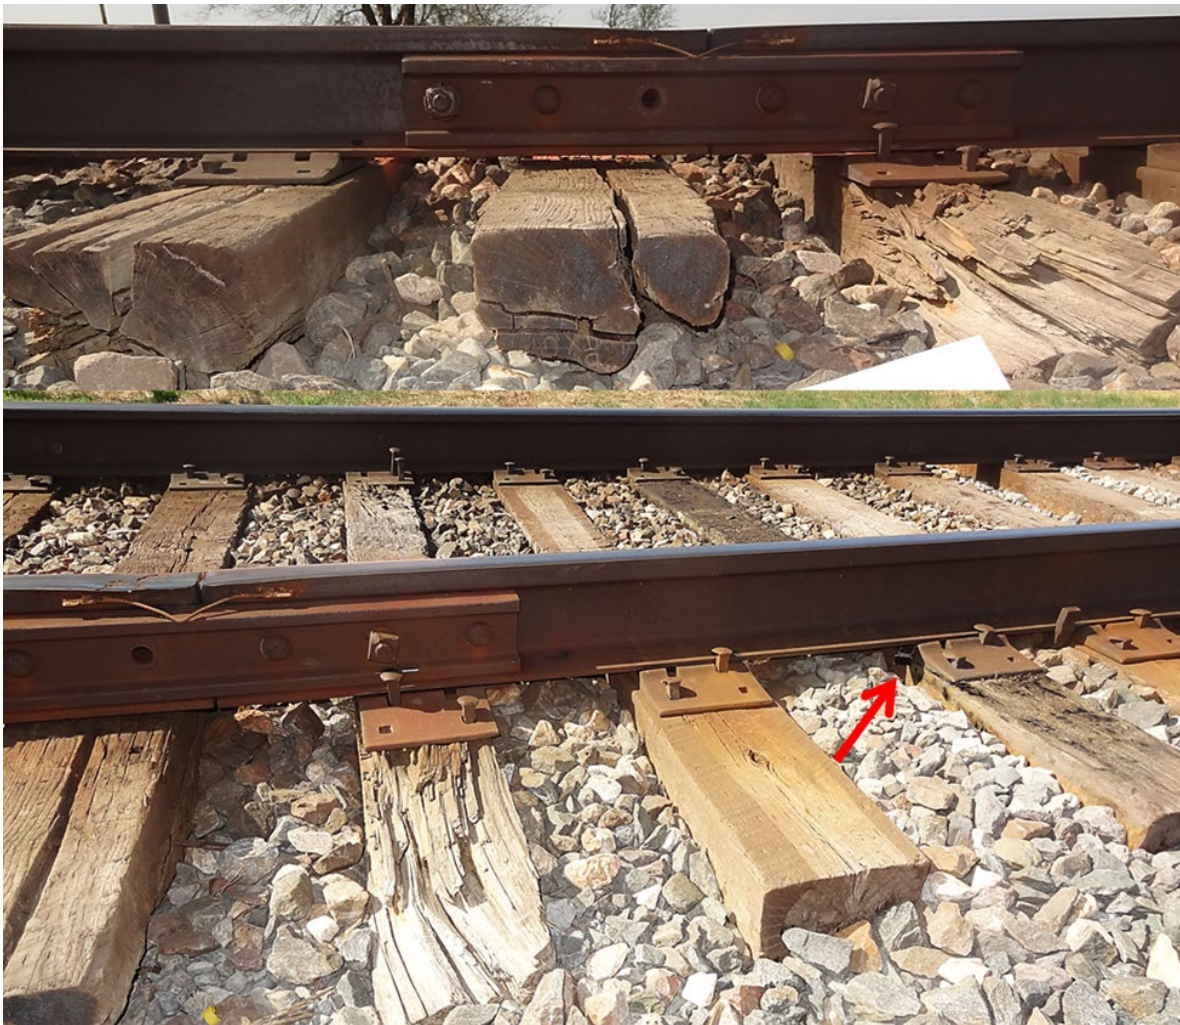
The most important observation made throughout the field surveys was evidence of localized deteriorated vertical track support conditions at most of the identified failed rail joint locations in contrast to very good vertical track support conditions at intact rail joint locations. Most of the failed rail joint locations also had signs of large vertical joint movements because of the deteriorated support conditions. Even though the deteriorated support conditions were localized to an area of a specific rail joint, they affected several, in many cases three of four, ties in either direction from the joint centerline. [Figure 8](#) shows a typical example of a failed rail joint with deteriorated track support, excessive vertical movement and wide deflection basin. This location was found in test zone C during the 2014 visit.

Figure 8. Large Vertical Movement and Wide Deflection Basin at a Failed Rail Joint Location

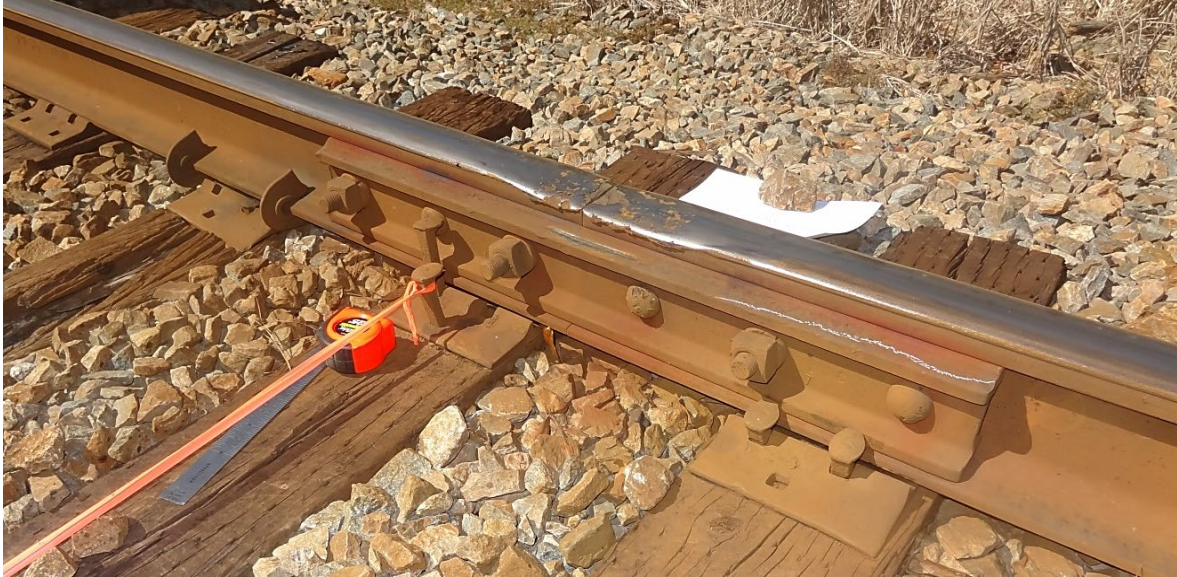
Adverse rail end conditions at failed rail joints, when compared to intact joint locations, were also observed on higher track classes, specifically at track Class 3. Most of the adverse rail end conditions consisted of moderate and in many cases significant rail end batter. Locations with chipped or otherwise degraded rail ends were also frequently found. However, on jointed territory on all classes, no excessive ramps or tread and gage mismatches were observed at either failed or intact joints. [Figure 9](#) shows an example of a failed joint location with a very significant rail end batter of 0.359 inches magnitude. This location was encountered on test zone D in 2013. The rail ends were also considerably chipped.

Figure 9. Large Rail End Batter at a Failed Rail Joint Location

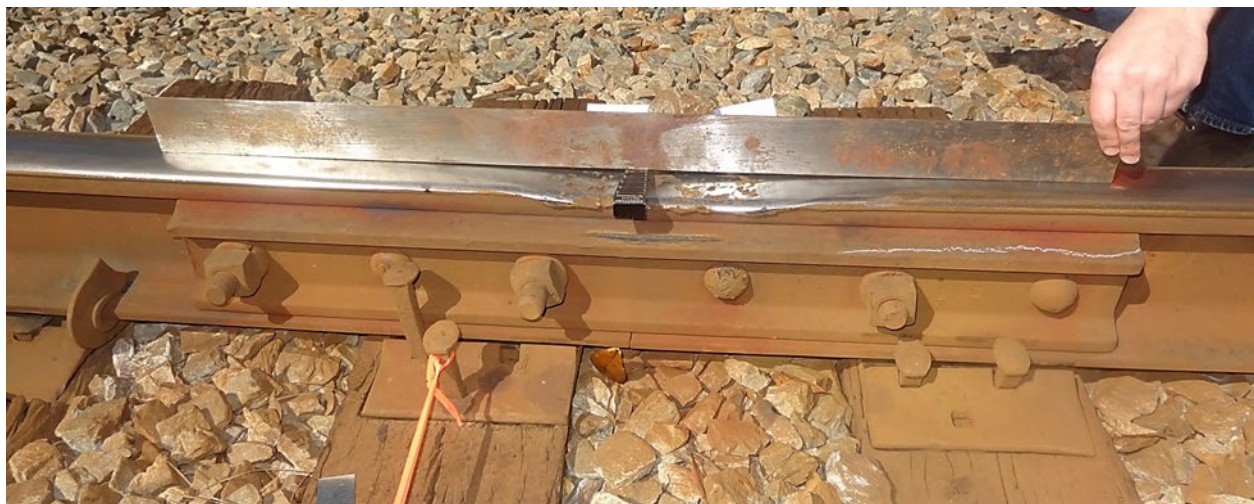
Figure 10. Large Rail End Batter at a Failed Rail Joint Location with Straight Edge to Demonstrate Magnitude

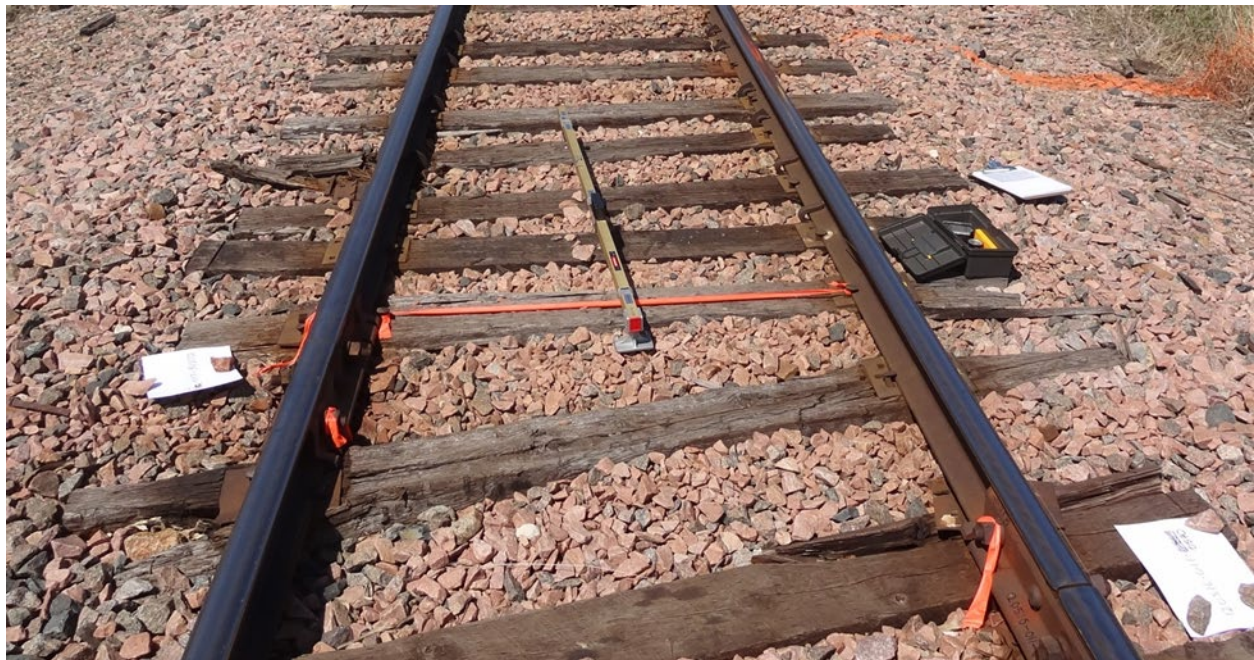
The investigated test zones showed evidence of a wide variety of rail longitudinal movements which mostly ranged between 0.25 and 6 inches. On several occasions, a very large portion of a particular investigated territory (test zone B1) showed evidence of large rail longitudinal movement (up to 9 inches). The longitudinal movement, however, did not seem to have a direct impact on the joint bar failure rate. Significant longitudinal movement was observed to affect long sections of track with both failed and intact joints; while other conditions, such as vertical and lateral movement, were localized to the individual investigated failed locations. However, longitudinal movement often resulted in skewed crossties and narrow (tight) gage at some of the joints, which led to loose fasteners and reduced lateral restraint and/or increased tie spacing under the joints. [Figure 12](#) shows an example of a location with a large longitudinal rail movement (9 inches) resulting in skewed ties and narrow (tight) gage. Two failed rail joints were present at this location.

Figure 12. Large Rail Longitudinal Movement and Skewed Ties

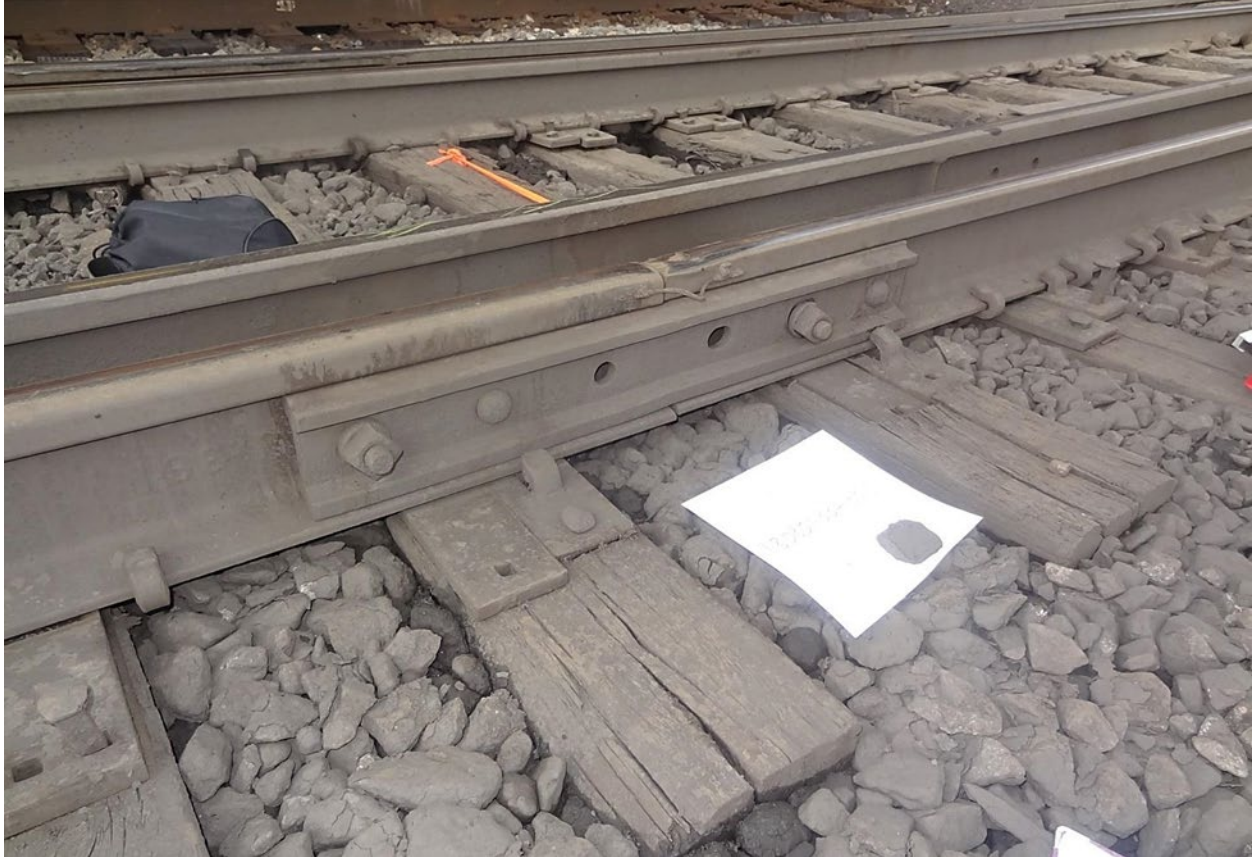
The five instances of failed joint bars were all top center cracks that occurred at temporary joints where repair rails were installed in a tangent wooden track. All the identified failed joints except for one exhibited deteriorated rail end conditions, either extensive rail mismatches (both tread and gage), abrupt rail end ramps or rail end batter. Significant lateral and vertical movements, as a result of insufficient joint support, were also present at three of the failed joint bar locations.

Figure 14. Failed Rail Joint at CWR Territory with Deteriorated Support and Rail End Conditions

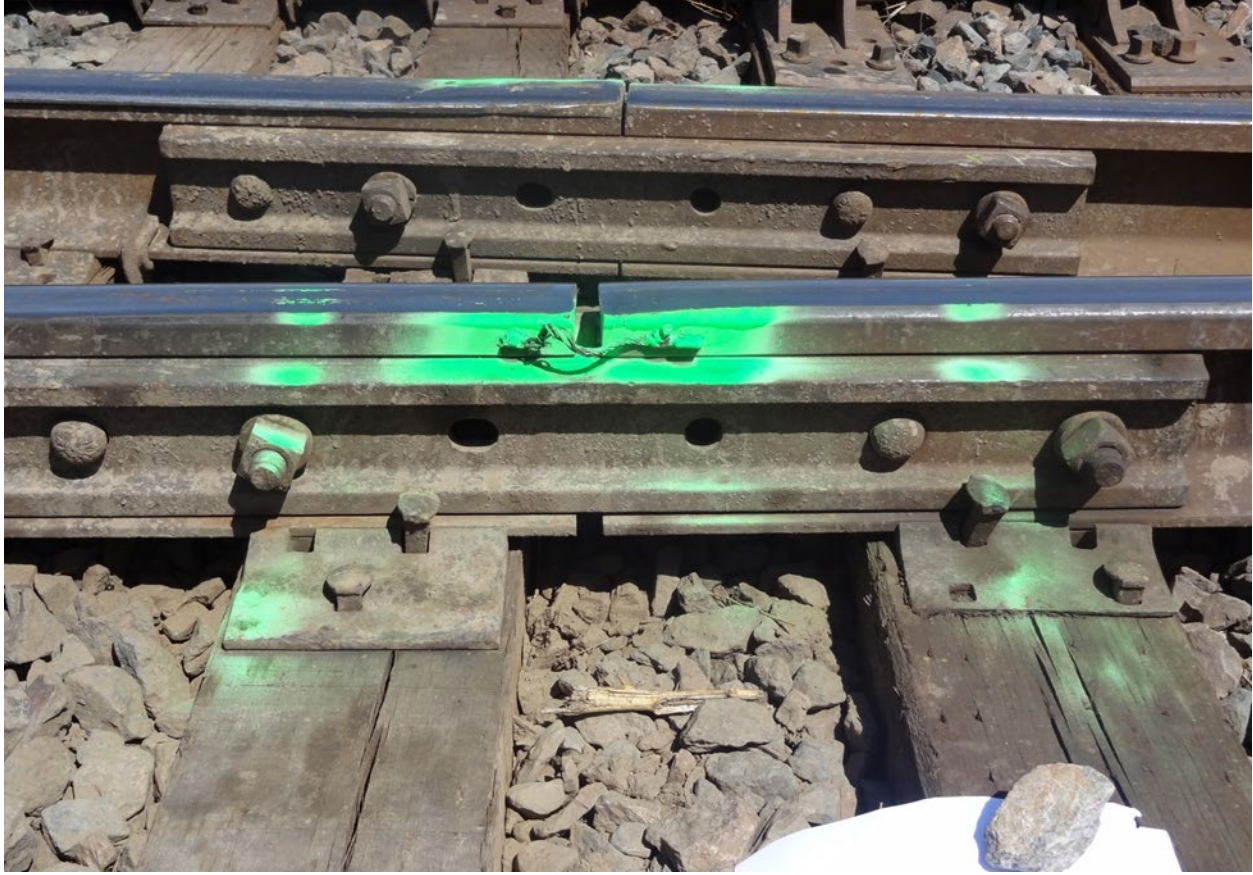
One identified defect located in a turnout did not exhibit any significant deviations in geometry, any lateral, vertical, or longitudinal movement. A moderate rail end ramp was present. The turnout appeared to have relatively new and recently replaced switch ties and ballast. It is possible that the initiation of the crack occurred before switch tie replacement and surfacing, or it was due to the recent maintenance work. This location is shown in Figure 15.

Figure 15. Failed Rail Joint at CWR Territory at Location of Recent Track Work

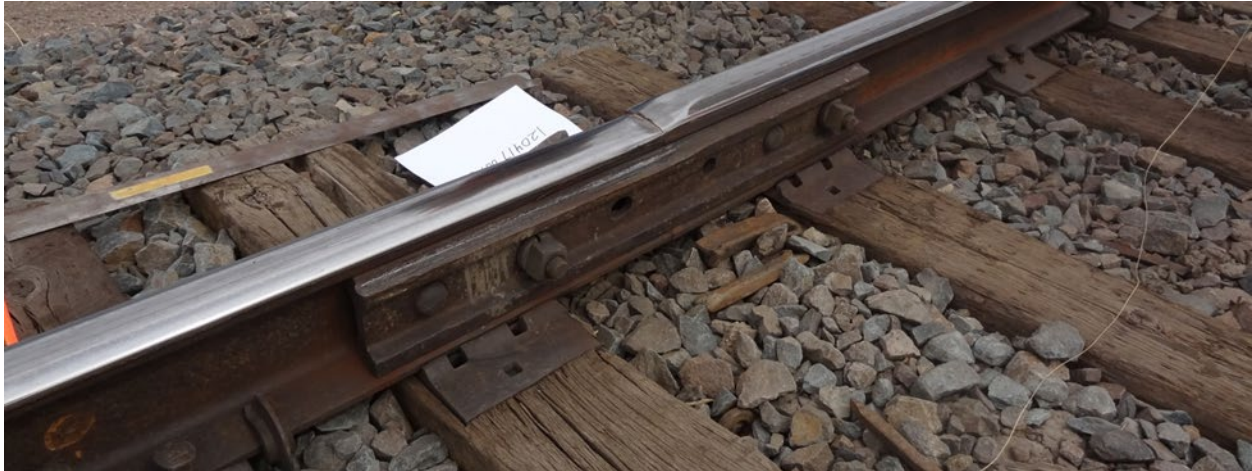
Deteriorated rail end conditions on Class 3 JNT were overwhelmingly represented by rail end batter, fairly even for both rail ends and developed gradually by repeated wheel impact loads at initially well-matched rail ends. On the other hand, rail end conditions on CWR territory consisted mostly of tread mismatches or abrupt rail end ramps. These mismatches were created when new or full ball repair rail sections were installed in track with worn rail. In some cases, mismatched rail ends were then battered down by repeated wheel impact loads resulting in the short and abrupt rail end ramps. As the head of the new rail was battered down, subsequent rail head widening led to horizontal mismatch on field or sometimes both sides of the rail head. An example of a misaligned, battered down rail end at a failed joint location is in [Figure 16](#). The top view of the same location in [Figure 17](#) illustrates the horizontal mismatches as the battered down rail head results in widening, mostly towards the field side of the rail.

Figure 16. Initially Misaligned Rail End Battered Down into Abrupt Rail End Ramp

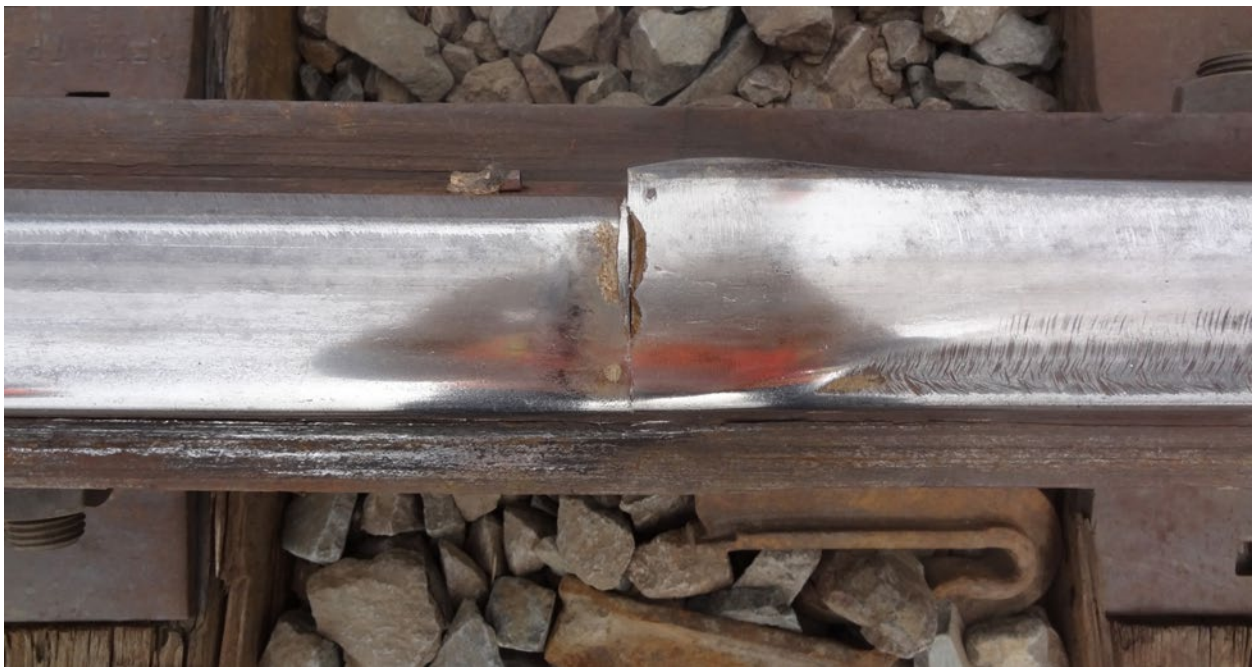
Figure 17. Widened Rail Head

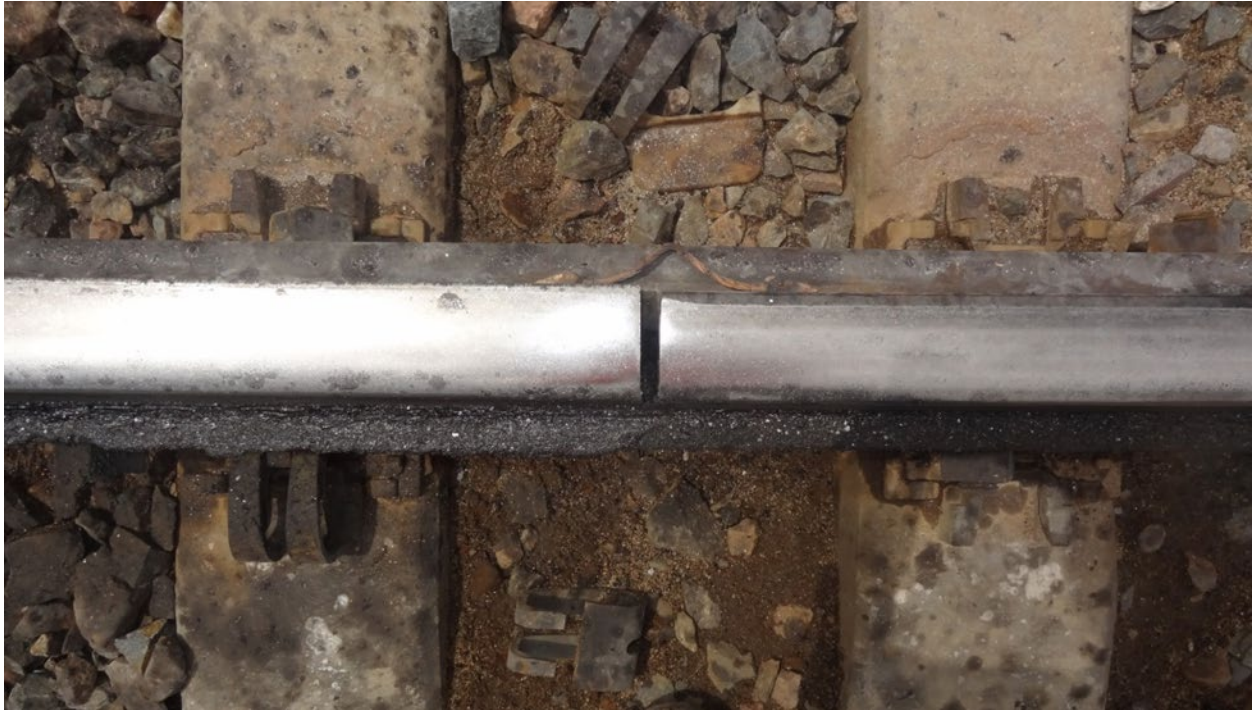
Figure 19. Temporary Joint on Concrete Ties Not Configured with Two Fasteners on the Same Rail

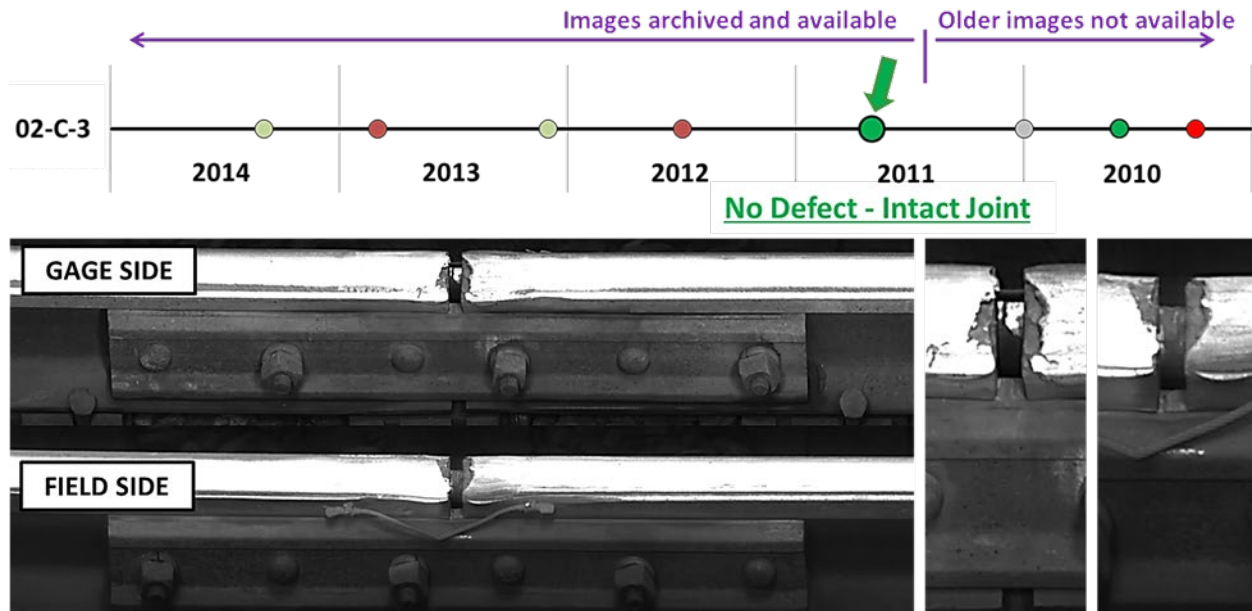
Figure 70. Repeat Failure Location 02-C-3—November 2013 JBIS Camera Image, Joint Failed

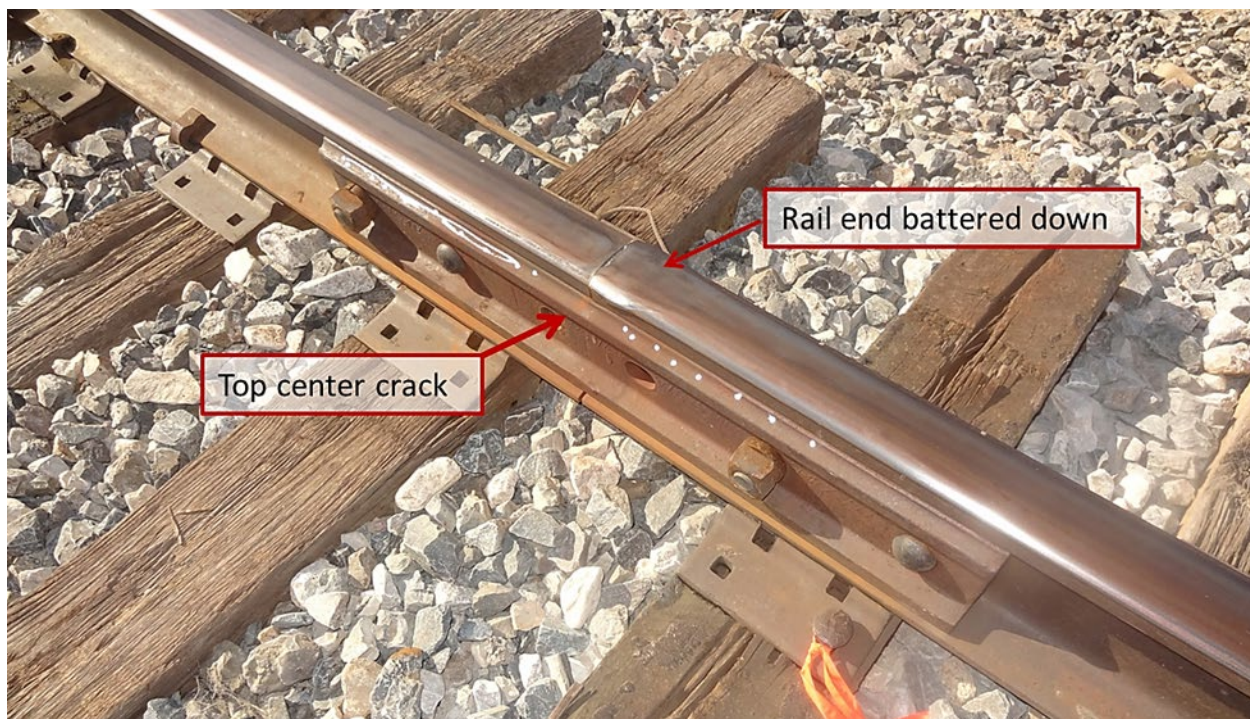
Figure 72. Repeat Failure Candidate 120727-004-0458—Field Conditions, Gage Side View

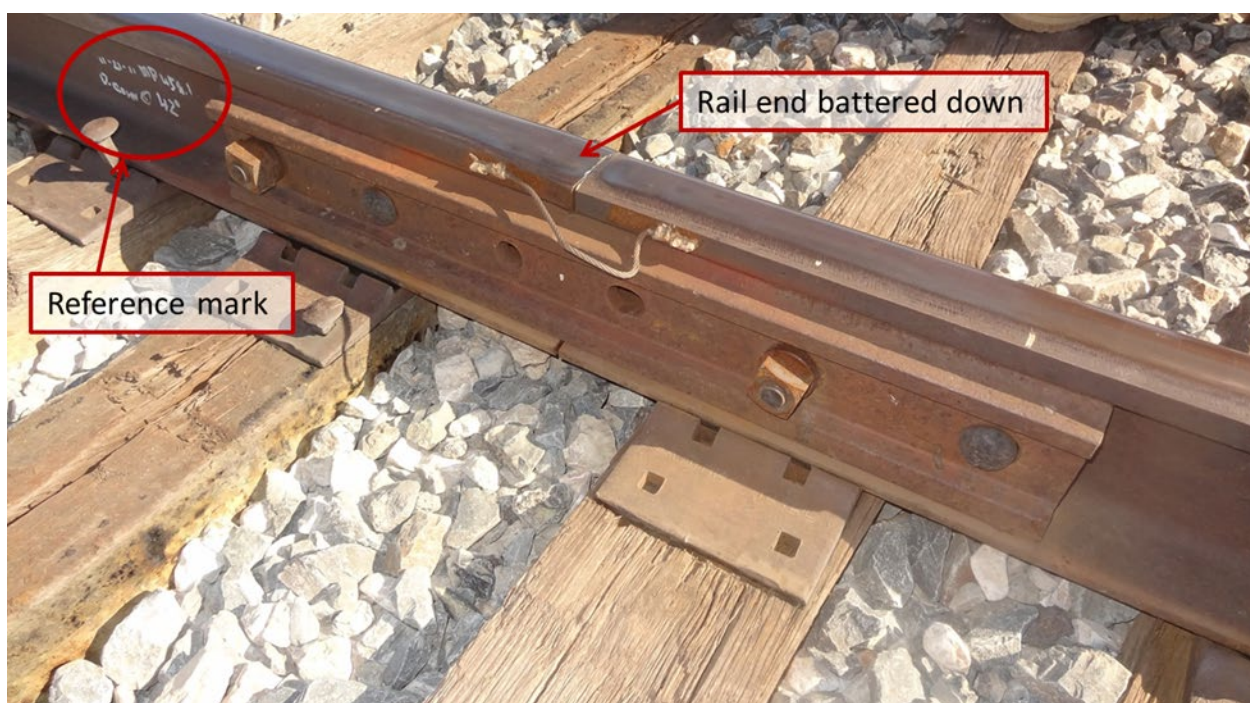
Figure 73. Repeat Failure Candidate 120727-004-0458—Field Conditions, Field Side View

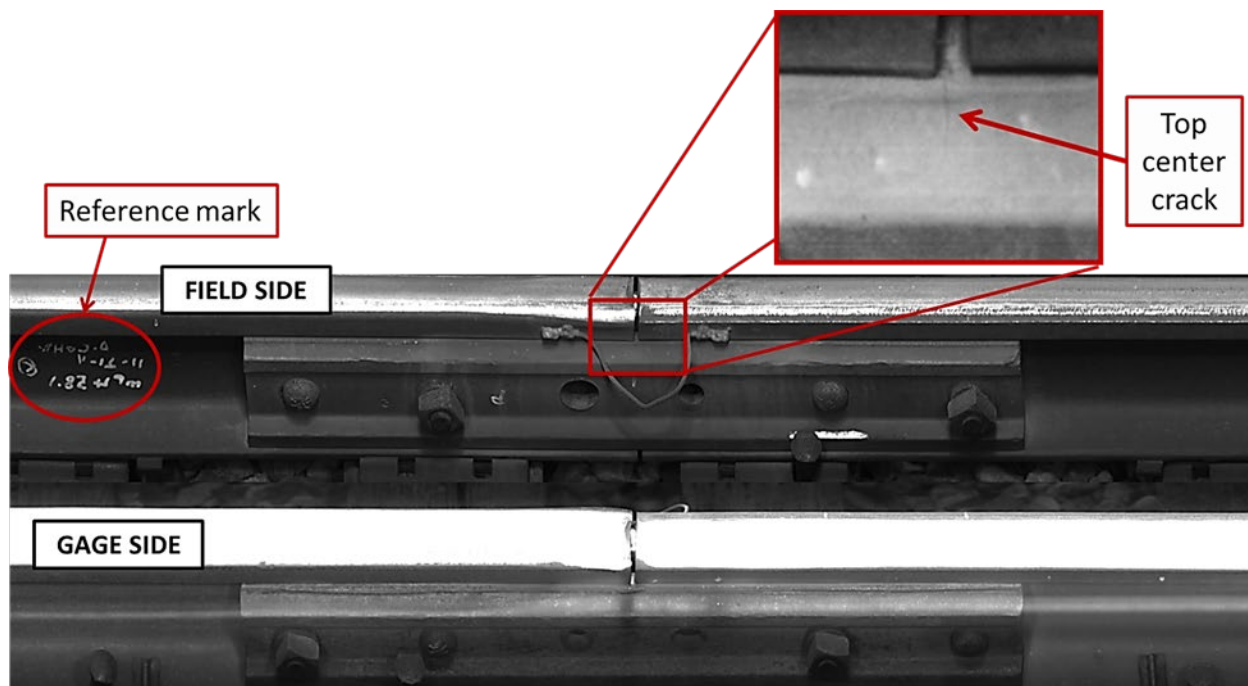
Figure 74. Repeat Failure Candidate 120727-004-0458—November 2013 JBIS Camera Image, Failed Joint

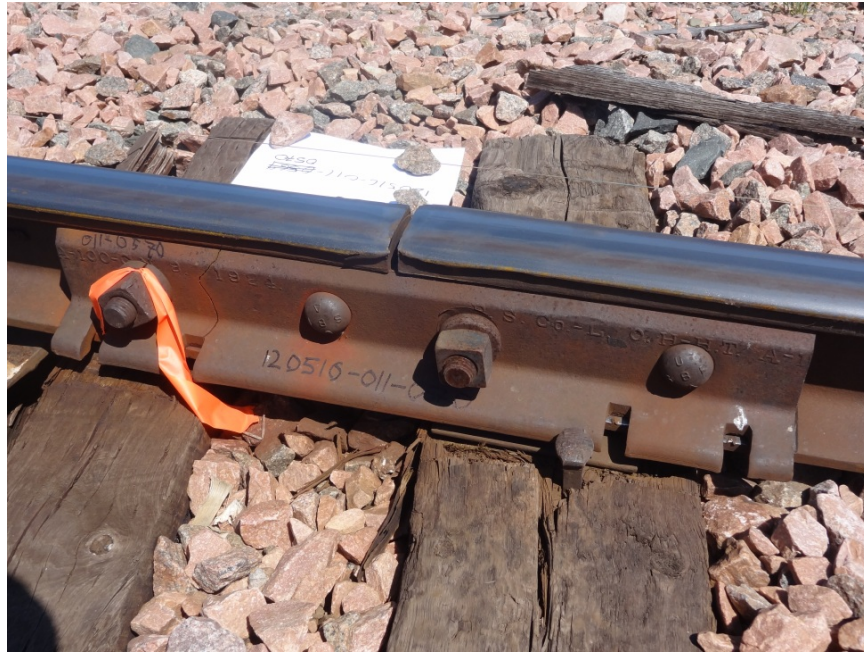
a) Gage Side View of a Rail Joint Defect in the Area of Large Longitudinal Movement

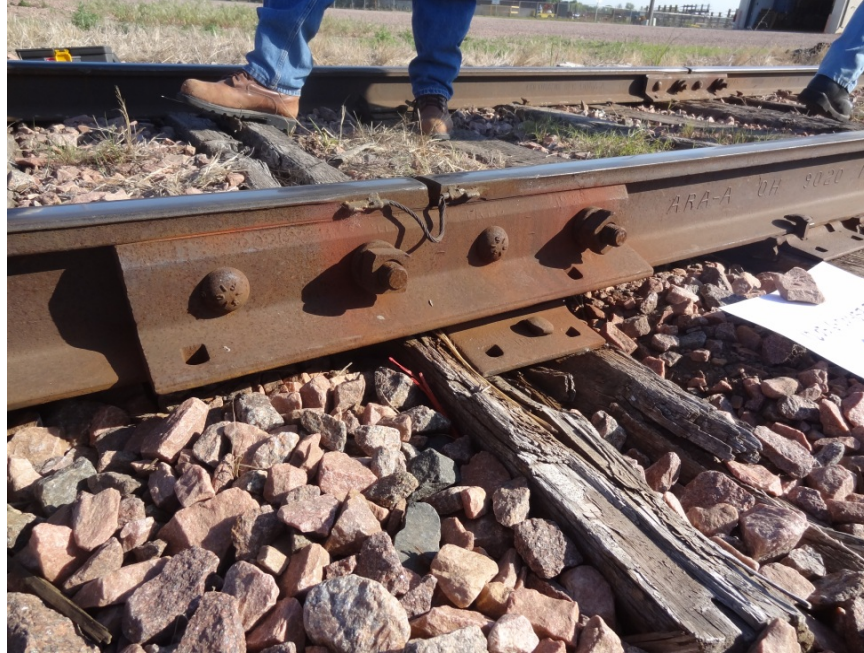
a) Field Side View of a Defect in with Large Longitudinal Movement and Ineffective Tie

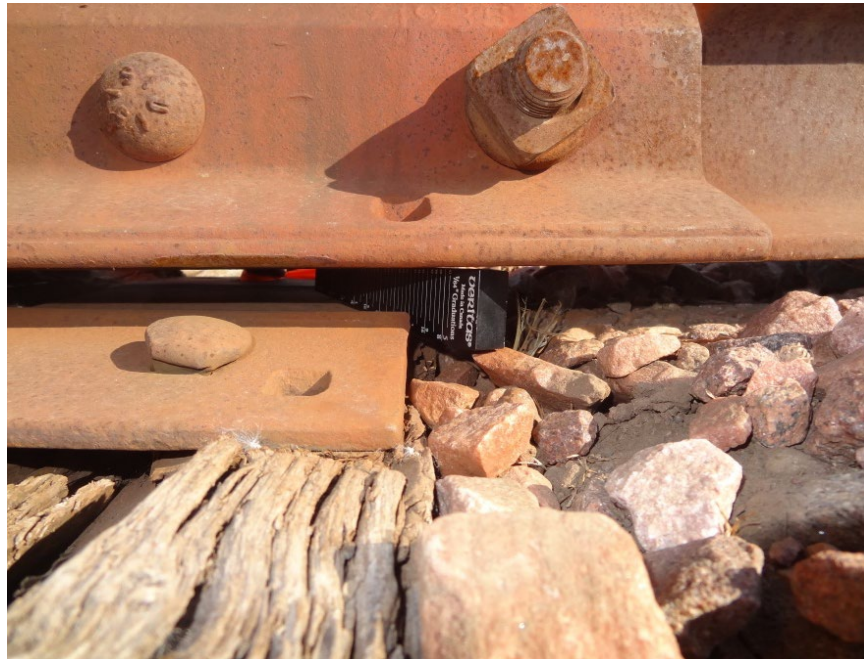
b) Detail of Gap between Rail Base and Tie Plate

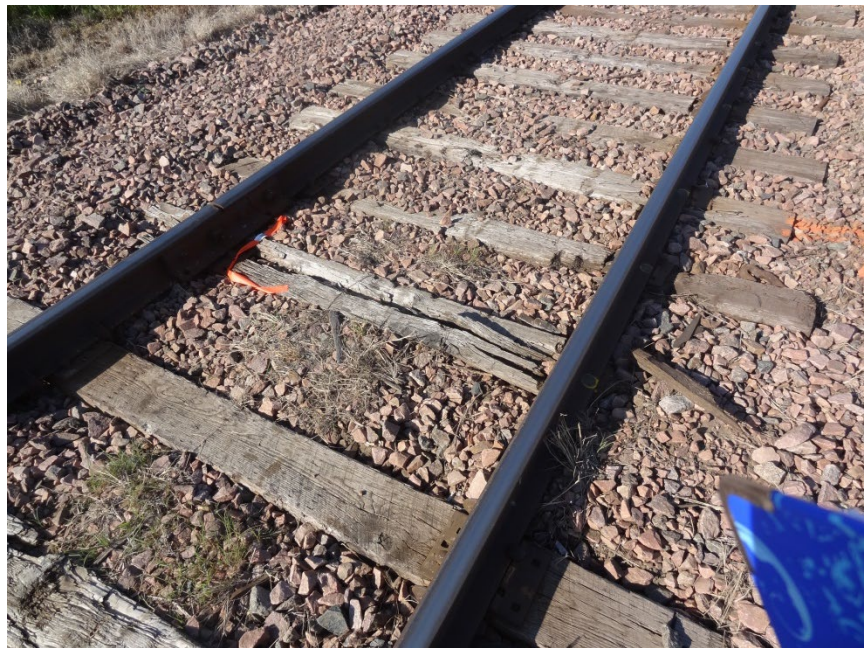
b) Fouled Ballast in a Vicinity of a Failed Joint

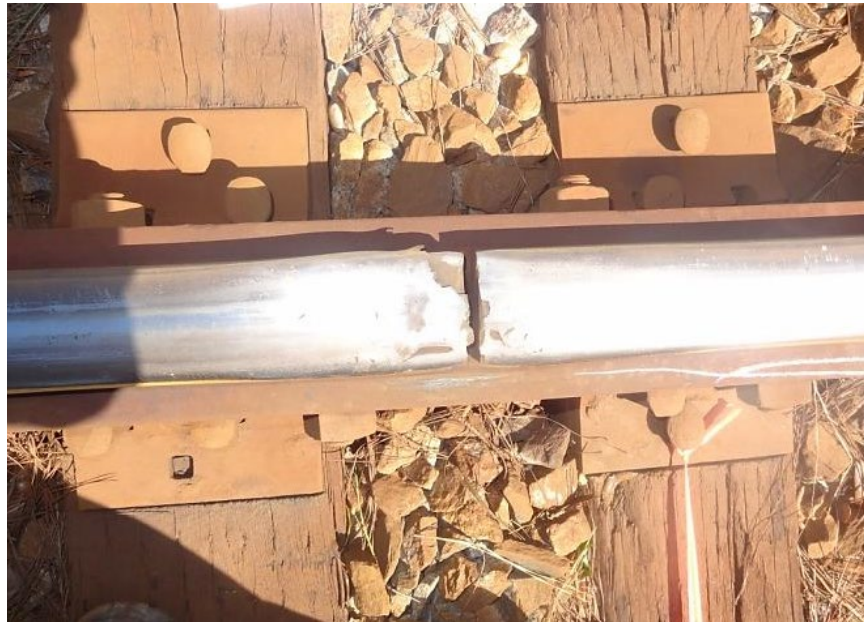
b) Chipped Rail Ends
