***Federal Railroad Administration  
Office of Railroad Safety  
Accident and Analysis Branch***

***Accident Investigation Report  
HQ-2017-1239***

***Amtrak 501  
DuPont, Washington  
December 18, 2017***

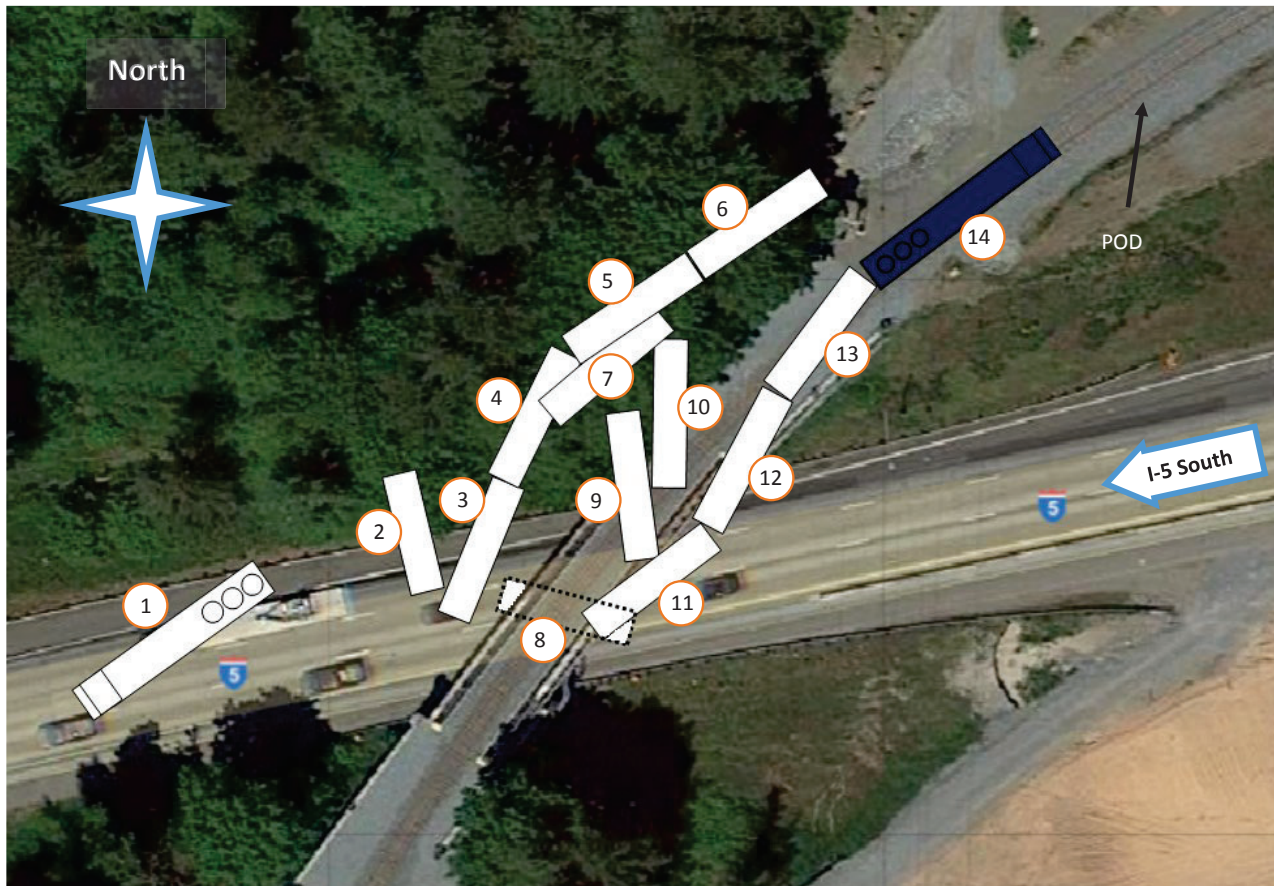
Sketch - ATK 501

**Amtrak Cascades Train 501 Consist Information**

| 1. WDTX 1402 - SC-44 Charger Locomotive (on freeway) | 8. ATK 7424 - Talgo Series 6 coach car (under bridge) |
| 2. ATK 7903 - Talgo Series 6 Power car (beside bridge) | 9. ATK 7423 - Talgo Series 6 coach car (derailed on bridge) |
| 3. ATK 7454 - Talgo Series 6 Business car (beside bridge) | 10. ATK 7422 - Talgo Series 6 coach car (derailed on bridge) |
| 4. ATK 7554 - Talgo Series 6 Bus. car ADA (beside bridge) | 11. ATK 7421 - Talgo Series 6 coach car (hanging off bridge) |
| 5. ATK 7804 - Talgo Series 6 Dining car (beside track) | 12. ATK 7420 - Talgo Series 6 coach car (hanging off bridge) |
| 6. ATK 7303 - Talgo Series 6 Bistro car (beside track) | 13. ATK 7102 - Talgo Series 6 Baggage car (beside track) |
| 7. ATK 7504 - Talgo Series 6 coach car ADA (beside track) | 14. ATK 181 - P-42 GE Locomotive |

**\*\* WDTX 1402 Lead Locomotive heading timetable South \*\* Not to Scale**
