***Federal Railroad Administration
Office of Railroad Safety
Accident and Analysis Branch***

***Accident Investigation Report
HQ-2018-1275***

***CSX Transportation (CSX)
Princeton, IN
June 17, 2018***

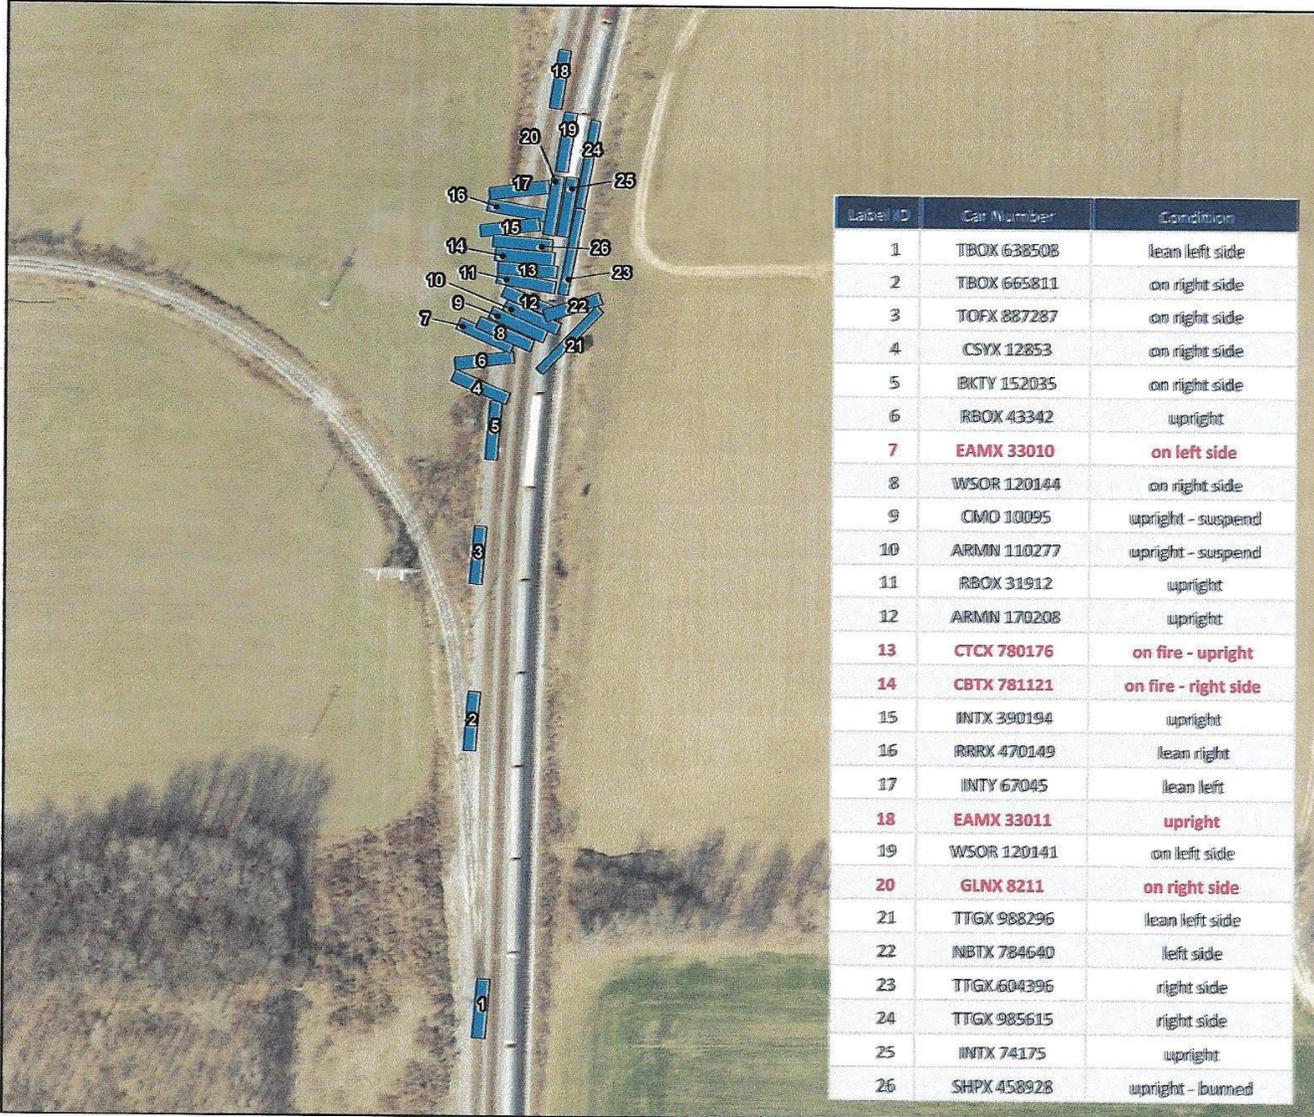
Sketch - Princeton Site Map Sketch HQ-2018-1275

Label ID	Car Number	Condition
1	TBOX 638508	lean left side
2	TBOX 665811	on right side
3	TOFX 887287	on right side
4	CSYX 12853	on right side
5	BKTY 152035	on right side
6	RBOX 43342	upright
7	EAMX 33010	on left side
8	WSOR 120144	on right side
9	CMO 10095	upright - suspend
10	ARMN 110277	upright - suspend
11	RBOX 31912	upright
12	ARMN 170208	upright
13	CTCX 780176	on fire - upright
14	CBTX 781121	on fire - right side
15	INTX 390194	upright
16	RRRX 470149	lean right
17	INTY 67045	lean left
18	EAMX 33011	upright
19	WSOR 120141	on left side
20	GLNX 8211	on right side
21	TTGX 988296	lean left side
22	NBTX 784640	left side
23	TTGX 604396	right side
24	TTGX 985615	right side
25	INTX 74175	upright
26	SHPX 458928	upright - burned
