Locomotive Collision Test #7 Freight Locomotive (DASH8-C39) Colliding with a Stationary Hopper Car

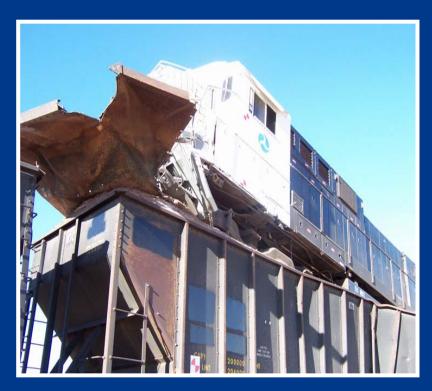
Position of locomotive following collision test

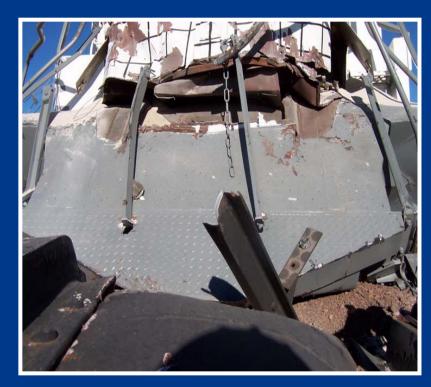
View of locomotive front end damage

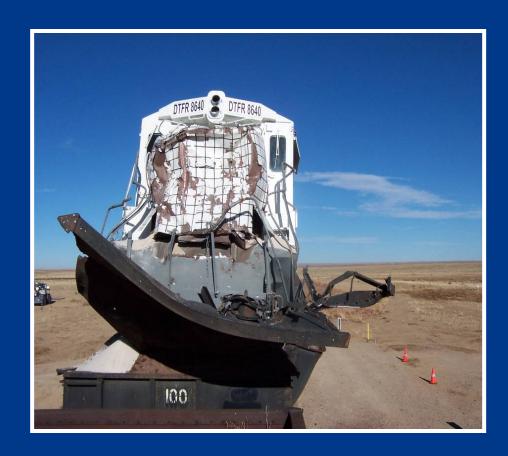
Extensive damage to the front end of the locomotive

- Even at low speeds (~30 mph), the locomotive can override stationary vehicles (Similar to Test #1)
- Anticlimber did not directly affect the outcome of this collision
- End plate and draft gear pocket formed a ramp that allowed the locomotive to ride up on top of the comparatively weaker hopper structure
- Hopper body provided no resistance to locomotive override
- Damage to the anticlimber and locomotive front, including the collision posts, was massive (locomotive to hopper car collision at 40 mph), and the draft gear failed
