***Federal Railroad Administration
Office of Safety
Headquarters Assigned
Accident Investigation Report
HQ-2012-41***

***CSX Transportation (CSX)
St. Charles, VA
December 9, 2012***

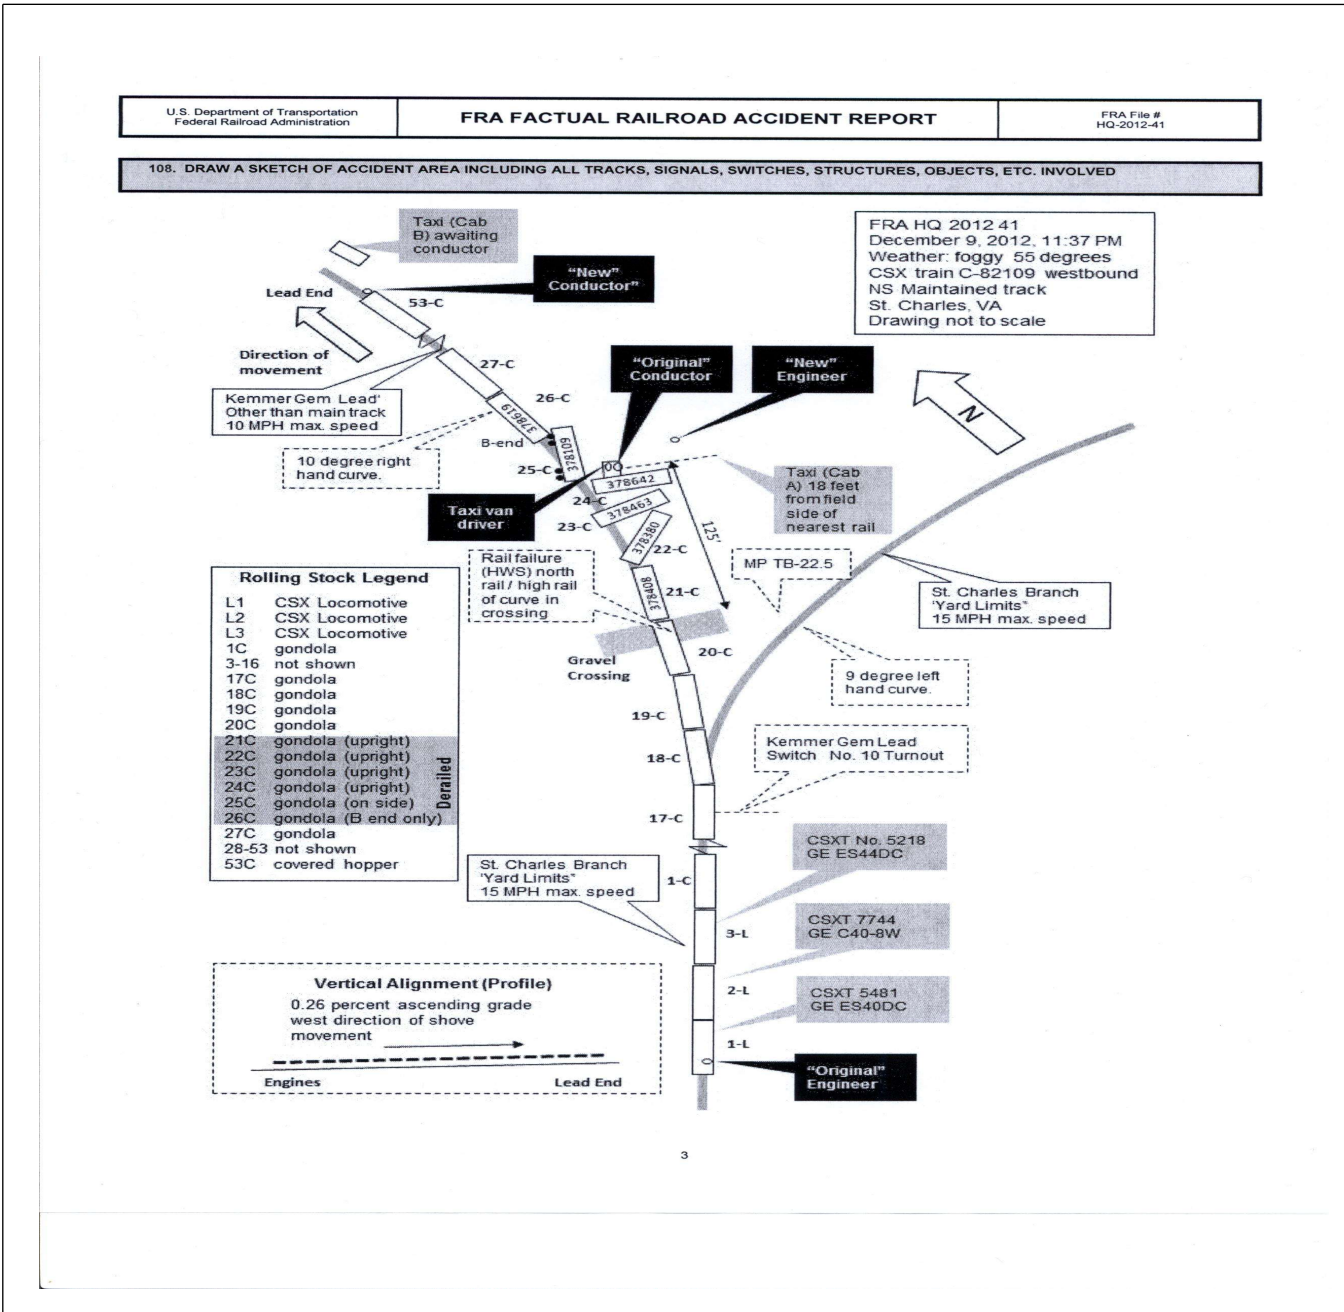
136. DRAW A SKETCH OF ACCIDENT AREA INCLUDING ALL TRACKS, SIGNALS, SWITCHES, STRUCTURES, OBJECTS, ETC., INVOLVED.

The accident was caused by a rail failure. Approximately 13 feet of the head of the rail was separated from the web. A head and web separation was identified on the north rail at the point of derailment.

Twenty-six cars had traversed over a private highway-rail grade crossing; as car No. 378109 traveled over the wheels encountered a discontinuity in the rail. As a result of the rail discontinuity, Car No. 378109 and five additional rail cars derailed. Car No. 378109 impacted an embankment on the north side of the track, as the movement continued west, Car No. 378462 departed the track to the north side and impacted Cab A.

At the point of derailment the vertical alignment is a 10 degree left hand curve, as viewed for the direction of travel. The lead has a 0.20 percent descending grade from the tracks end east toward the main track switch. The track is constructed jointed rail of various sizes, seated on double shoulder rail plates, and attached using steel cut spikes. In the subject curve the rail is box anchored and the spike pattern utilized is one rail spike and one anchor spike on the field side, and two rail spikes and one anchor spike on the gage side, on each rail in the curve. The crossing where the subject rail was embedded is constructed of gravel; the gravel is level with the top running surface of the rail. Rails which are embedded at grade crossing are very difficult to inspect for the normal signs of rail failures. The subject rail section is Tennessee 100 25 RE, manufactured in February, 1931. The subject rail exhibited severe corrosion in the head-web fillet area of the rail section. Rail corrosion is common in rail buried in road crossings and is essentially a rusting away of the metal. The corrosion weakens the rail and contributes to a complete rail failure. After the rail was removed from the gravel crossing, a previous separation was noted in the gage side head-web fillet area of the rail. The rail was discolored in this area which indicates that a void had been present prior to the rail failure.

Conclusion: Rail discontinuity caused by the rail head separation at the point of derailment was determined to be the primary cause.
