***Federal Railroad Administration  
Office of Safety  
Headquarters Assigned  
Accident Investigation Report  
HQ-2009-02***

***CSX Transportation (CSX)  
Defiance, OH  
January 2, 2009***

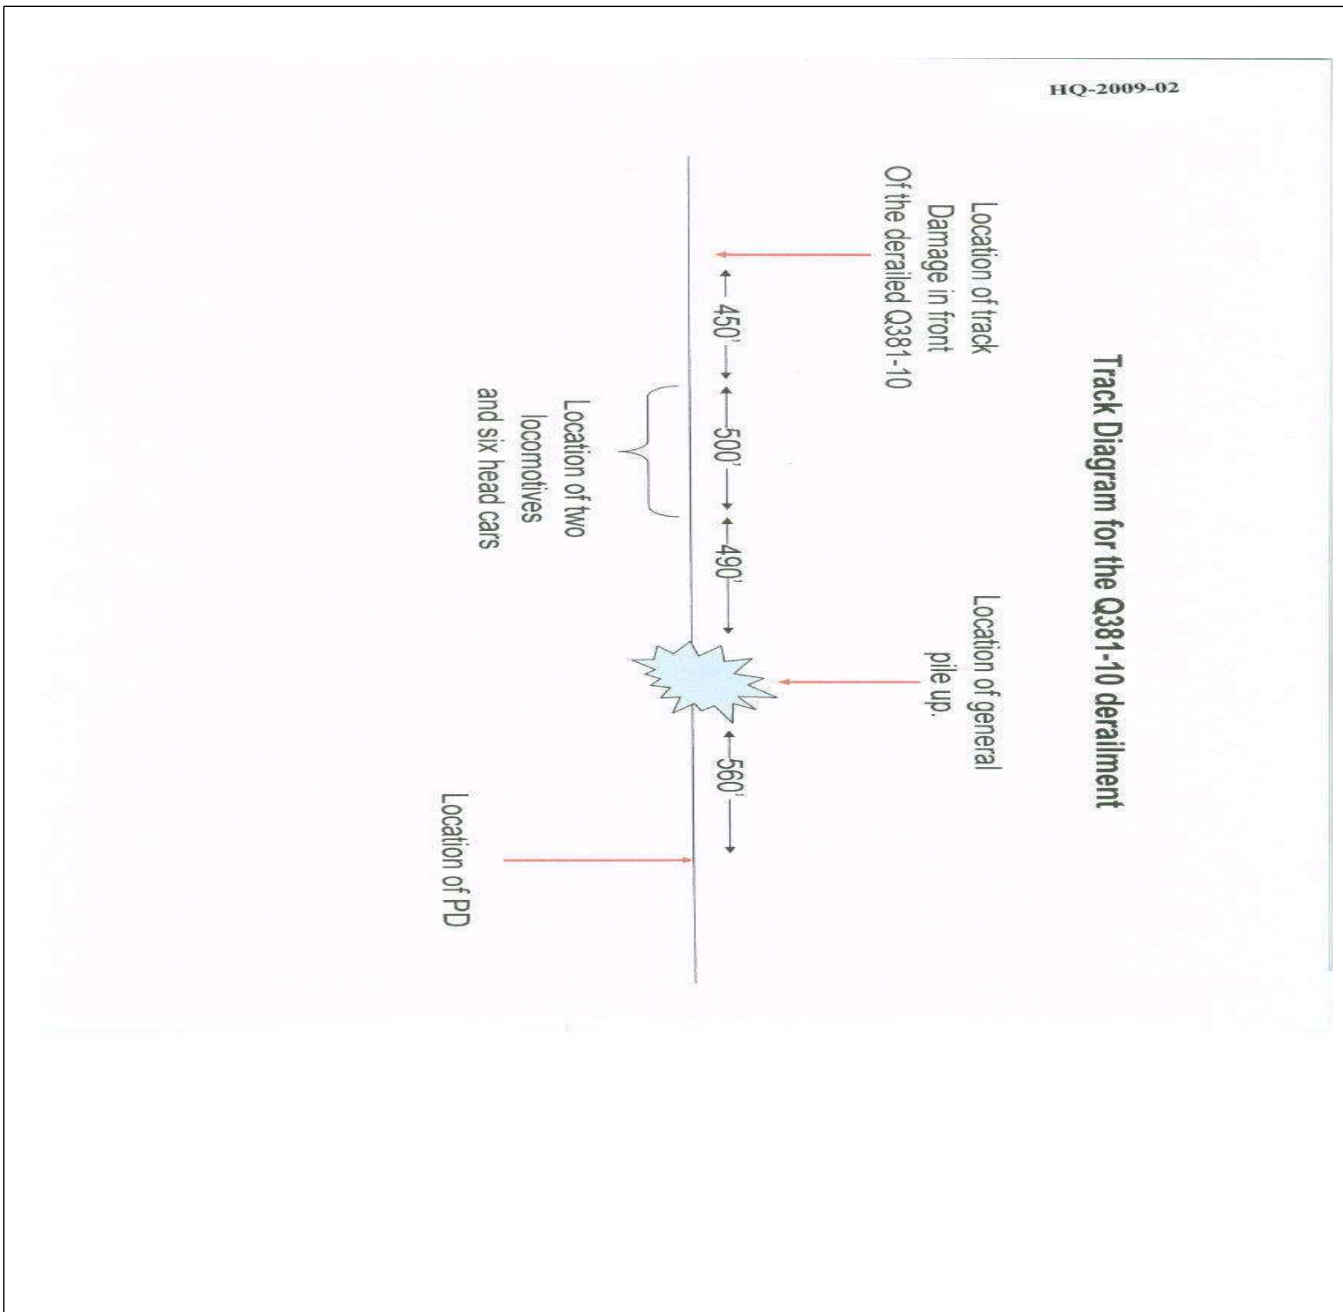
136. DRAW A SKETCH OF ACCIDENT AREA INCLUDING ALL TRACKS, SIGNALS, SWITCHES, STRUCTURES, OBJECTS, ETC., INVOLVED.

The point of derailment for CSX Train Q381-10 was at the south rail on the No. 1 Main Track at the rail joint bars connecting the west end of a 29 foot installed plug rail to the parent rail. This plug rail was installed on November 18, 2008 as a result of a defective plant weld detected during a Sperry Ultra-sonic Rail test on November 18, 2008. During the on-site investigation, it was determined that there were missing spikes in and beyond the area of the aforementioned joint at milepost BI90.2. The only spikes present were the anchor spikes holding the tie plate to the cross-tie.

**CONCLUSION** - Defective track conditions were a cause of this accident due to the missing spikes found on the field side of the rail joint at milepost 190.2 at the accident scene. The missing rail spikes on the field side of the rail coupled with missing rail holding spikes on the gauge side of the joint caused the rail to spread under load conditions. The gauge was measured at the PD at 58-1/2 inches.
