***Federal Railroad Administration  
Office of Safety  
Headquarters Assigned  
Accident Investigation Report  
HQ-2009-55***

***Canadian Pacific (CP)  
Northbrook, IL  
November 1, 2009***

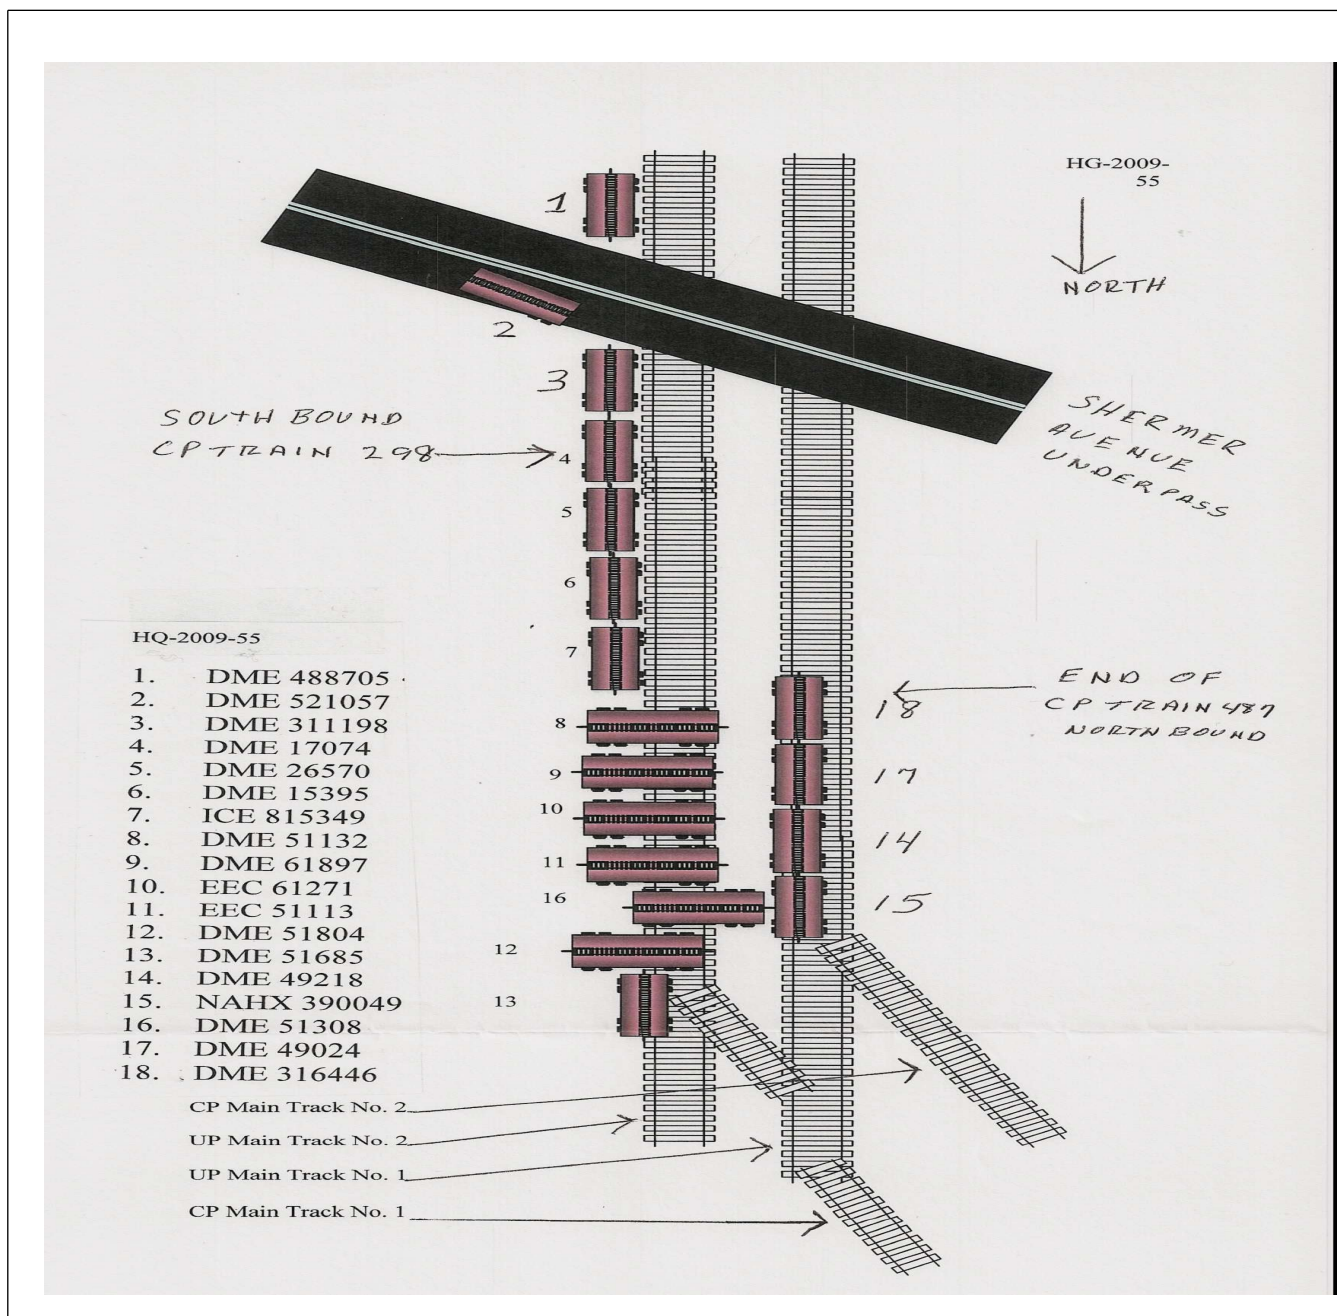
136. DRAW A SKETCH OF ACCIDENT AREA INCLUDING ALL TRACKS, SIGNALS, SWITCHES, STRUCTURES, OBJECTS, ETC., INVOLVED.

On November 1, 2009, at 3:01 p.m. CDT, eastbound Canadian Pacific (CP) Train 298-29 derailed 14 loaded cars on the Union Pacific Railroad (UP) Milwaukee Subdivision Main Track # 1. CP Train 298-29 was operating from CP Main Track # 1 to UP Main Track # 1 and crossing over to UP Main Track # 2. CP Train 298-29 struck and derailed the last four cars of westbound CP Train 487-01 which was standing on UP Main Track # 1 and CP Main Track # 2. The derailment occurred at UP Milepost 17.5 in Northbrook, Illinois. The railroad timetable directions are west and east and geographic directions are north and south. Timetable directions are used throughout the body of this report. Approximately 1,280 feet of track was destroyed.

Flange marks for a distance of approximately 22 feet were evident on the inside closure rail. The POD was just north of the right hand floating heel block in the switch. The first car to derail was DME 488705 that was positioned as the 67th car in the train. The evidence suggests this car had a binding truck condition on the B-end of the car which allowed the wheels to climb the closure rail of the switch. As CP Train 298-29 operated through the turnout and crossover switches the derailling cars from CP Train 298 -29 struck and derailed the last four cars in standing CP Train 487-01.
