***Federal Railroad Administration
Office of Safety
Headquarters Assigned
Accident Investigation Report
HQ-2008-17***

***Burlington Northern Santa Fe (BNSF)
Walshville, IL
February 8, 2008***

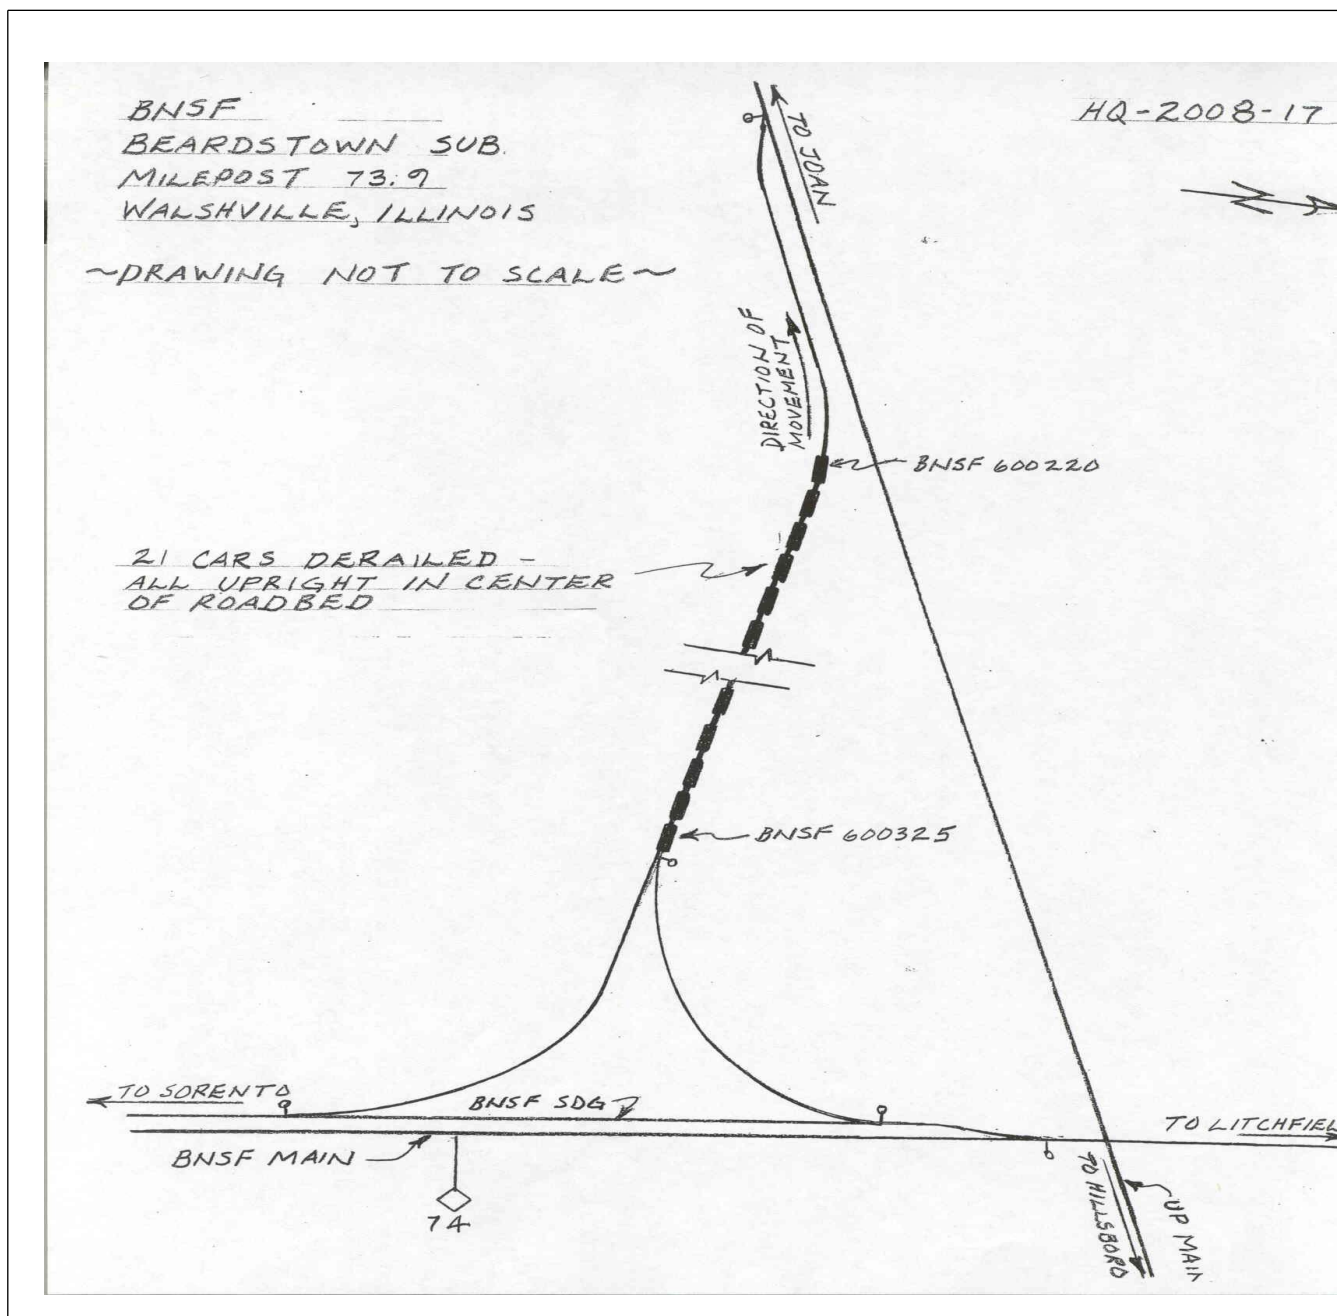
136. DRAW A SKETCH OF ACCIDENT AREA INCLUDING ALL TRACKS, SIGNALS, SWITCHES, STRUCTURES, OBJECTS, ETC., INVOLVED.

The track disturbed by the derailment began approximately 13 feet west of the switch point of the UP Connection Switch and proceeded westward approximately 725 feet, with the last 80 feet being in the spiral of a left-hand curve. The north rail had been rolled inward pulling the spikes on the field side completely out of the ties for approximately 75 feet and lifting the spikes for an additional 300 feet. Wheel marks were found on the field side web of the north rail indicating that at least one wheel had been over the rail.

Wheel marks were also found at a joint on the north rail where a wheel had crossed back over the rail from the north to the south. After being rolled inward, the north rail had then been set back upright and pushed north beyond the tie plates. In addition, the north rail had been shoved westward, out of a joint located approximately 12 feet west of the UP Connection Switch. The north rail was broken 200 feet west of the switch point and the rails bypassed and overlapped approximately 8 feet. Photographs, supplied by the BNSF, showed a gap in the north rail at the east end which appears to be significantly larger than the overlap at the west end. This appears to indicate that an additional break in the north rail had occurred and that a piece of rail at least 8 feet in length was unaccounted for.

The south rail had been rolled outward onto its side beginning at a point 13 feet west of the switch point and

continuing west for approximately 700 feet. The south wheels of the derailed cars were running on the edge of the overturned rail and on the ties inside of the rail.
