***Federal Railroad Administration  
Office of Safety  
Headquarters Assigned  
Accident Investigation Report  
HQ-2008-20***

***Union Pacific (UP)  
Des Moines, IA  
February 15, 2008***

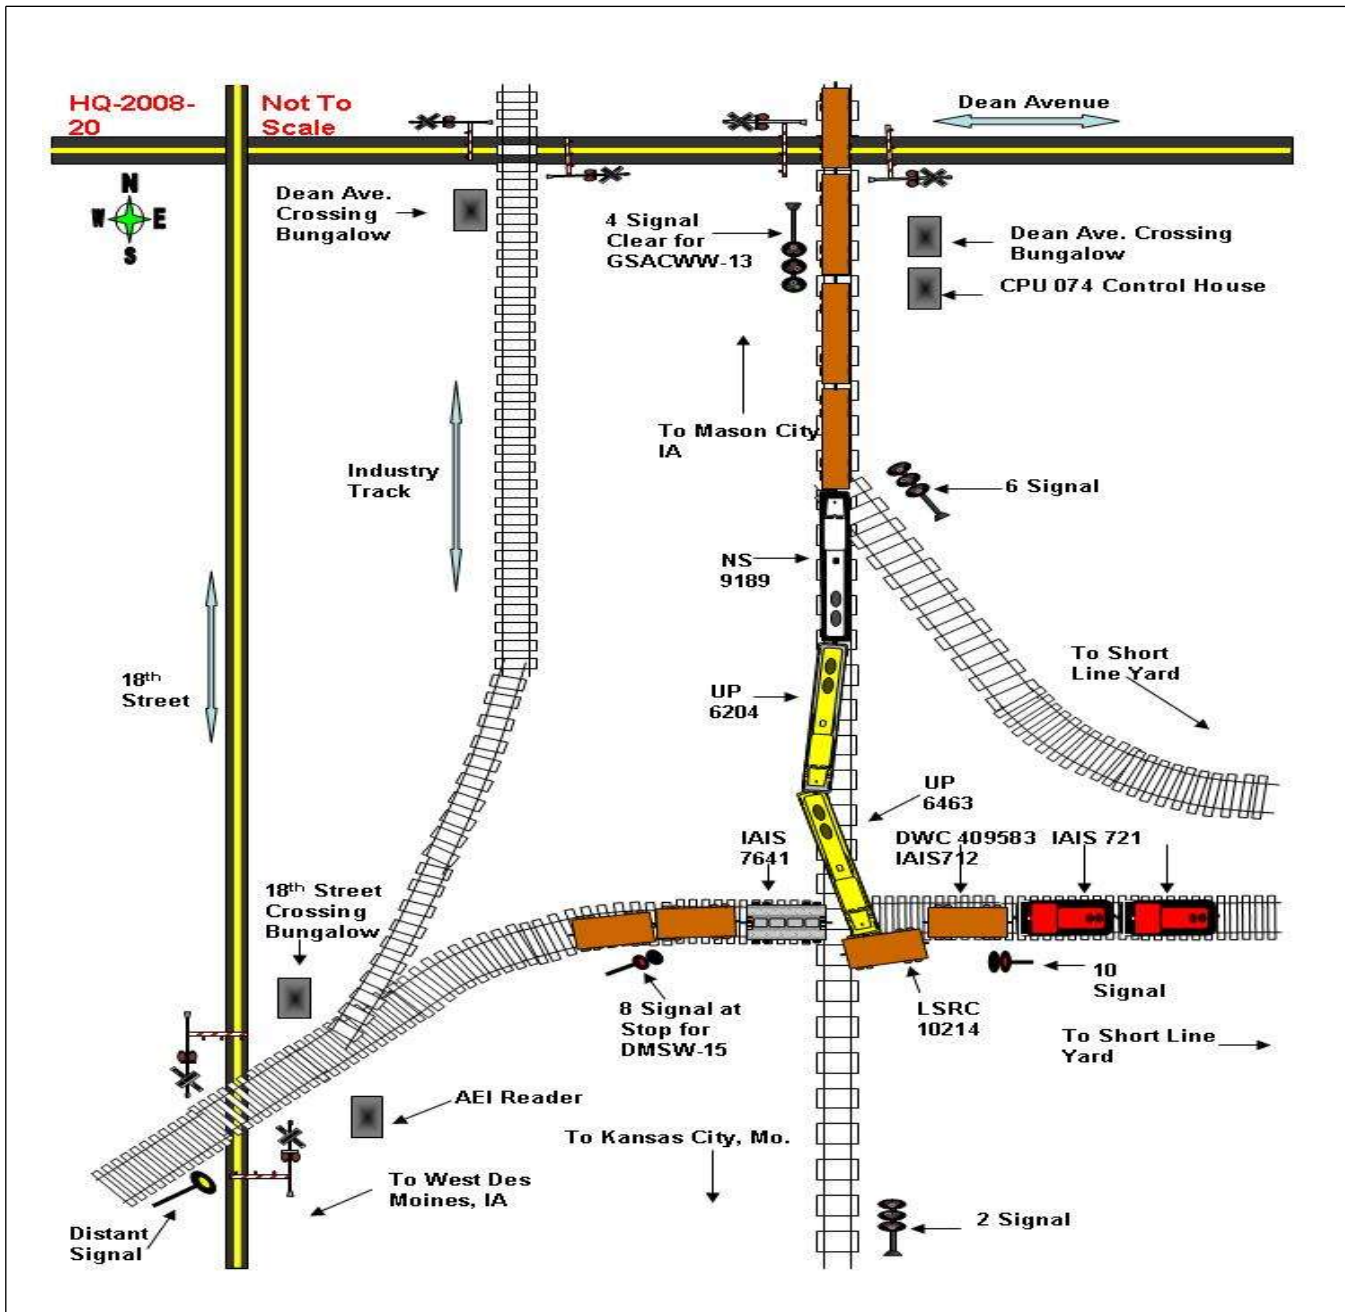
136. DRAW A SKETCH OF ACCIDENT AREA INCLUDING ALL TRACKS, SIGNALS, SWITCHES, STRUCTURES, OBJECTS, ETC., INVOLVED.

On February 15, 2008, at 2:42 p.m. CST, a side impact collision occurred between the Iowa Interstate Railroad Ltd.'s (IAIS) Train DMSW-15 and Union Pacific Railroad Company's (UP) Train GSACWW-13. The IAIS train was operating on the UP Twin Cities Service Unit, Iowa Area, Perry Subdivision at milepost (MP) 355.50 and the UP train was operating on the Twin Cities Service Unit, Iowa Area, UP Mason City Subdivision at MP 73.60. The collision occurred at Control Point (CP) U074, a UP manual interlocking in Des Moines, Polk County, Iowa. The head two locomotives of UP Train GSACWW-13 and the second car of IAIS Train DMSW-15 were derailed. Damage estimates from the UP are \$209,685 to locomotive equipment and \$9,728 to track damages. IAIS damage estimates are \$21,512 to equipment and no in track, signal, way, and structure damage.

The probable cause of this incident was failure of the IAIS crew of Train DMSW-15 to comply with the signal indication of eastbound Interlocking Signal No 8 which governs movement to the railroad crossing at grade, at CP U074 (Cause Code H221).
