***Federal Railroad Administration
Office of Safety
Headquarters Assigned
Accident Investigation Report
HQ-2008-26***

***Union Pacific (UP)
Fairfield, NE
March 7, 2008***

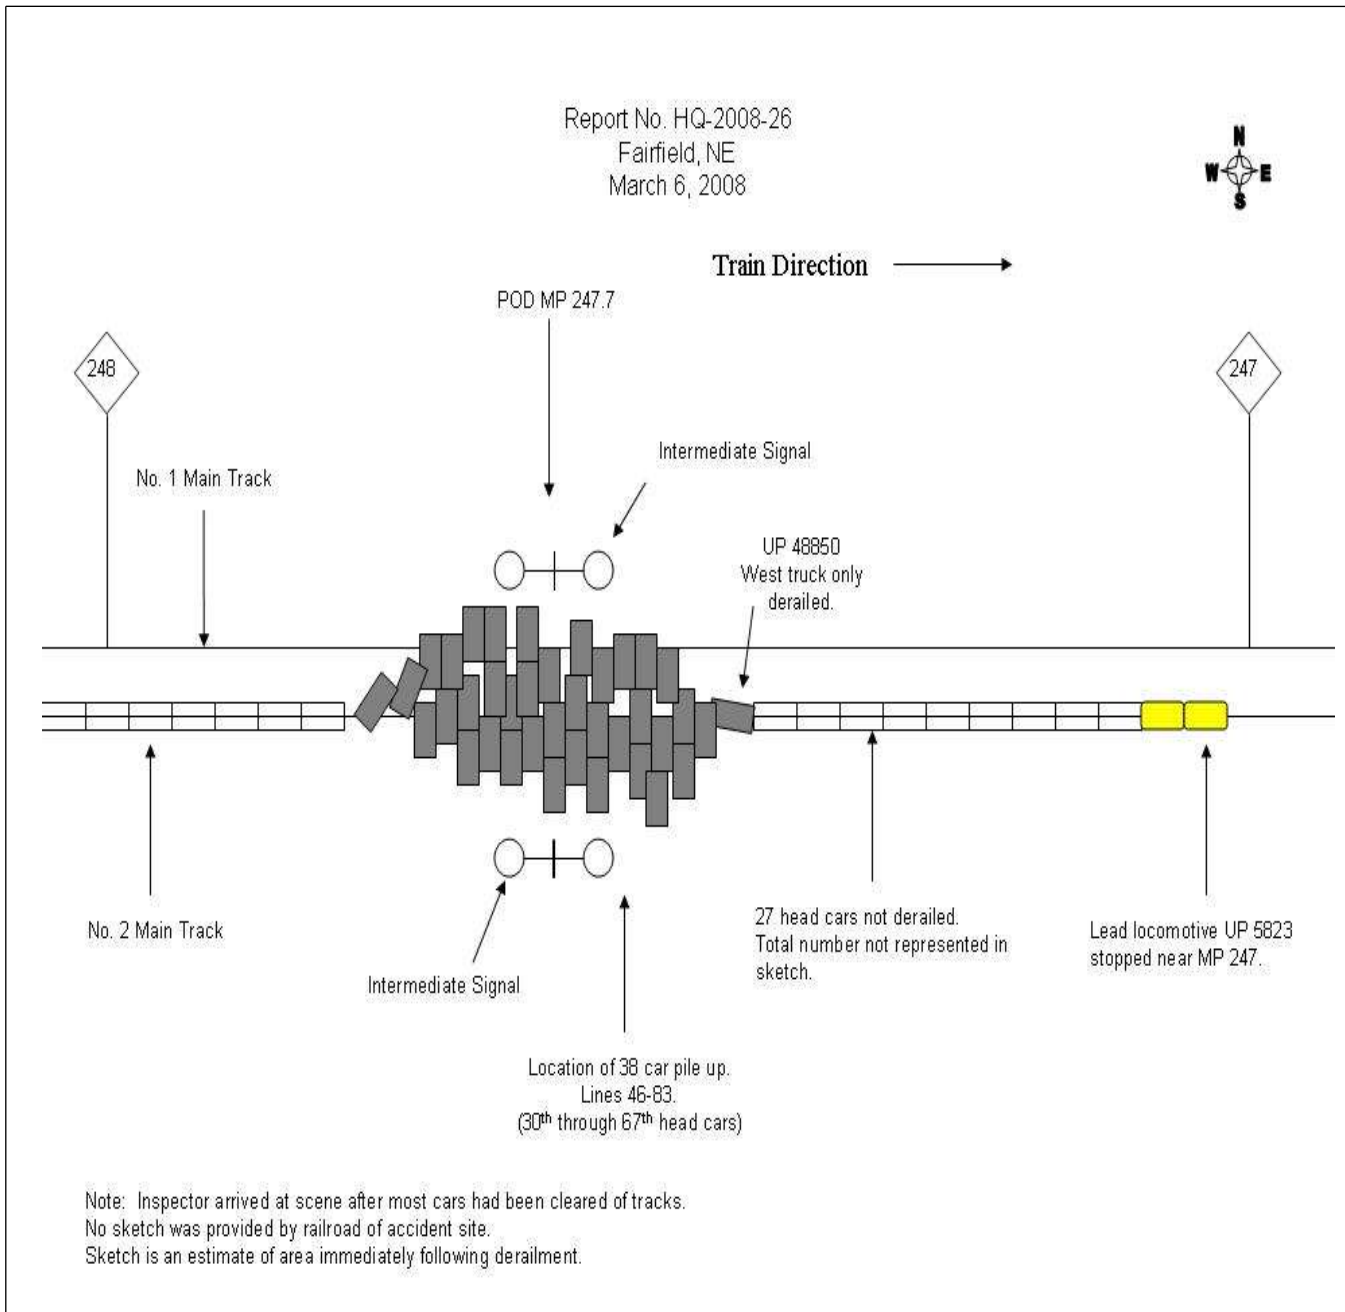
136. DRAW A SKETCH OF ACCIDENT AREA INCLUDING ALL TRACKS, SIGNALS, SWITCHES, STRUCTURES, OBJECTS, ETC., INVOLVED.

Eastbound Union Pacific Railroad Company (UP) Unit Coal Train CBTLU9-05 derailed on March 6, 2008, at 11:54 p.m. CST. The accident occurred near the town of Fairfield, Nebraska at milepost (MP) 247.7 on the North Platte Service Unit, Marysville Subdivision. As a result of the accident 38 cars were derailed.
