***Federal Railroad Administration  
Office of Safety  
Headquarters Assigned  
Accident Investigation Report  
HQ-2007-39***

***Metro North Commuter Railroad Company (MNCW)  
Milford, Connecticut  
June 21, 2007***

DEPARTMENT OF TRANSPORTATION FEDERAL RAILROAD ADMINISTRATION		FRA FACTUAL RAILROAD ACCIDENT REPORT				FRA File # <u>HQ-2007-39</u>	
1. Name of Railroad Operating Train #1 Metro North Commuter RR Co. [MNCW]			1a. Alphabetic Code MNCW		1b. Railroad Accident/Incident No. 2007062115

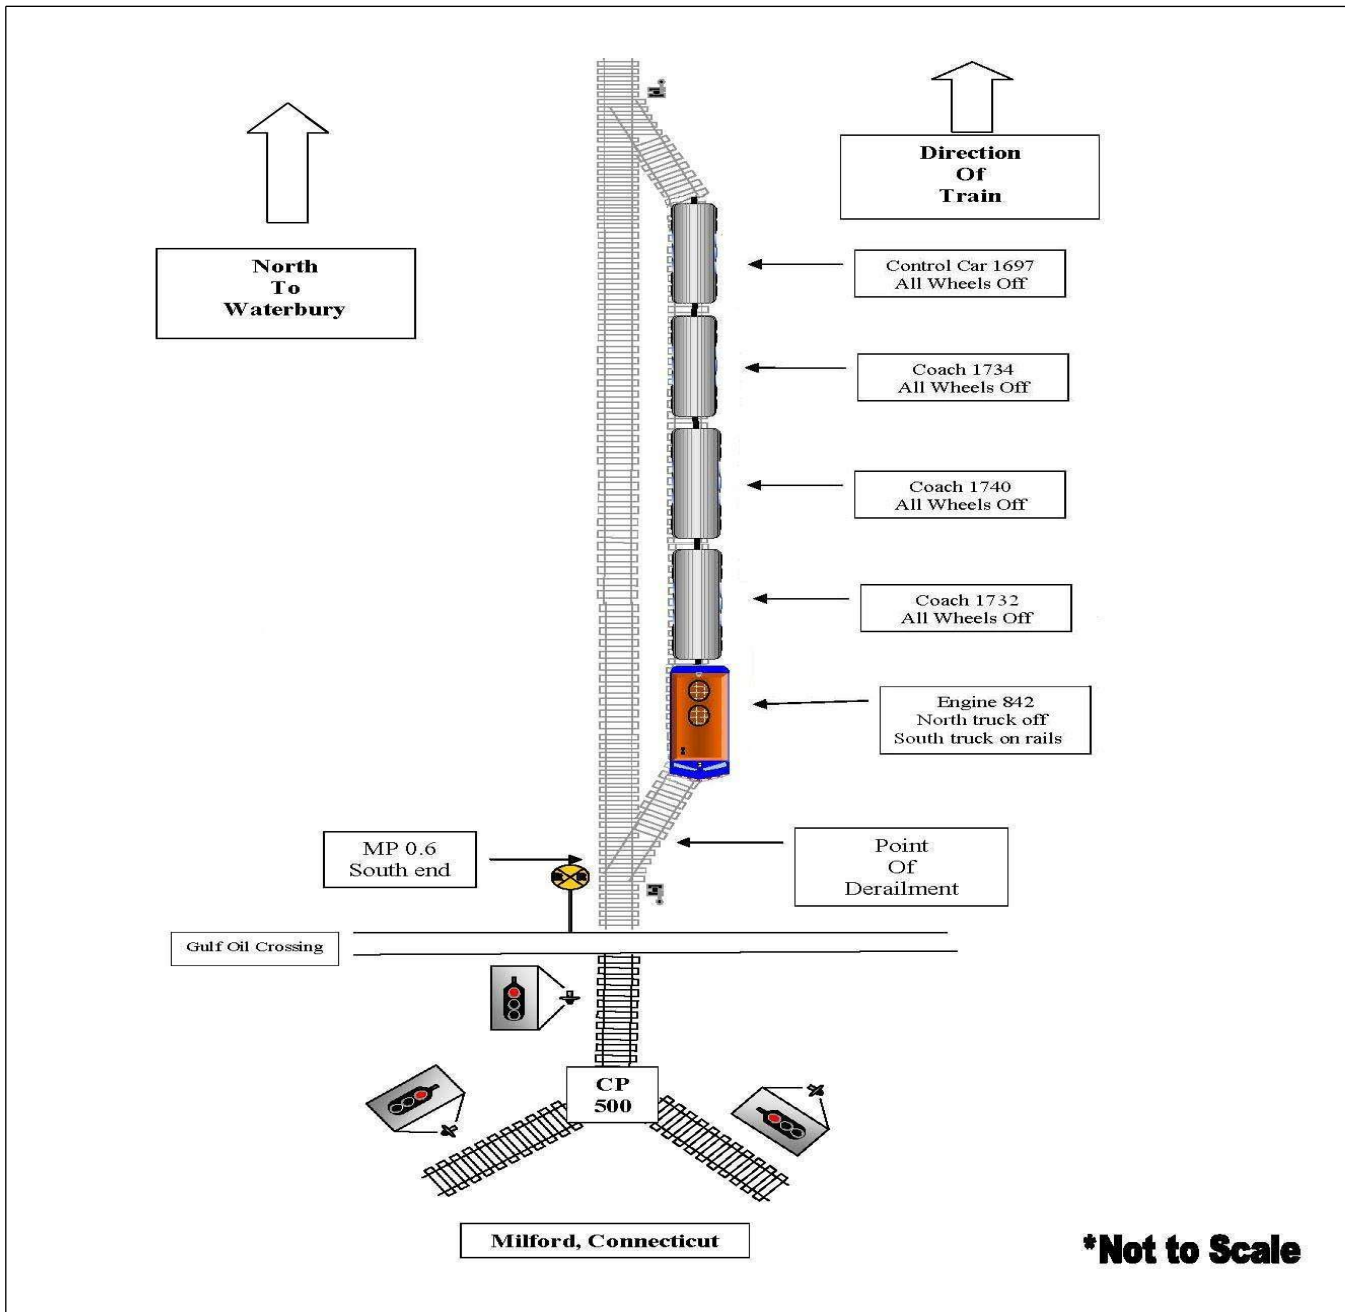
136. DRAW A SKETCH OF ACCIDENT AREA INCLUDING ALL TRACKS, SIGNALS, SWITCHES, STRUCTURES, OBJECTS, ETC., INVOLVED.

At approximately 1:46 PM EDST June 21, 2007, Metro North Railroad northward commuter train Number 1926 derailed Control Car 1697, three additional coaches and Engine 842 (pushing) on the Waterbury Branch in Milford, CT. The train derailed at the south end of the hand operated switch to the Ballast Track at Mile Post 0.6. Train 1926 was operating at 47 MPH. A total of 38 passengers and crew were onboard the train when it derailed. Two crew members and two passengers experienced minor injuries. The weather was clear, temperature 72 degrees and it was daylight. The Rail Traffic Controller in Grand Central Terminal, New York City had previously instructed the driver on an on-track Track Patrol vehicle to leave the hand switch to the Ballast Track in the reverse position for a following movement of a Ballast Regulator to clear in that track. The Ballast Regulator instead cleared the Single Track at a hand switch known as Track 5 at Mile Post 0.3. The Rail Traffic Controller mistakenly thought Track 5 and the south end of the Ballast Track were the same location and recorded the Single Track as clear. A southward train, Number 1963, then trailed through the misaligned switch and damaged it. The engineer of the southward train did not observe the switch in the reverse position as his attention was diverted away from the track by activity at the Gulf Oil Highway Crossing just beyond the hand switch in the reverse position. Train 1926 later approached the switch and observed it in the reverse position but was unable to stop in time. The train entered the side track and derailed.

Probable cause : The cause of the derailment was a misaligned switch.
