***Federal Railroad Administration
Office of Safety
Headquarters Assigned
Accident Investigation Report
HQ-2006-13***

***Union Pacific (UP)
Yukon, Oklahoma
March 7, 2006***

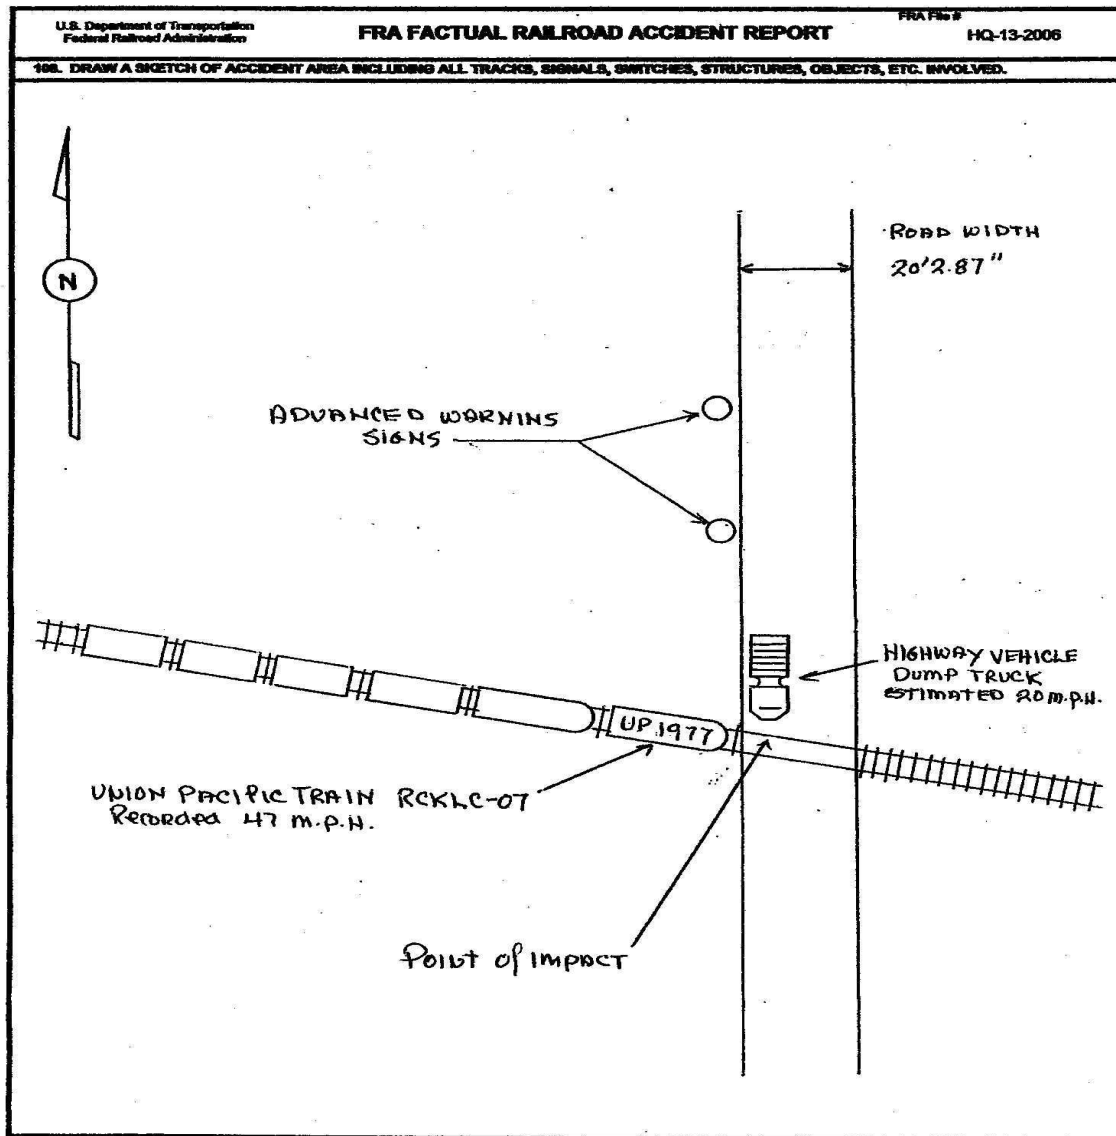
108. DRAW A SKETCH OF ACCIDENT AREA INCLUDING ALL TRACKS, SIGNALS, SWITCHES, STRUCTURES, OBJECTS, ETC., INVOLVED.
HQ-13-
2006.jpg

An eastbound Union Pacific freight train, collided with a loaded sand truck, at a rail/highway grade crossing, on March 7, 2006, at 09:47 a.m. The accident occurred within the City of Yukon, Oklahoma, at mile post 503.7, on the Oklahoma City Subdivision, of the Dallas / Ft. Worth Area, Wichita Service Unit.

Approximately four seconds prior to impact, it became apparent to the Engineer, that the highway vehicle was not going to stop. Approximately 216 feet prior to occupying the crossing, the engineer applied an emergency application of the train brakes, still continuing to sound the horn and bell. The highway vehicle continued southward, occupied the crossing and was struck by Union Pacific train RCKLC-07, at 9:47a.m.

There are no active warning devices at this crossing. Also, due to the fact that this is dark territory, there is not an active track signal system, The last whistle board approaching from the west is 1,320 feet from the crossing. Two southbound advanced warning signs are located at 521 and 368 feet respectively, north of the rail/highway crossing
