***Federal Railroad Administration
Office of Safety
Headquarters Assigned
Accident Investigation Report
HQ-2006-19***

***Union Pacific
Higginson, AZ
April 5, 2006***

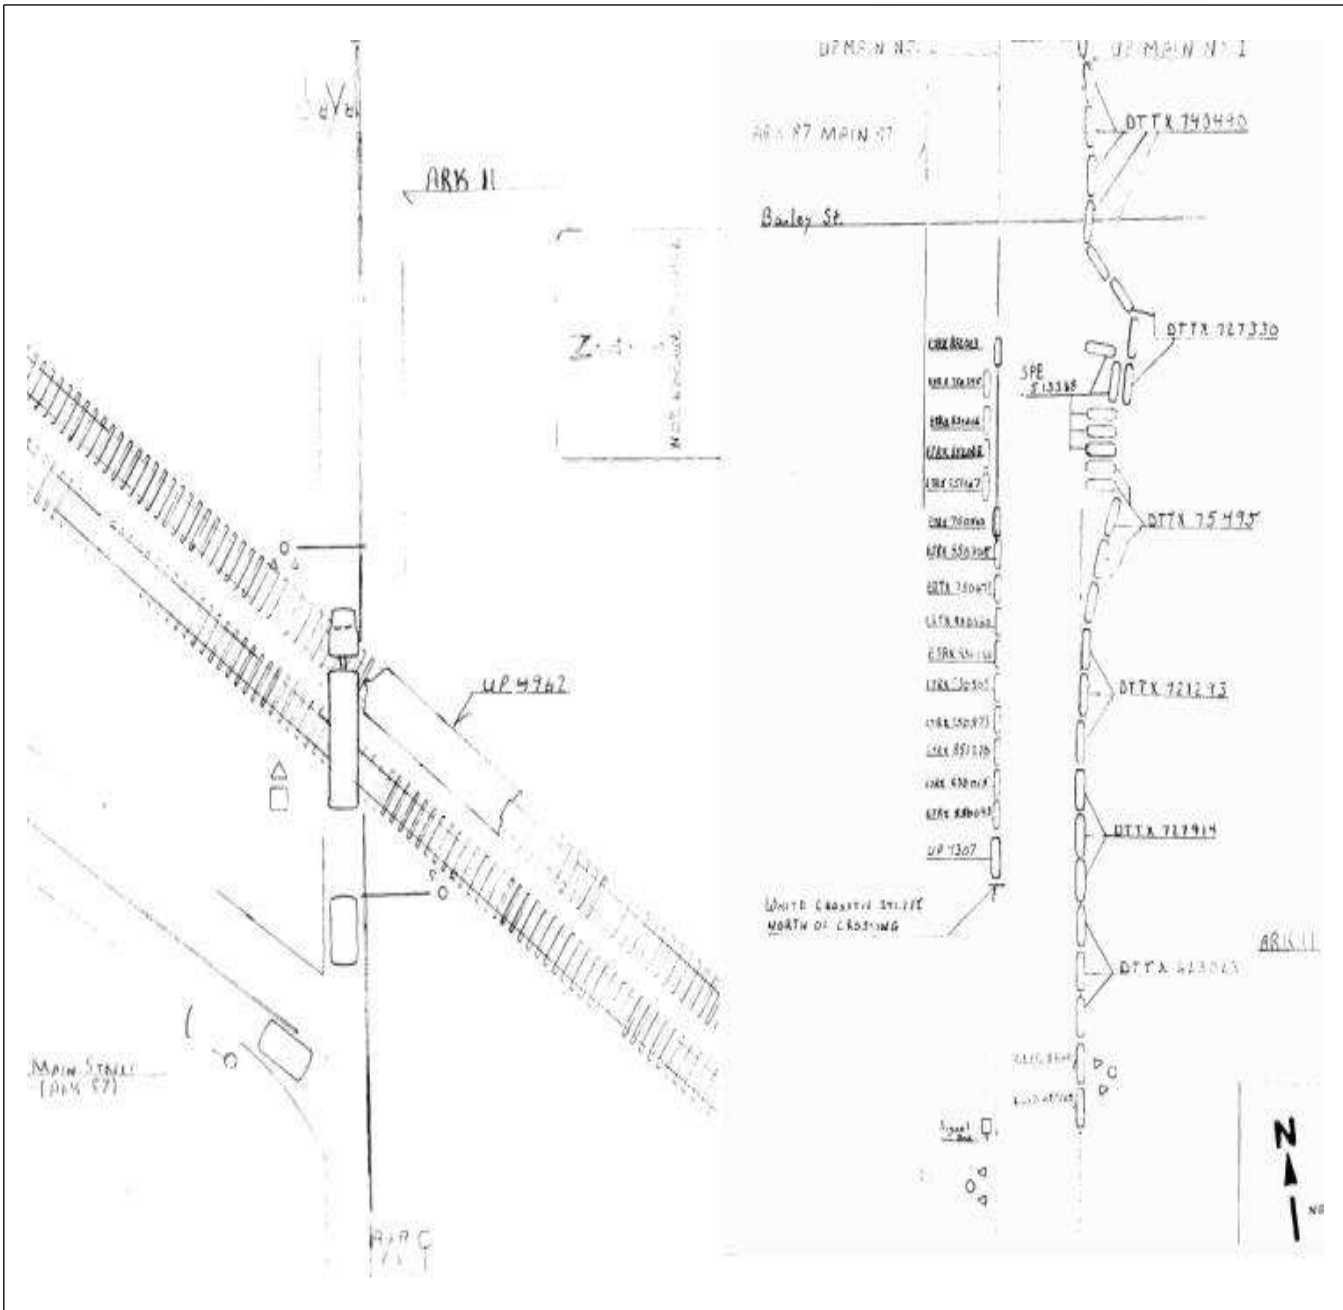
108. DRAW A SKETCH OF ACCIDENT AREA INCLUDING ALL TRACKS, SIGNALS, SWITCHES, STRUCTURES, OBJECTS, ETC., INVOLVED.
HQ19-
2006.JPG

A northbound Union Pacific (UP) train, ITIMNX 01, collided with a eastbound tractor/trailer on Arkansas State Highway 11 at a highway-rail grade crossing, on April 5, 2006 at 1:40 p.m. The accident occurred in Higginson, AR on the UP Number 2 main track at Milepost 300 on the Hoxie Subdivision. After the collision the vehicle was dragged down the track and hit a coal train, CNANW 02, standing on the number one main. The impact caused the vehicle to separate. The tractor was thrown clear of the track into a ditch. The trailer came to rest on the No. 1 main track after impacting UP 7307.
