***Federal Railroad Administration
Office of Safety
Headquarters Assigned
Accident Investigation Report
HQ-2006-28***

***Union Pacific (UP)
Dalton, Illinois
May 11, 2006***

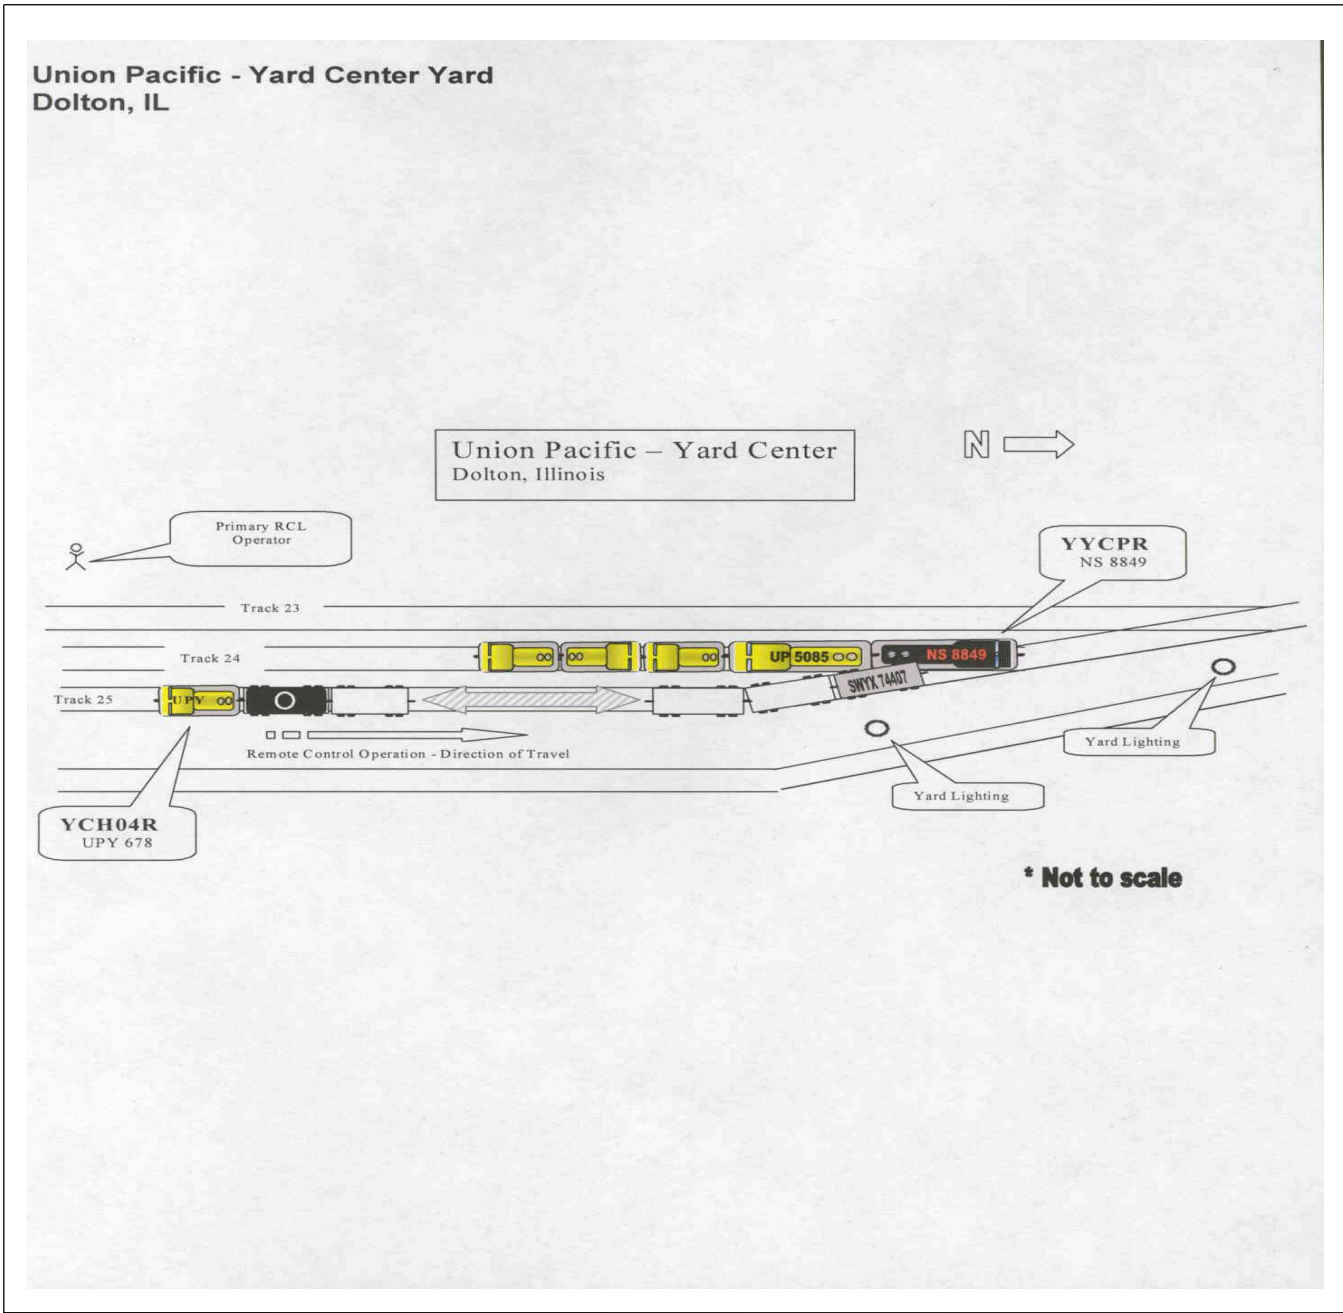
HQ-28-
2006
Accident
Sketch.jpg

On May 11, 2006, at 3:43 a.m. c.d.t. remote-controlled assignment YCH04R-10, while shoving 32 cars north on track 25 in 9-yard, collided with YYCPR-09. The accident occurred at the Union Pacific Yard Center Yard near Dolton, Illinois, UP Milepost 18.0 on the Villa Grove Subdivision. YYCPR-09, an extra yard transfer assignment, was fouling the lead at the north end of 9-yard.

The primary remote control operator (RCO) on YCH04R-10 shoved track 25 northward and the north car struck the lead locomotive, NS 8849, and the second locomotive, UP 5085, of YYCPR-09. The collision resulted in an estimated \$12,100 in damages to the two locomotives and about \$625 damage to the north car on track 25, SWYX 74407. As a result of the collision the NS 8849 and the SYNX 74407 derailed and two train crew members on board the NS 8849 were injured.
