***Federal Railroad Administration
Office of Safety
Headquarters Assigned
Accident Investigation Report
HQ-2006-31***

***Burlington Northern Santa Fe (BNSF)
Preston, Oklahoma
May 19, 2006***

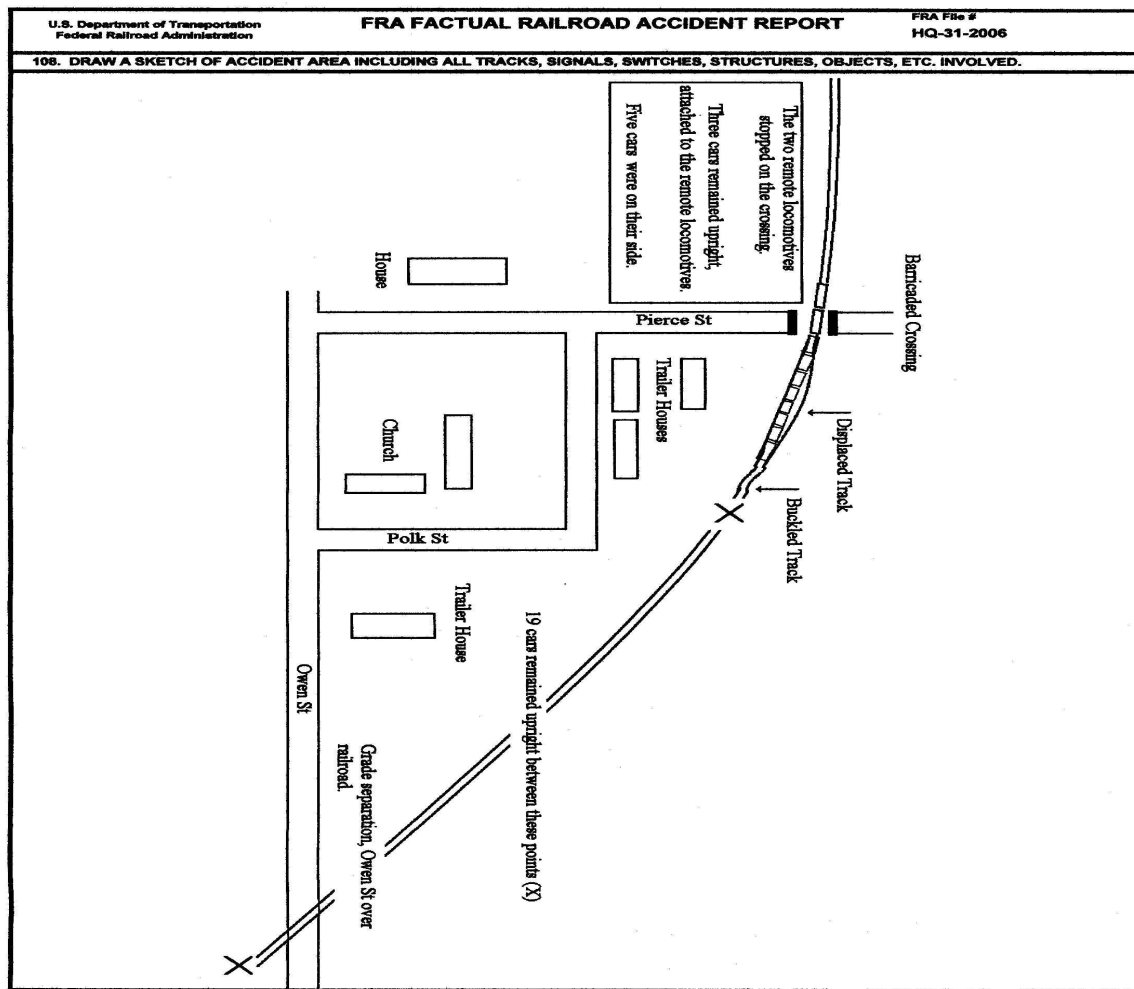
108. DRAW A SKETCH OF ACCIDENT AREA INCLUDING ALL TRACKS, SIGNALS, SWITCHES, STRUCTURES, OBJECTS, ETC., INVOLVED.
HQ-31-
2006.jpg

A southbound BNSF freight train derailed on May 19th, 2006, at approximately 5:30 p.m. The accident occurred in Preston, Oklahoma, at BNSF Milepost 462.1, on the BNSF Creek Subdivision.

27 cars derailed, 22 remained upright with five turned over on their side. Two remote locomotives directly behind the derailed cars remained on the track. There were no injuries to the train crew. There was extensive damage to track, roadbed, and equipment totaling about \$228,000.

The accident was caused by issues with rail anchors and ballast, coupled with high temperatures, resulting in a sun kink which caused the derailment.
