***Federal Railroad Administration  
Office of Safety  
Headquarters Assigned  
Accident Investigation Report  
HQ-2006-54***

***CSX Transportation  
Baltimore, MD  
June 25, 2006***

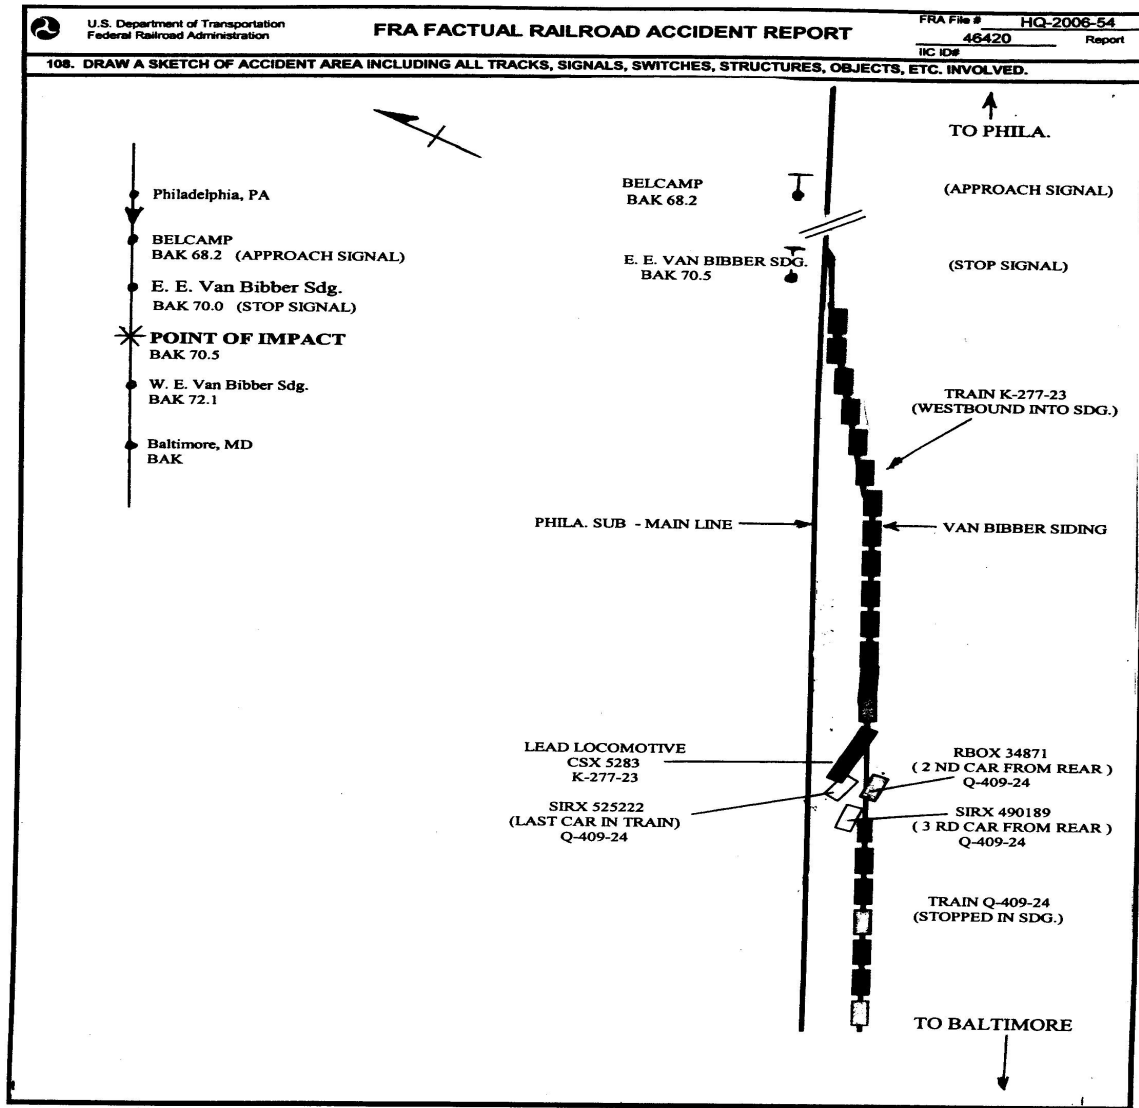
SKETCH  
HQ-2006-  
54.jpg

K-277-23, a westbound CSX freight train struck the rear of standing train, CSX, Q-409-24, on June 26, 2006 at 08:13 a.m. The impact occurred in Van Bibber, MD, at MP BAK 070.51, located at the east end of Van Bibber siding on the Philadelphia Subdivision of the Baltimore division.

The collision occurred on the east end of the Van-Bibber siding located at mile post BAK 070.51. The collision caused the lead unit of K277-23 to derail but remain in an upright / cross-way position. The rear three cars on the Q409-24 derailed. The rear car SIRX 525222 was empty and remained upright. RBOX 34871 was loaded and remained in an upright position, and SIRX 490189 was empty and remained in an upright position.
