***Federal Railroad Administration
Office of Safety
Headquarters Assigned
Accident Investigation Report
HQ-2006-82***

***Burlington Northern Santa Fe
St. Genevieve, Missouri
October 21, 2006***

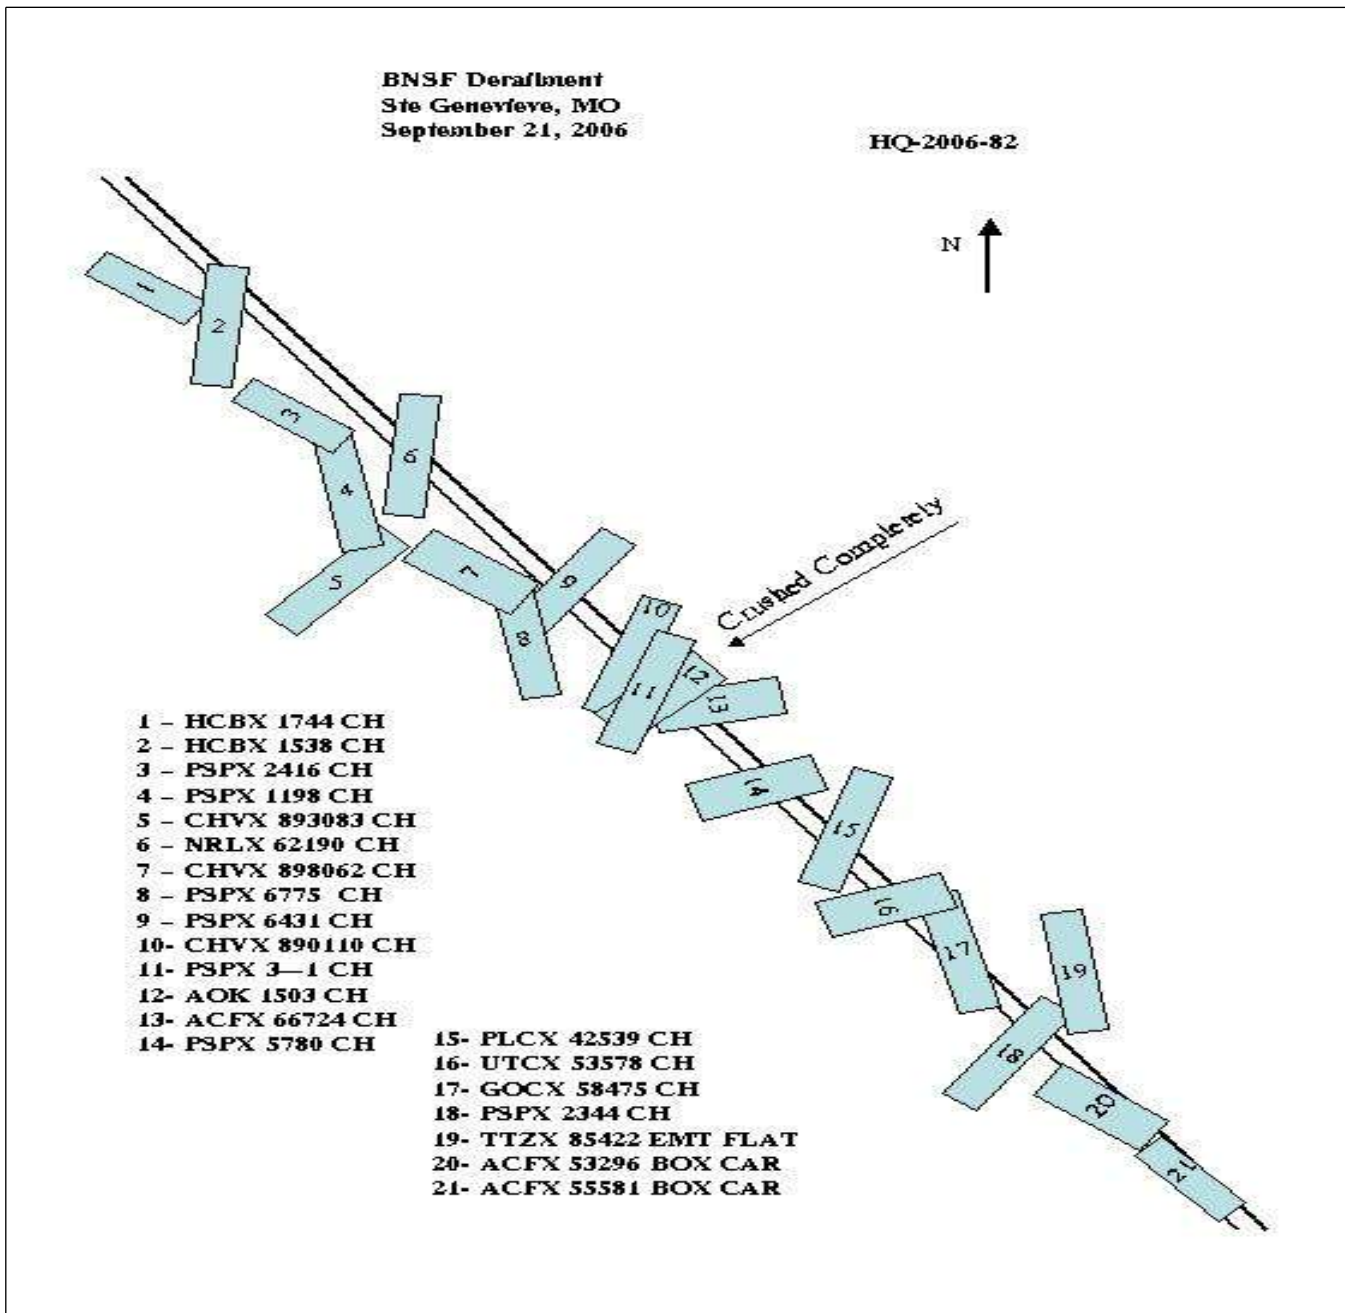
HQ-2006-
82_sketch.
jpg

108. DRAW A SKETCH OF ACCIDENT AREA INCLUDING ALL TRACKS, SIGNALS, SWITCHES, STRUCTURES, OBJECTS, ETC., INVOLVED.

At approximately 9:30 a.m. CDT, October 21, 2006, northbound BNSF Railway Company (BNSF) manifest Train Symbol HMEMNTW1 20A derailed the rear set of wheels on the second locomotive and the following 21 cars. The derailment occurred on the BNSF Springfield Division, River Subdivision at the south siding switch at Ste. Genevieve, Missouri, milepost(MP) 67.3.
