***Federal Railroad Administration
Office of Safety
Headquarters Assigned
Accident Investigation Report
HQ-2005-01***

***CSX Transportation (CSX)
Glenco, Kentucky
January 5, 2005***

HQ-01-2005

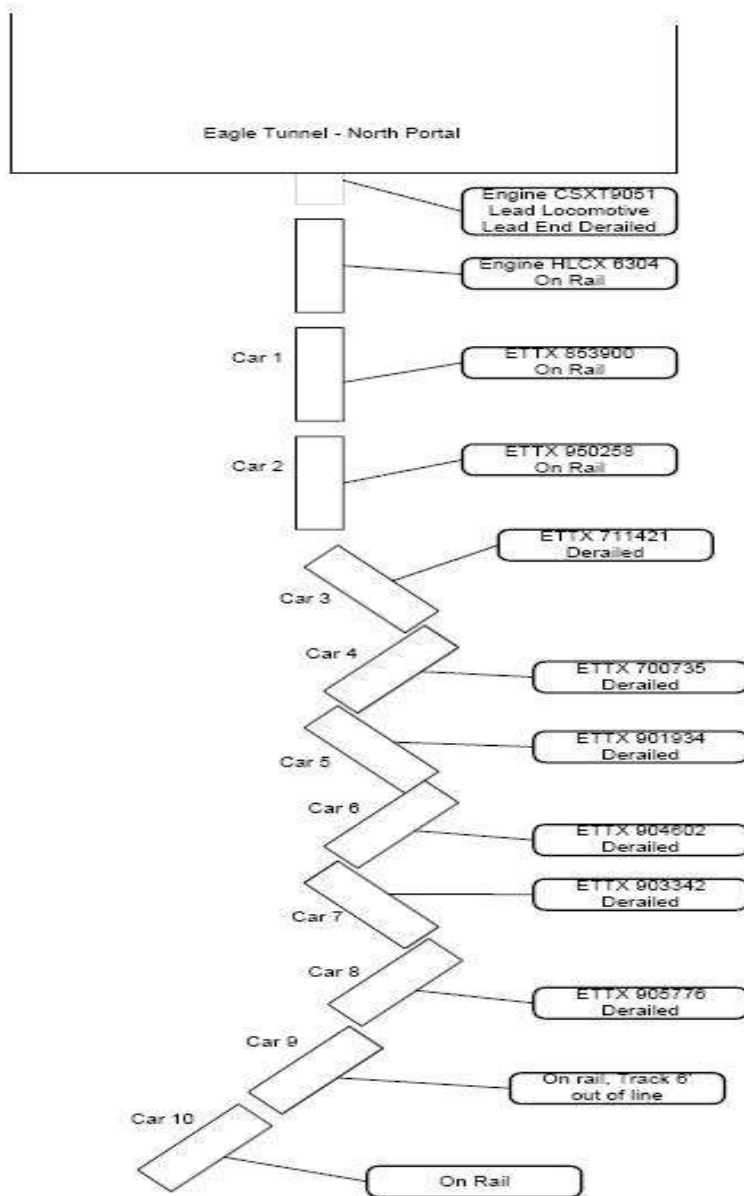
108. DRAW A SKETCH OF ACCIDENT AREA INCLUDING ALL TRACKS, SIGNALS, SWITCHES, STRUCTURES, OBJECTS, ETC., INVOLVED.
HQ-1-2005
sketch.jpg

The southbound train was traveling about 17 miles per hour (mph) before the derailment. The event recorder showed that an emergency brake application was initiated about six seconds before impact, slowing the train to a recorded speed of seven mph. The derailment occurred about 40 feet inside the north portal of Eagle Tunnel.

A portion of the west side wall of the tunnel, about 60-feet from the north end portal, collapsed. This collapsed portion was about 75 feet long. A crack was observed 40 to 60-feet in from the north end emanating from the collapsed arch, it extended about 20 feet into the crown. An area of about 10-feet from the collapse showed a flattening in the crown.
