***Federal Railroad Administration  
Office of Safety  
Headquarters Assigned  
Accident Investigation Report  
HQ-2005-02***

***Norfolk Southern (NS)  
Graniteville, South Carolina  
January 6, 2005***

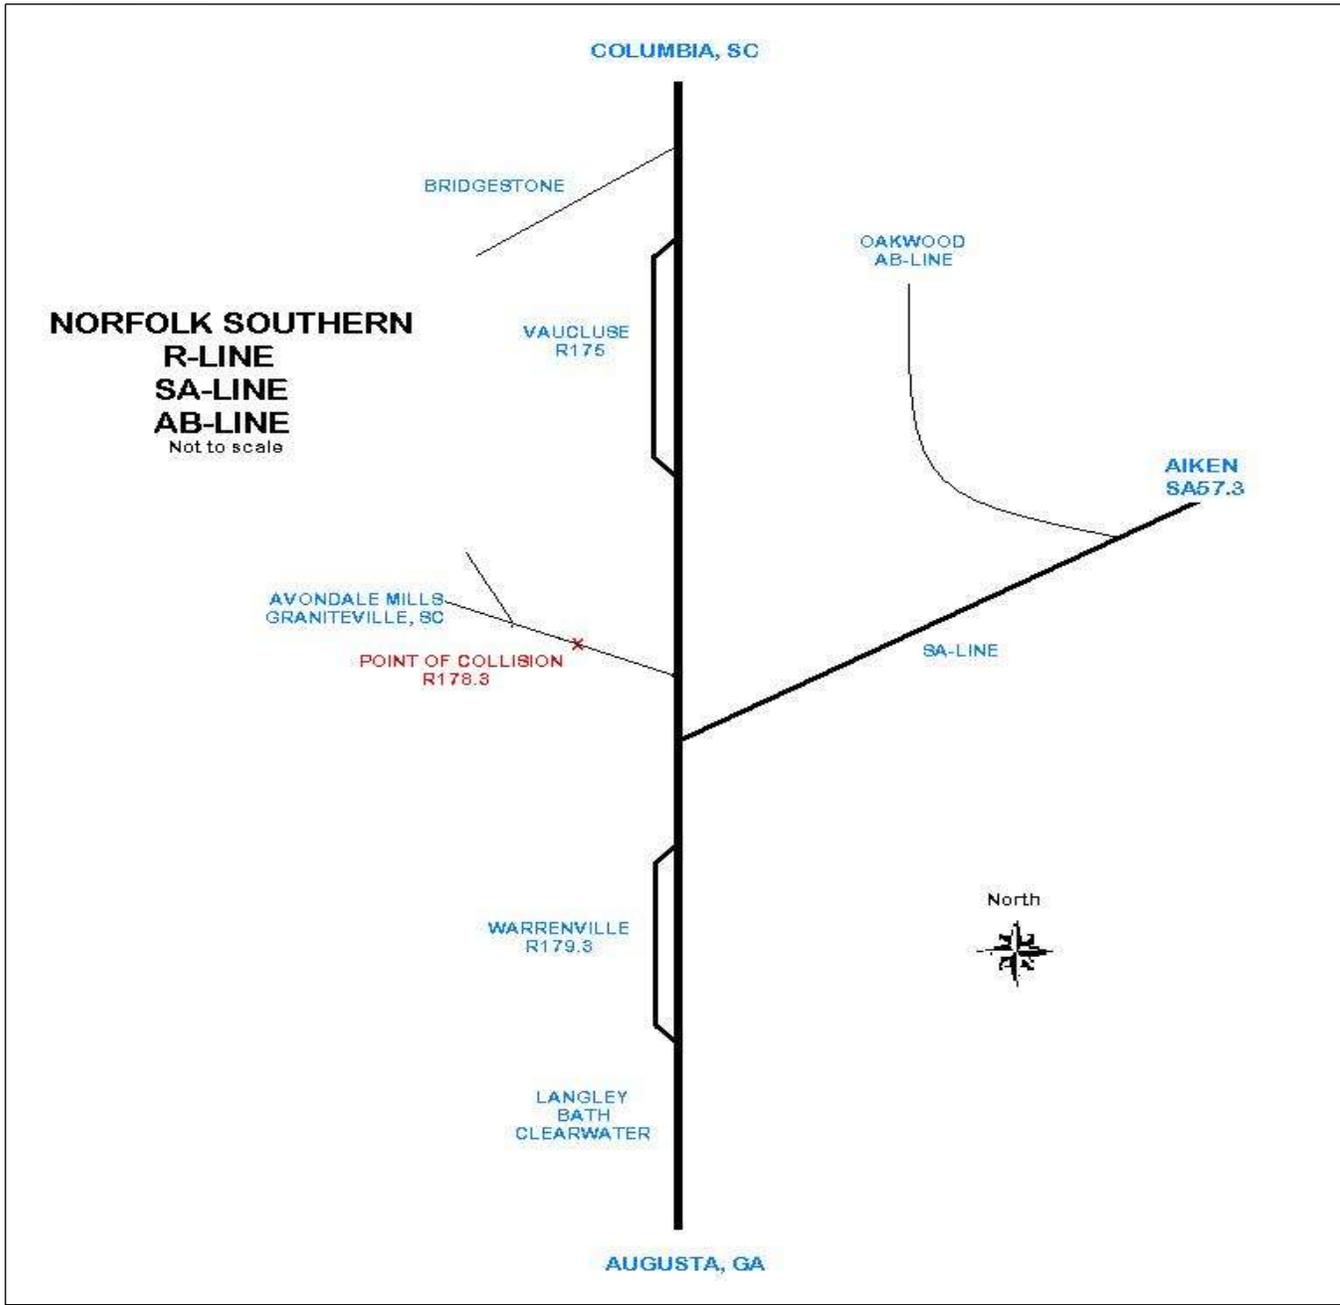
Graniteville  
Derailment  
Sketch.  
JPG

On January 6, 2005, at 2:39 a.m., Eastern Standard Time (EST), a head-on collision occurred in the Avondale Mills Gregg Industry track on the Norfolk Southern Railway Company (NS) Piedmont Division in Graniteville, South Carolina, NS Milepost (MP) R178.3. The striking train was northbound NS freight train 192P005. The train consisted of two locomotives, NS 6653 and NS 6593, 25 loads and 17 empties and was operated by a locomotive engineer and conductor. The unattended standing train was NS train P22P005, consisting of locomotive NS 4622 and two coupled rail cars.

The probable cause of the accident was the main track switch not being restored to the normal position after use. The normal position for the main track switch is lined and locked for movement on the main track.
