# Federal Railroad Administration Office of Safety Headquarters Assigned Accident Investigation Report HQ-2005-05

Union Pacific (UP)
Bayport, Texas
January 8, 2005

FRA File # HQ-2005-5

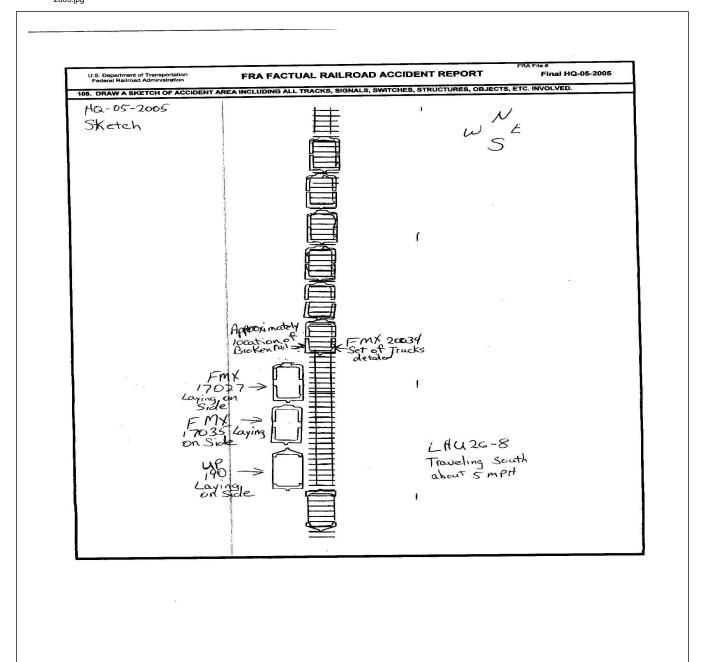
The accident was caused by a twelve (12) inch horizontal split head in the rail.

The FRA determined that the probable cause of the derailment was a horizontal spit head measuring 12 inches that broke from the parent rail as the lead locomotive unit traversed across the rail. The service failed rail then caused the second locomotive unit and the first and second tank cars to derail and fall onto their sides. The third car from the second locomotive unit had it's leading set of trucks derailed but remained upright.
