***Federal Railroad Administration
Office of Safety
Headquarters Assigned
Accident Investigation Report
HQ-2005-17***

***Union Pacific (UP)
Salem, Illinois
February 21, 2005***

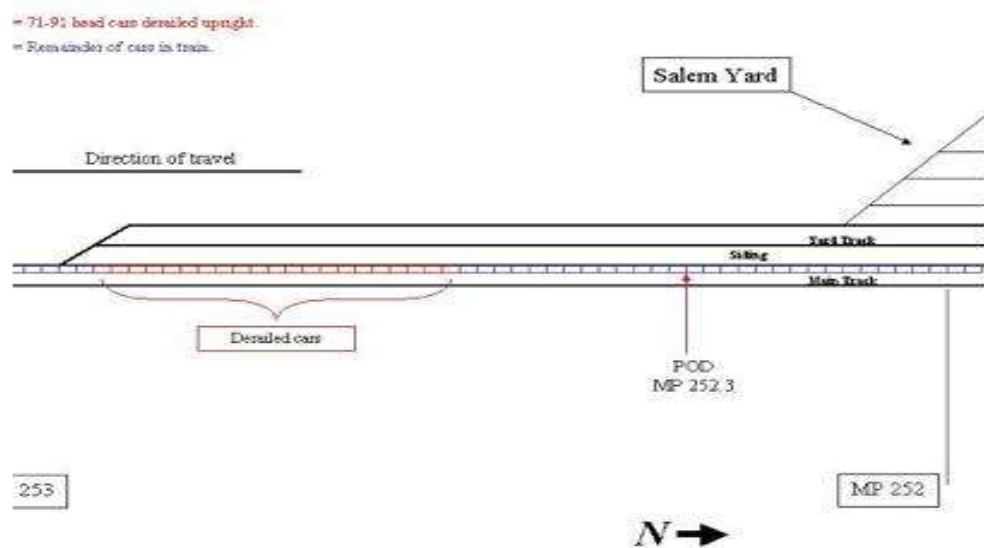
108. DRAW A SKETCH OF ACCIDENT AREA INCLUDING ALL TRACKS, SIGNALS, SWITCHES, STRUCTURES, OBJECTS, ETC., INVOLVED.

The engineer was able to quickly recover the train brake pipe air and determined the air was being restored to the rear of the train by observation of the head-end air gauges. The crew decided not to walk the train as UP Operating Rule 6.23 requires, and started to pull south. The train moved approximately 2,737 feet and experienced a second undesired emergency. The crew felt a series of jerks as they stopped. The conductor and the Salem switch crew then walked the train and found the 69th through 89th head cars (21 cars) derailed. The 75th head car (Car No. ACFX 77263) was a load of hydrogen cyanide (poison gas); however it was not compromised, and no evacuation was initiated. All derailed cars were upright and in line with the rail. The east rail was rolled out the entire length of the derailed cars.
