***Federal Railroad Administration
Office of Safety
Headquarters Assigned
Accident Investigation Report
HQ-2005-19***

***Union Pacific (UP)
Meachum, Oregon
March 5, 2005***

DEPARTMENT OF TRANSPORTATION FEDERAL RAILROAD ADMINISTRATION		FRA FACTUAL RAILROAD ACCIDENT REPORT				FRA File # <u>HQ-2005-19</u>	
1. Name of Railroad Operating Train #1 UNION PACIFIC RAILROAD COMPANY			1a. Alphabetic Code UP		1b. Railroad Accident/Incident No. 0305PD009

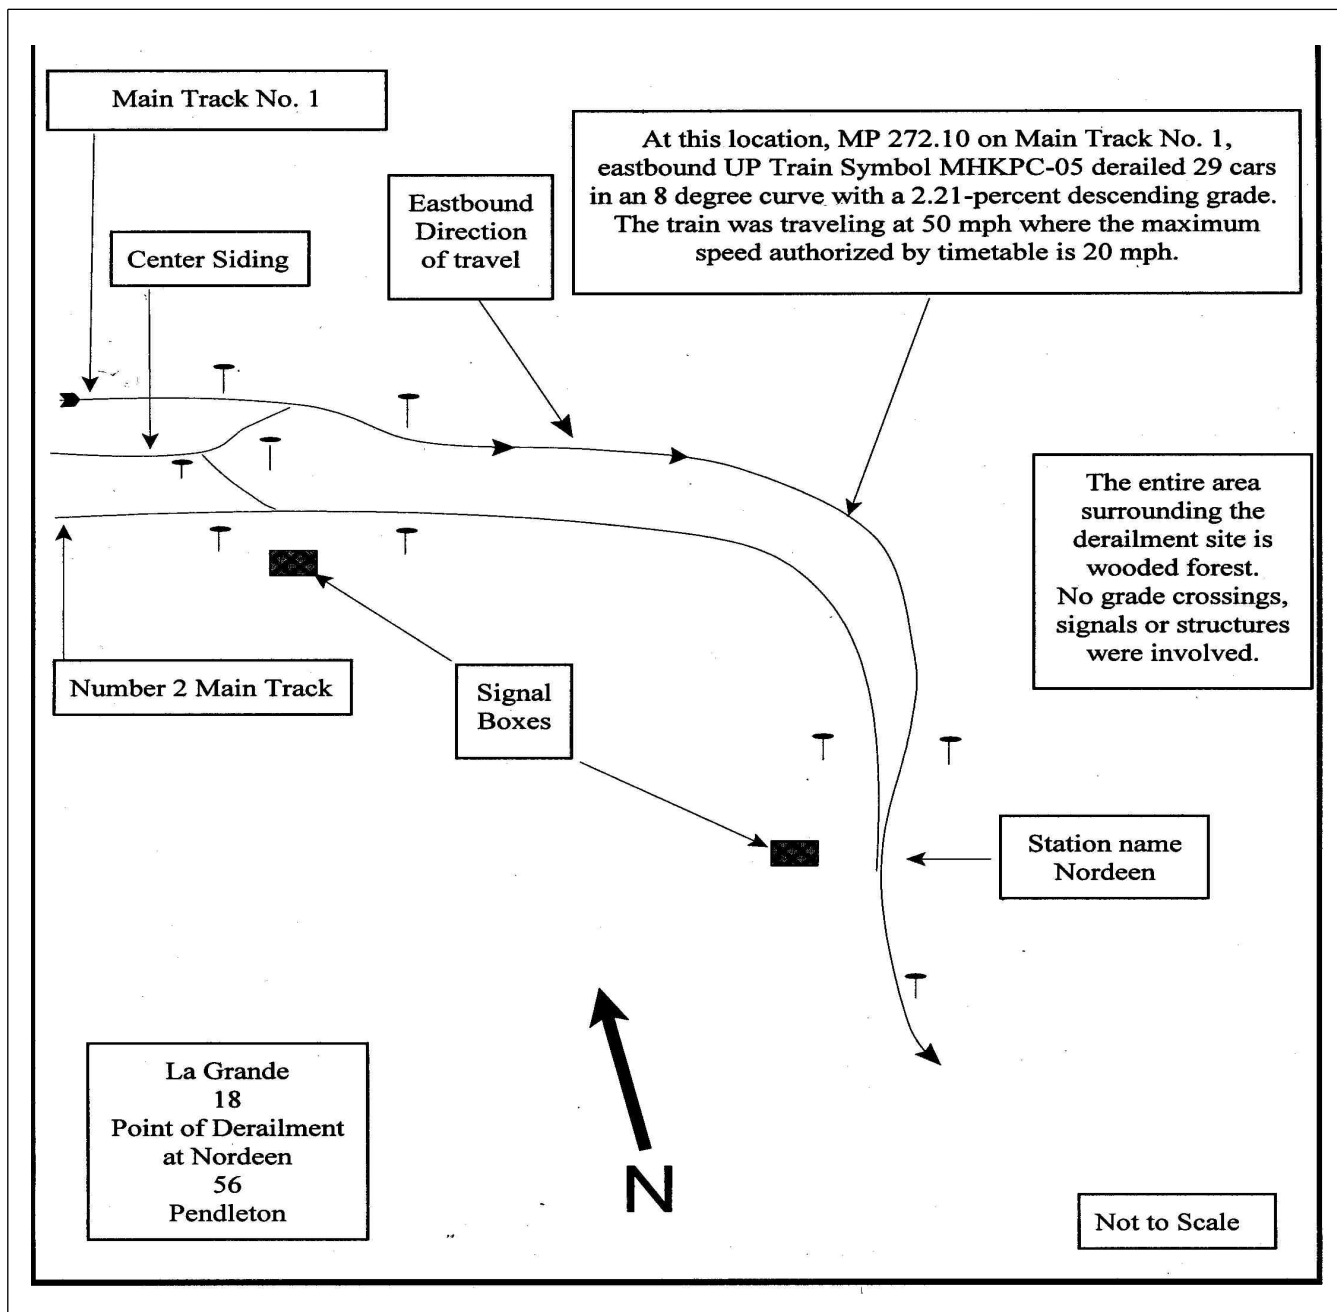
108. DRAW A SKETCH OF ACCIDENT AREA INCLUDING ALL TRACKS, SIGNALS, SWITCHES, STRUCTURES, OBJECTS, ETC., INVOLVED.

After coming to a stop, the engineer notified the train dispatcher of the emergency brake application and the conductor walked back to inspect the train. The conductor found the derailment site but for safety reasons did not enter it. Further examination by local UP managers responding to the accident disclosed that 29 cars had derailed, fouling both main tracks. The initial point of derailment was at milepost 272.1 in the body of an 8-degree 36-minute curve with a 2.21 percent descending grade. The derailment occurred approximately, 300 feet west of the switch at Nordeen, where the two main tracks converge into single main track.

The train derailed on Main Track No. 1 while traveling at 50 mph through an 8-degree curve with a 2.21-percent descending grade where the maximum authorized speed was 20 mph. The event recorder confirmed the speed at the derailment location to be 50 mph, which is 30 mph above the maximum authorized speed.
