***Federal Railroad Administration
Office of Safety
Headquarters Assigned
Accident Investigation Report
HQ-2005-21***

***BNSF (BNSF)/Fort Worth & Western (FWW)
Dublin, Texas
March 6, 2005***

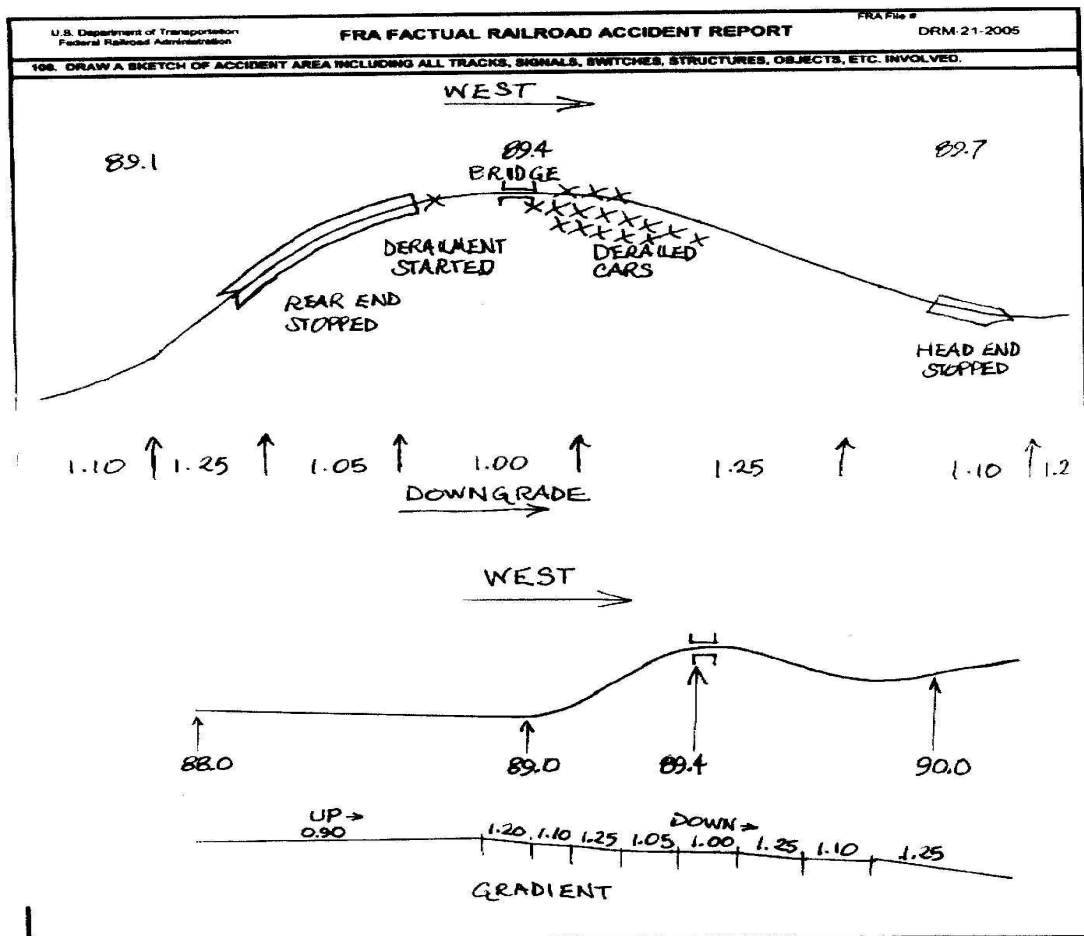
108. DRAW A SKETCH OF ACCIDENT AREA INCLUDING ALL TRACKS, SIGNALS, SWITCHES, STRUCTURES, OBJECTS, ETC., INVOLVED.
 DRM-21-2005.jpg

On Sunday, March 6, 2005, at 4:16 PM CST, while moving westbound in rain, BNSF mixed freight train H-ALTBAR-3-06, engine BNSF 5051 experienced a strong run-in and then an undesired emergency application of the train air brakes, derailling nineteen cars and destroying a bridge. There were no injuries but one tank car released hazardous materials. No evacuation was called. The cause of the derailment was train make-up. There was an empty flat car in the middle of the 9803 ton train that incurred excessive buff force which forced the car off the track.. Contributing cause was defective cross ties at the sight of the derailment that allowed the excessive force to turn over the rail on the outside of the curve.
