***Federal Railroad Administration
Office of Safety
Headquarters Assigned
Accident Investigation Report
HQ-2005-28***

***Union Pacific (UP)
Rialto, California
April 5, 2005***

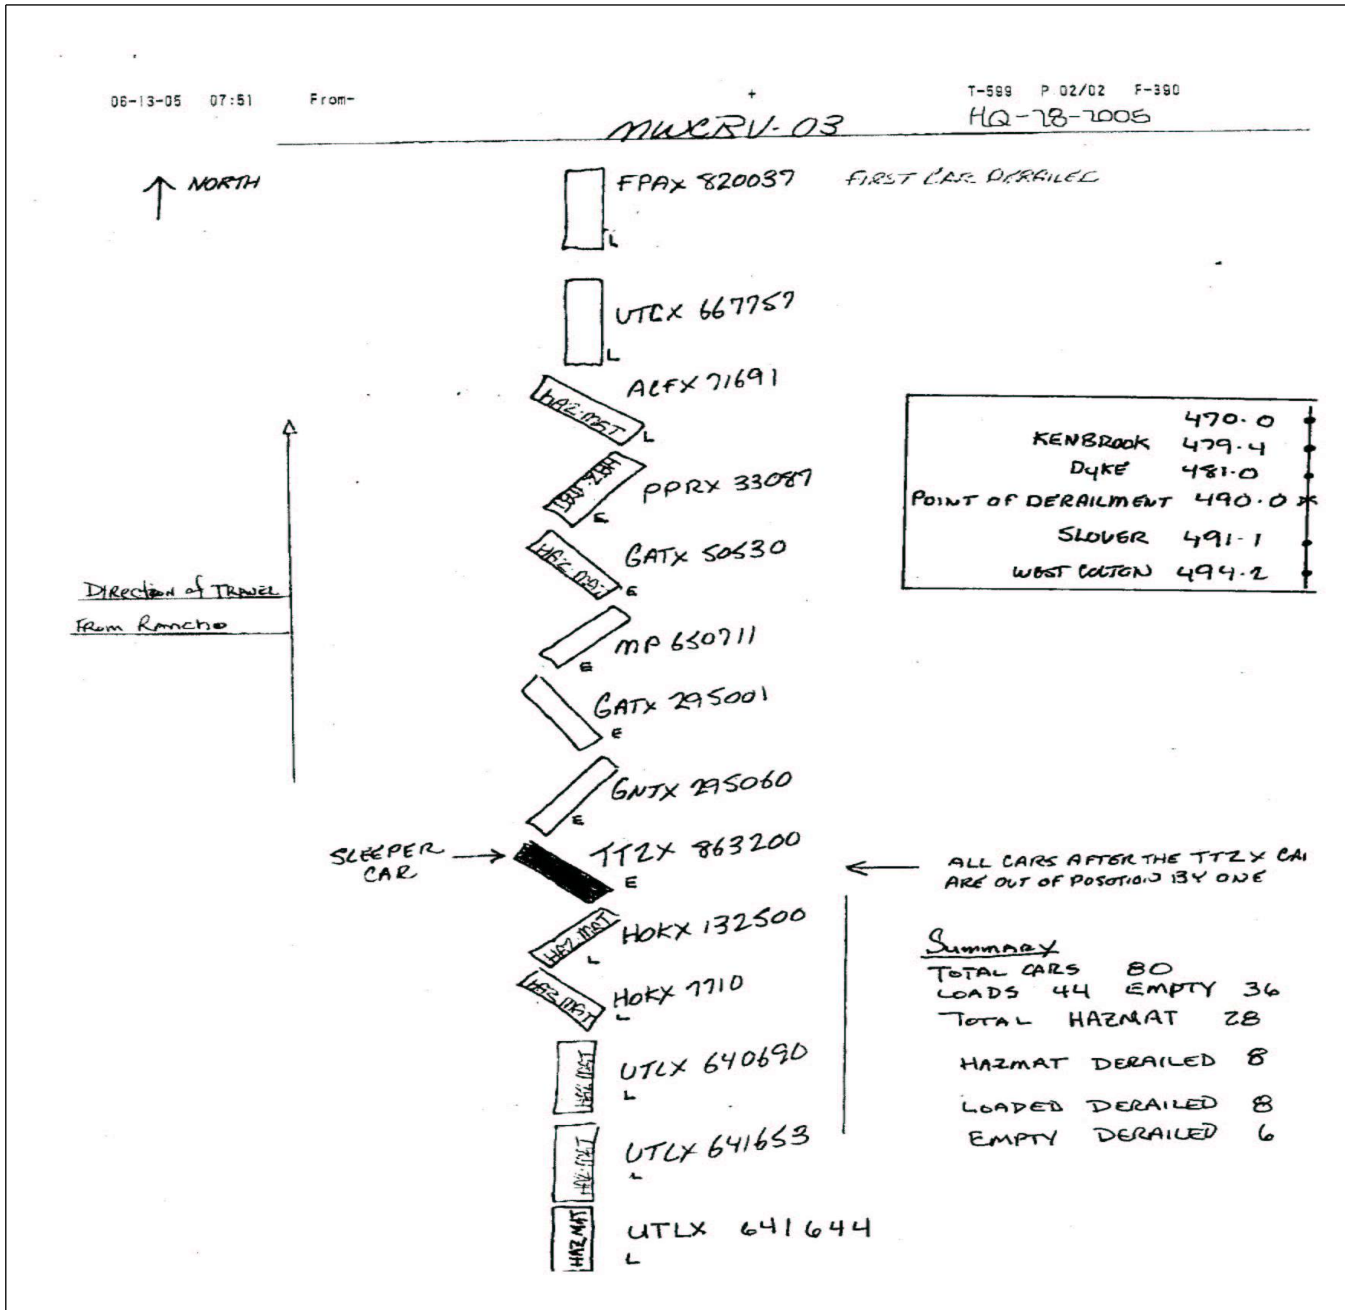
108. DRAW A SKETCH OF ACCIDENT AREA INCLUDING ALL TRACKS, SIGNALS, SWITCHES, STRUCTURES, OBJECTS, ETC., INVOLVED.
HQ-28-
2005.jpg

At approximately 8:30 p.m. PST on April 4, 2005, Union Pacific Railroad Company (UP) train symbol M-WCRV-03, consisting of five locomotives, 44 loads and 36 empties derailed 14 cars at milepost 490.0, near Rialto, California. (The train consist showed 44 loads and 35 empties; however, one additional "sleeper" car for a total of 80 cars was discovered following the derailment.) The train was departing the North Slover switch and derailed about 30 feet north of the switch. The estimated speed was 25 mph. Cars derailed were positioned 3 through 16 from the trailing locomotive.
