***Federal Railroad Administration
Office of Safety
Headquarters Assigned
Accident Investigation Report
HQ-2005-38***

***Union Pacific (UP)
North Bend, Nebraska
May 2, 2005***

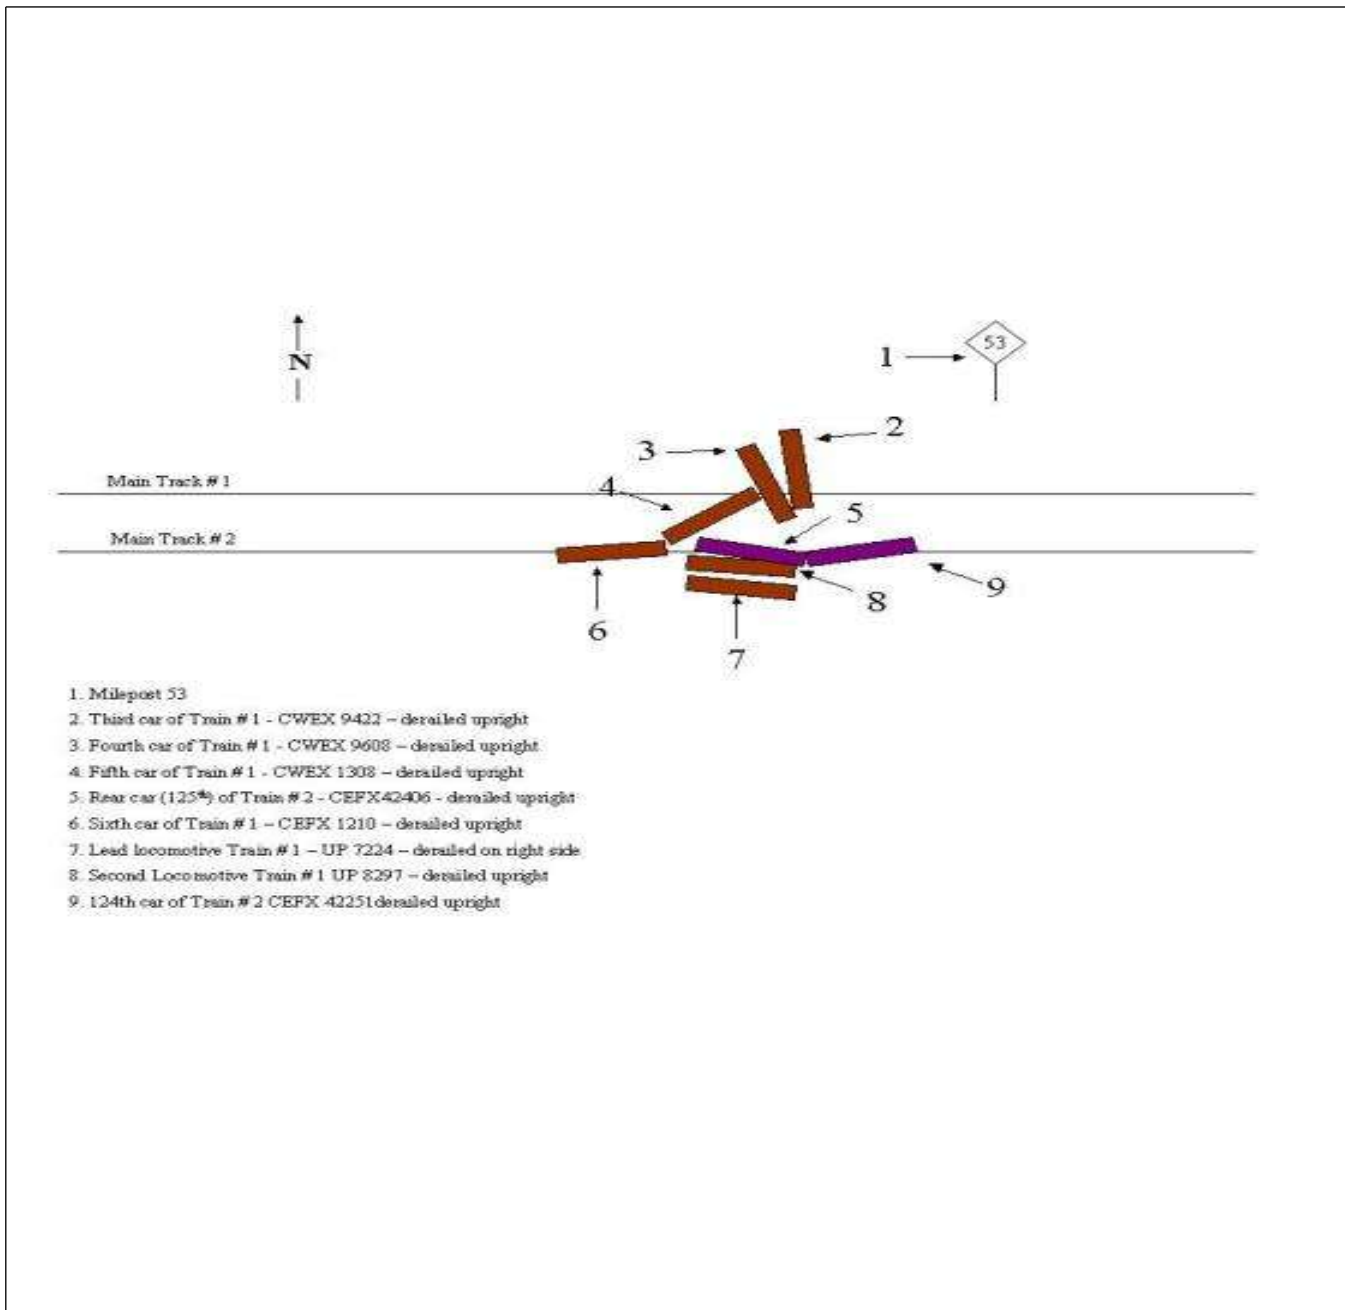
HQ-38
Sketch.jpg

An eastbound UP freight train bearing Train Symbol CNAWK-01 (Train No. 1) collided with another eastbound UP freight train bearing Train Symbol CCAFL9-30 (Train No. 2) on May 2, 2005, at 11:25 p.m. The accident occurred on UP Main Track No. 2, near North Bend, Nebraska, milepost (MP) 53.49, on the Columbus Subdivision, Council Bluffs Service Unit.

The accident was caused by the failure of the crew of Train No. 1 to comply with signal indications displayed by both wayside and on-board cab signal aspects. A contributing factor was crew fatigue.
