***Federal Railroad Administration
Office of Safety
Headquarters Assigned
Accident Investigation Report
HQ-2005-40***

***Burlington Northern Santa Fe (BNSF)
Casselton, North Dakota
May 5, 2005***

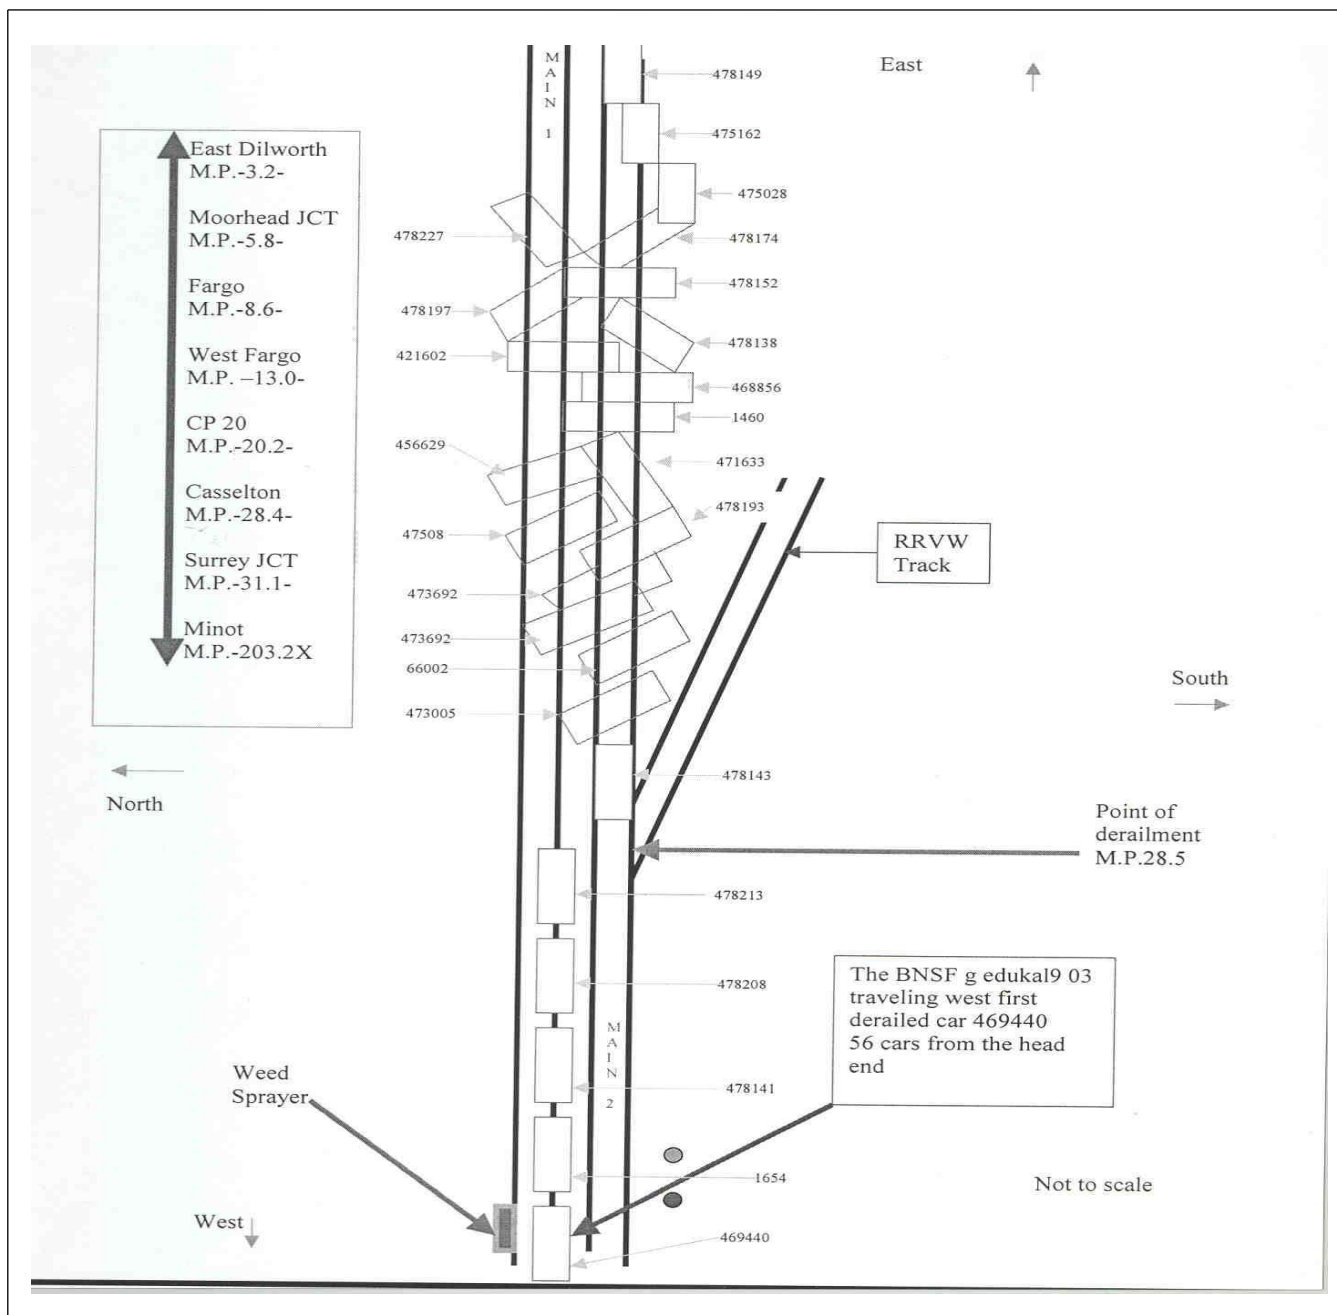
108. DRAW A SKETCH OF ACCIDENT AREA INCLUDING ALL TRACKS, SIGNALS, SWITCHES, STRUCTURES, OBJECTS, ETC., INVOLVED.

A westbound BNSF Railway Company (BNSF) freight train derailed on May 5, 2005, at 2:15 p.m., CDT. The derailment occurred west of Casselton, North Dakota, on Main 2 track, at milepost 28.5, on the Twin Cities Division, KO Subdivision.

The train consisted of three locomotives and 107 loaded grain cars. The 56th car in the consist derailed as it passed over the Red River Valley & Western Railroad Company junction switch and a general derailment of the following 24 cars ensued. The first car that derailed went north toward Main 1 track and struck a weed spray truck, contracted by BNSF and owned by "Right A Way Applicators" (RAW). The RAW spray truck was on Main 1 track.

Further examination of the scene noted that 25 cars had derailed. The initial point of derailment was at milepost 28.5 at the Red River Valley & Western Railroad Company junction switch. The derailment happened on Main 2 track. The first car derailed struck the RAW weed spray truck on Main 1 track. The driver of the spray truck was trapped inside the cab of the truck for approximately one hour.
