***Federal Railroad Administration
Office of Safety
Headquarters Assigned
Accident Investigation Report
HQ-2005-41***

***Heber Valley Railroad (HVRX)
Heber, Utah
May 10, 2005***

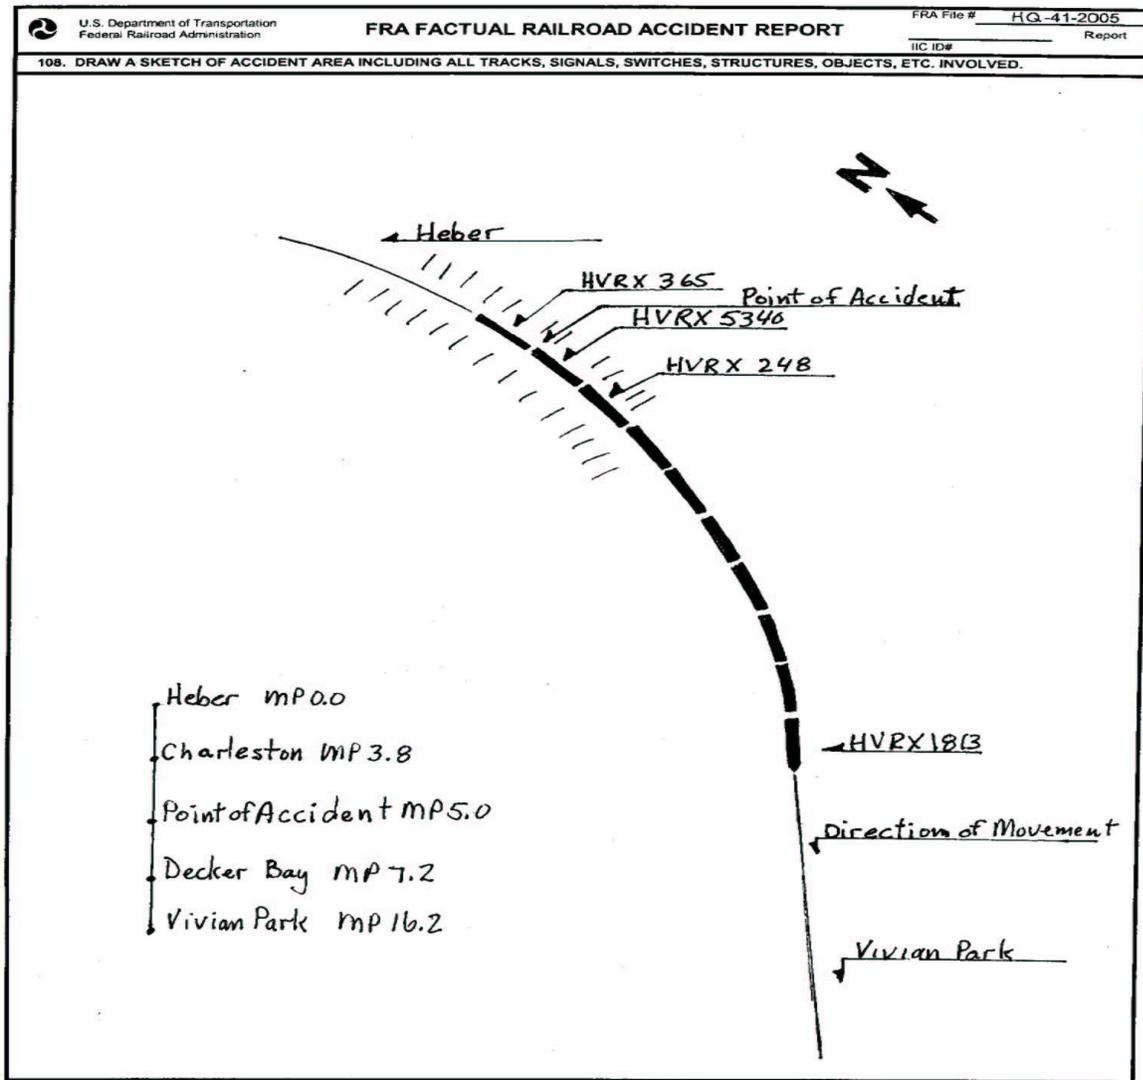
108. DRAW A SKETCH OF ACCIDENT AREA INCLUDING ALL TRACKS, SIGNALS, SWITCHES, STRUCTURES, OBJECTS, ETC., INVOLVED.
HQ-41-2005.jpg

At about 11:30 A.M., May 10, 2005 a single, free rolling passenger car (HRVX 365), struck the rear end of standing HVRX Train #3 on the main track at Mile Post (MP) 5.0. The point of the accident is located between Charleston Siding and Decker Bay on Heber Valley Railroad main track.

Car HRVX 365, which was set out in Track Three, began to move freely because it did not have an operative hand brake; the air brakes released due to a loss of air pressure (bleed off), there was not a chock or derail applied to prevent movement on to the main track; and it was not coupled to the cars previously placed in Track Three. The car rolled out of Track Three, passed through the Track Three switch, rolled five miles and struck Train #3. The main track is a continuous downhill grade from the Track Three switch to a point just prior to impact, where there is a slight upgrade. The speed of car HRVX 365, at point of impact, was estimated to be between 10 and 18 MPH.

Inspection of the site revealed there was not a derail south of the station to protect against uncontrolled movement from the yard. It was recommended derails be placed in order to prevent any uncontrolled movements in the future. This recommendation has been completed.
