***Federal Railroad Administration
Office of Safety
Headquarters Assigned
Accident Investigation Report
HQ-2005-48***

***Norfolk Southern (NS)
Galilee, Pennsylvania
June 20, 2005***

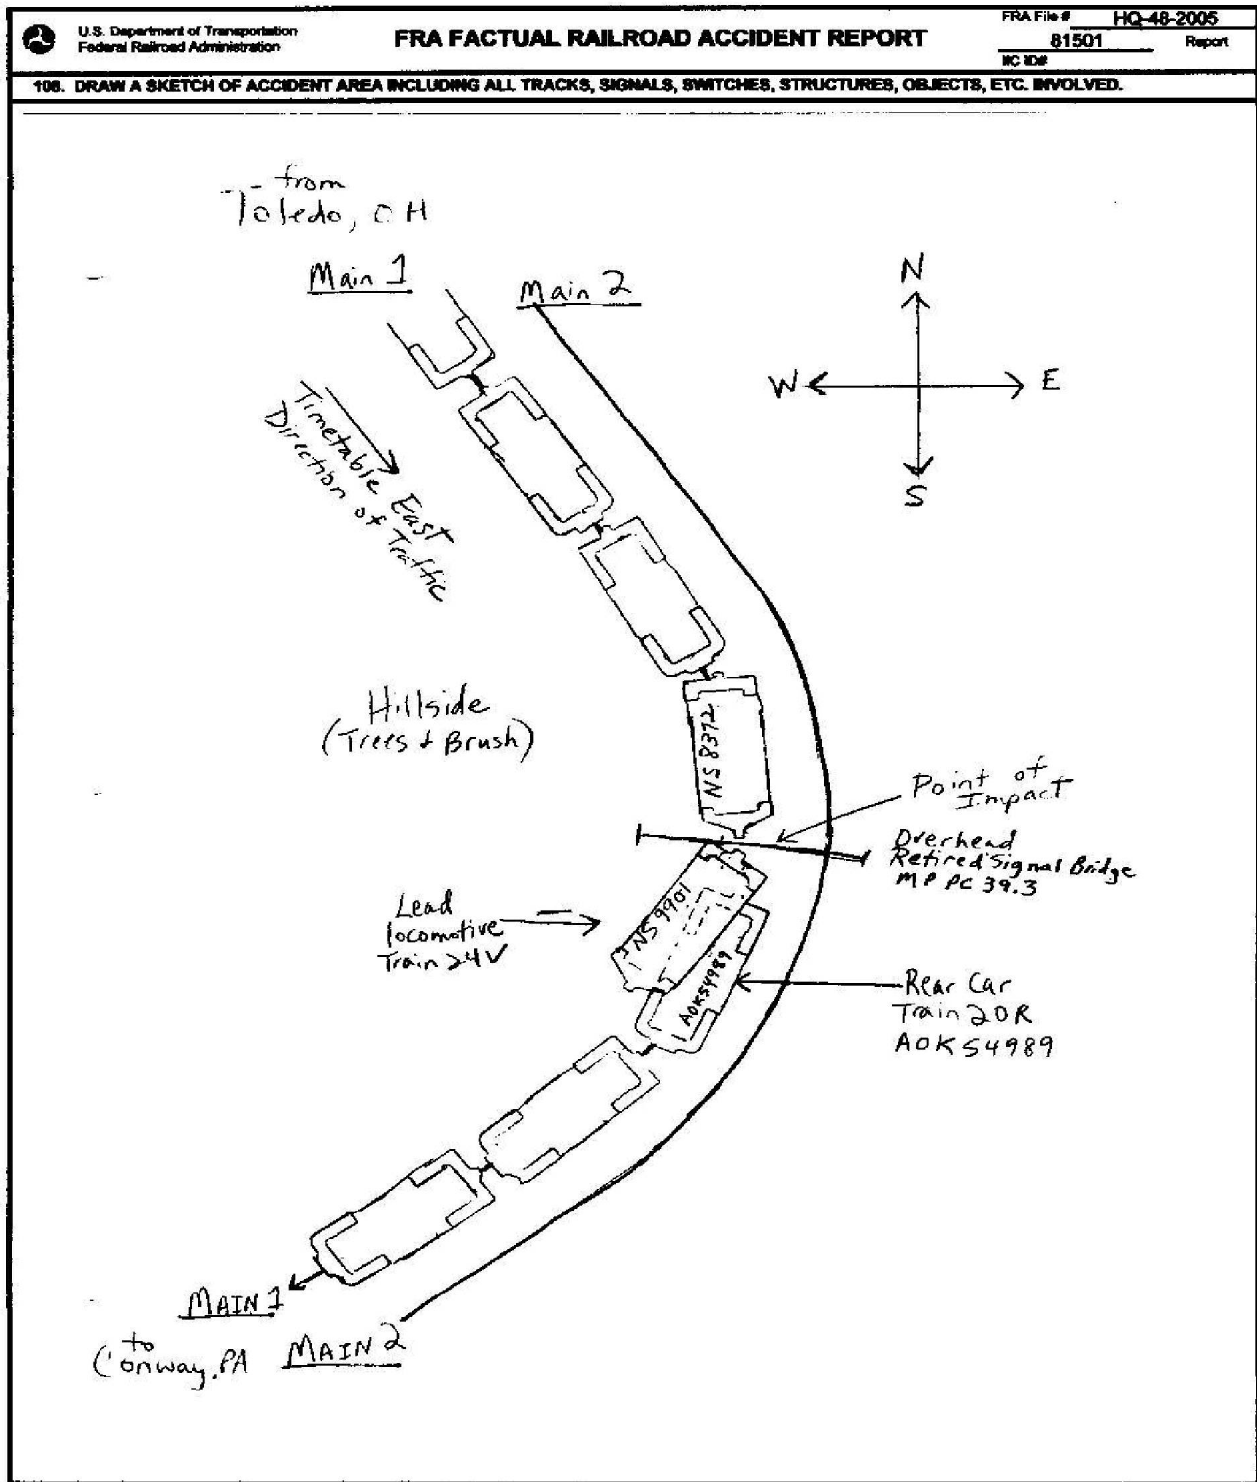
108. DRAW A SKETCH OF ACCIDENT AREA INCLUDING ALL TRACKS, SIGNALS, SWITCHES, STRUCTURES, OBJECTS, ETC., INVOLVED.

Track geography at the point of impact: full body of a 5.9 degree left hand curve with a .21 percent ascending grade.
