***Federal Railroad Administration
Office of Safety
Headquarters Assigned
Accident Investigation Report
HQ-2005-53***

***Burlington Northern Santa Fe (BNSF)
Verona, Missouri
July 2, 2005***

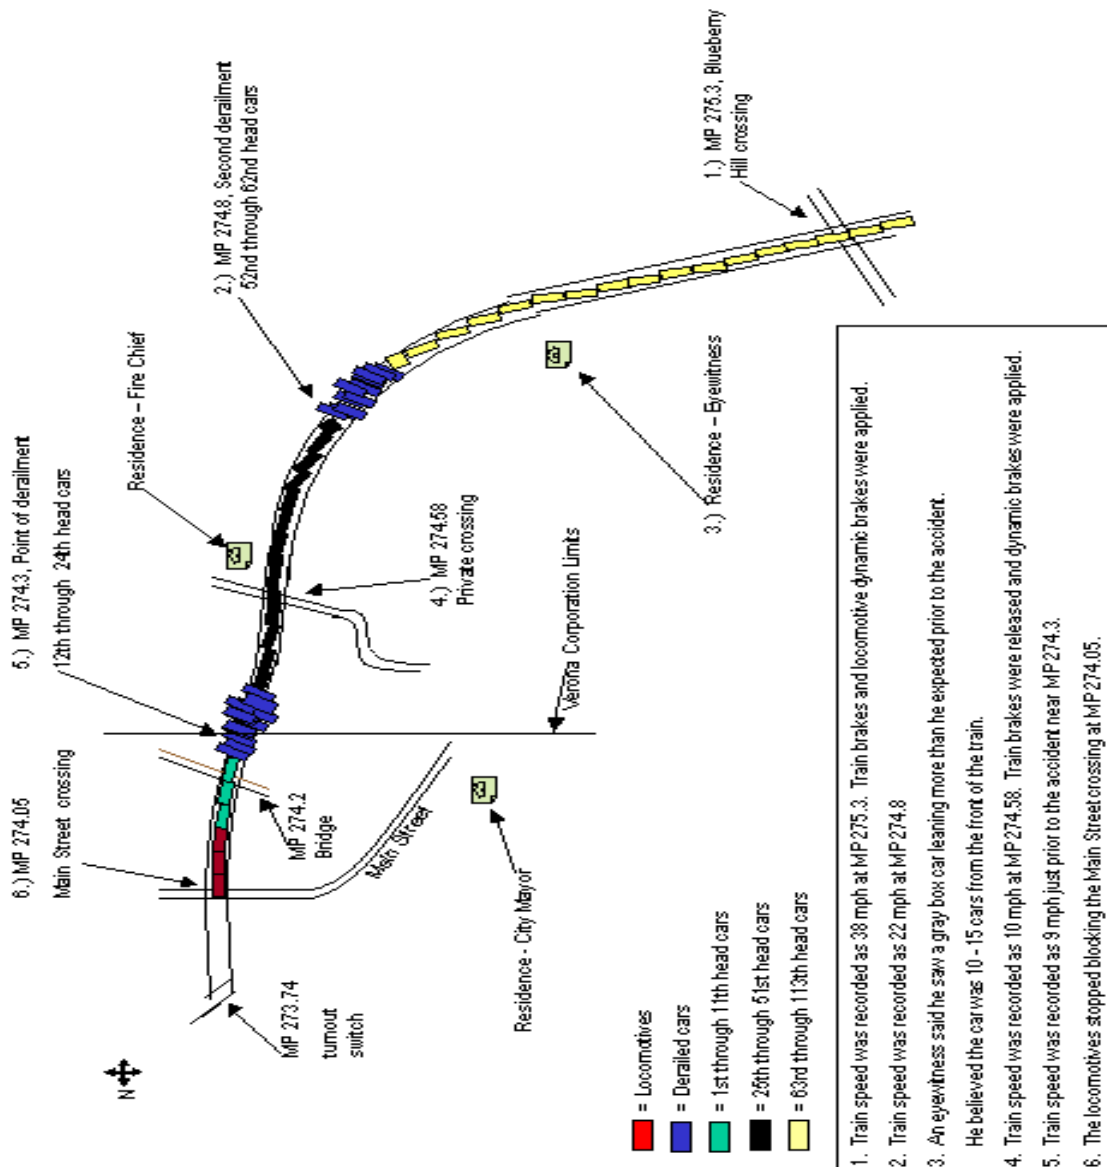
108. DRAW A SKETCH OF ACCIDENT AREA INCLUDING ALL TRACKS, SIGNALS, SWITCHES, STRUCTURES, OBJECTS, ETC., INVOLVED.

Train Symbol M-TULGAL1-02 was derailed in two portions. The 12th through the 24th cars were derailed at MP 274.3, the point of derailment. The 52nd through the 62nd cars were derailed at MP 274.8. Several cars were overturned spilling plastic pellets and lime. Equipment damage was estimated at \$178,277.

A 3-degree, 3-minute, left hand curve extends from MP 274.9 to 274.6. The track is tangent from MP 274.6 to MP 274.4. A 1-degree, 9-minute, right hand curve extends from MP 274.4 to 274.25. The track is tangent from MP 274.25 to 274.07. There is a 1-degree, 3-minute, left hand curve from MP 274.07 to MP 273.75.

At MP 274.3, the point of derailment, the north rail (high rail) is 136-pound continuous-welded rail (CWR) laid in 2002. The south rail (low rail) is 132-pound CWR laid in 1977. At MP 274.8, the north rail (low rail) is 136-pound CWR laid in 2001. The south rail (high rail) is 136-pound CWR laid in 1998. The rail rests on double shoulder tie plates on timber ties secured by 6-inch rail-holding spikes. The track is ballasted.
