***Federal Railroad Administration  
Office of Safety  
Headquarters Assigned  
Accident Investigation Report  
HQ-2005-56***

***Burlington Northern Santa Fe (BNSF)  
Kingman, Arizona  
July 30, 2005***

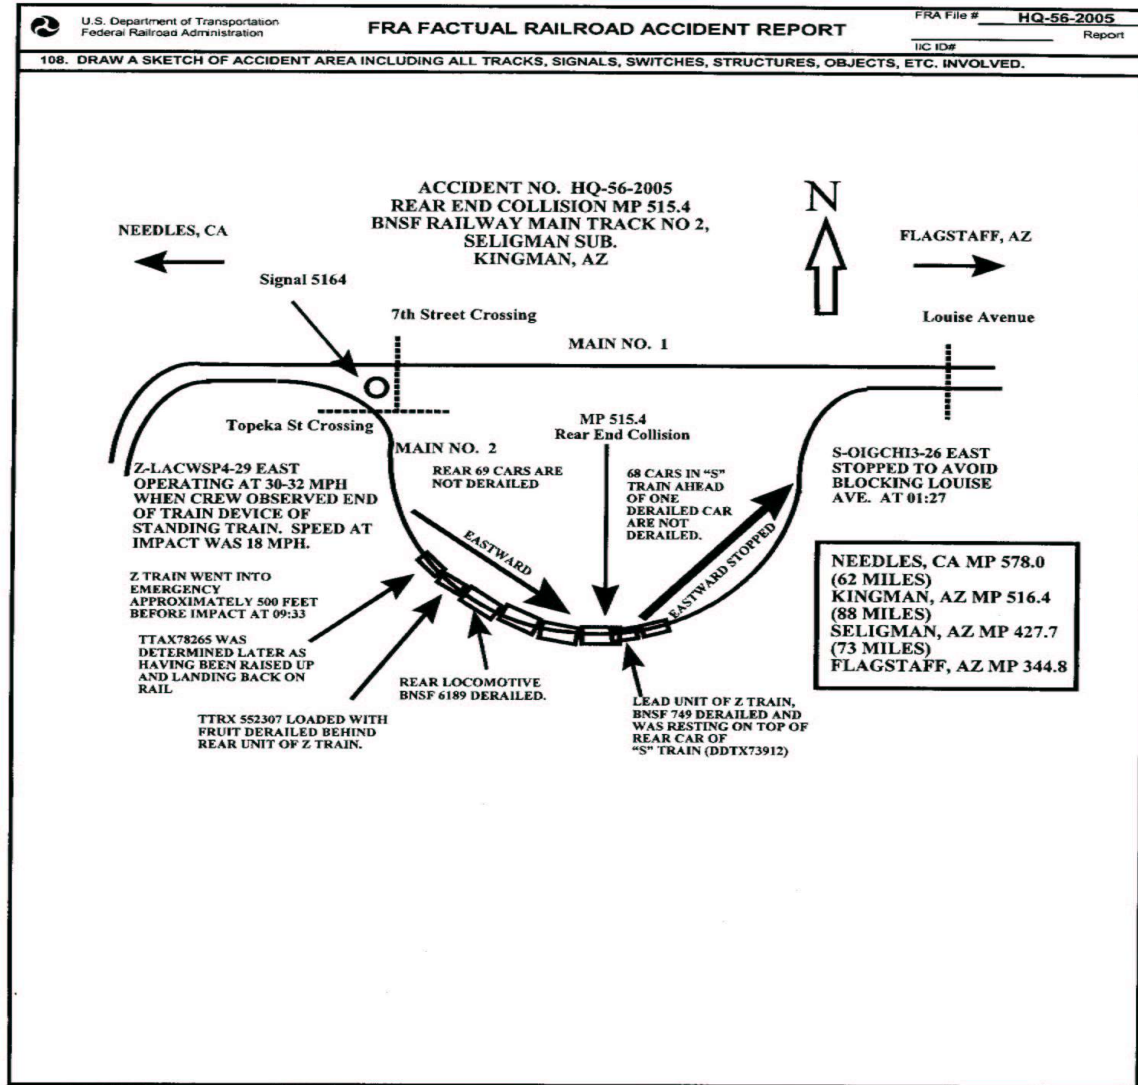
108. DRAW A SKETCH OF ACCIDENT AREA INCLUDING ALL TRACKS, SIGNALS, SWITCHES, STRUCTURES, OBJECTS, ETC., INVOLVED.  
HQ-56-2005.jpg

The accident occurred on BNSF's Main Track No. 2 in Kingman at MP 515.4 on the Seligman Subdivision, Southwest Division. Approaching Kingman from the west, there is a long right-hand, compound curve with a maximum curvature of 4 degrees. Approximately 500 feet west of the signal at MP 516.3, Main Track No. 2 diverges from Main Track No. 1 and returns to a parallel configuration near MP 514.1. East of the signal, the track curves to the left at 3 degrees for approximately 1,000 feet before the point of collision. Main Track No. 2 ascends eastward at up to 1.4 percent. The railroad timetable and geographical directions of both trains is east. The maximum authorized speed for this subdivision is 70 mph, as designated in the current BNSF Timetable No. 2, effective October 20, 2004. However, the maximum operating speed at this location is 40 mph for passenger trains and 35 mph for freight trains.

The collision occurred on a long, lefthand curve on a high earthen fill. Visibility was temporarily obscured by the presence of an unused tool shed on the north side of Main Track No. 2. The accident did not affect Main Track No. 1.
