***Federal Railroad Administration  
Office of Safety  
Headquarters Assigned  
Accident Investigation Report  
HQ-2005-57***

***Dakota, Minnesota & Eastern (DME)  
Pierre, South Dakota  
July 31, 2005***

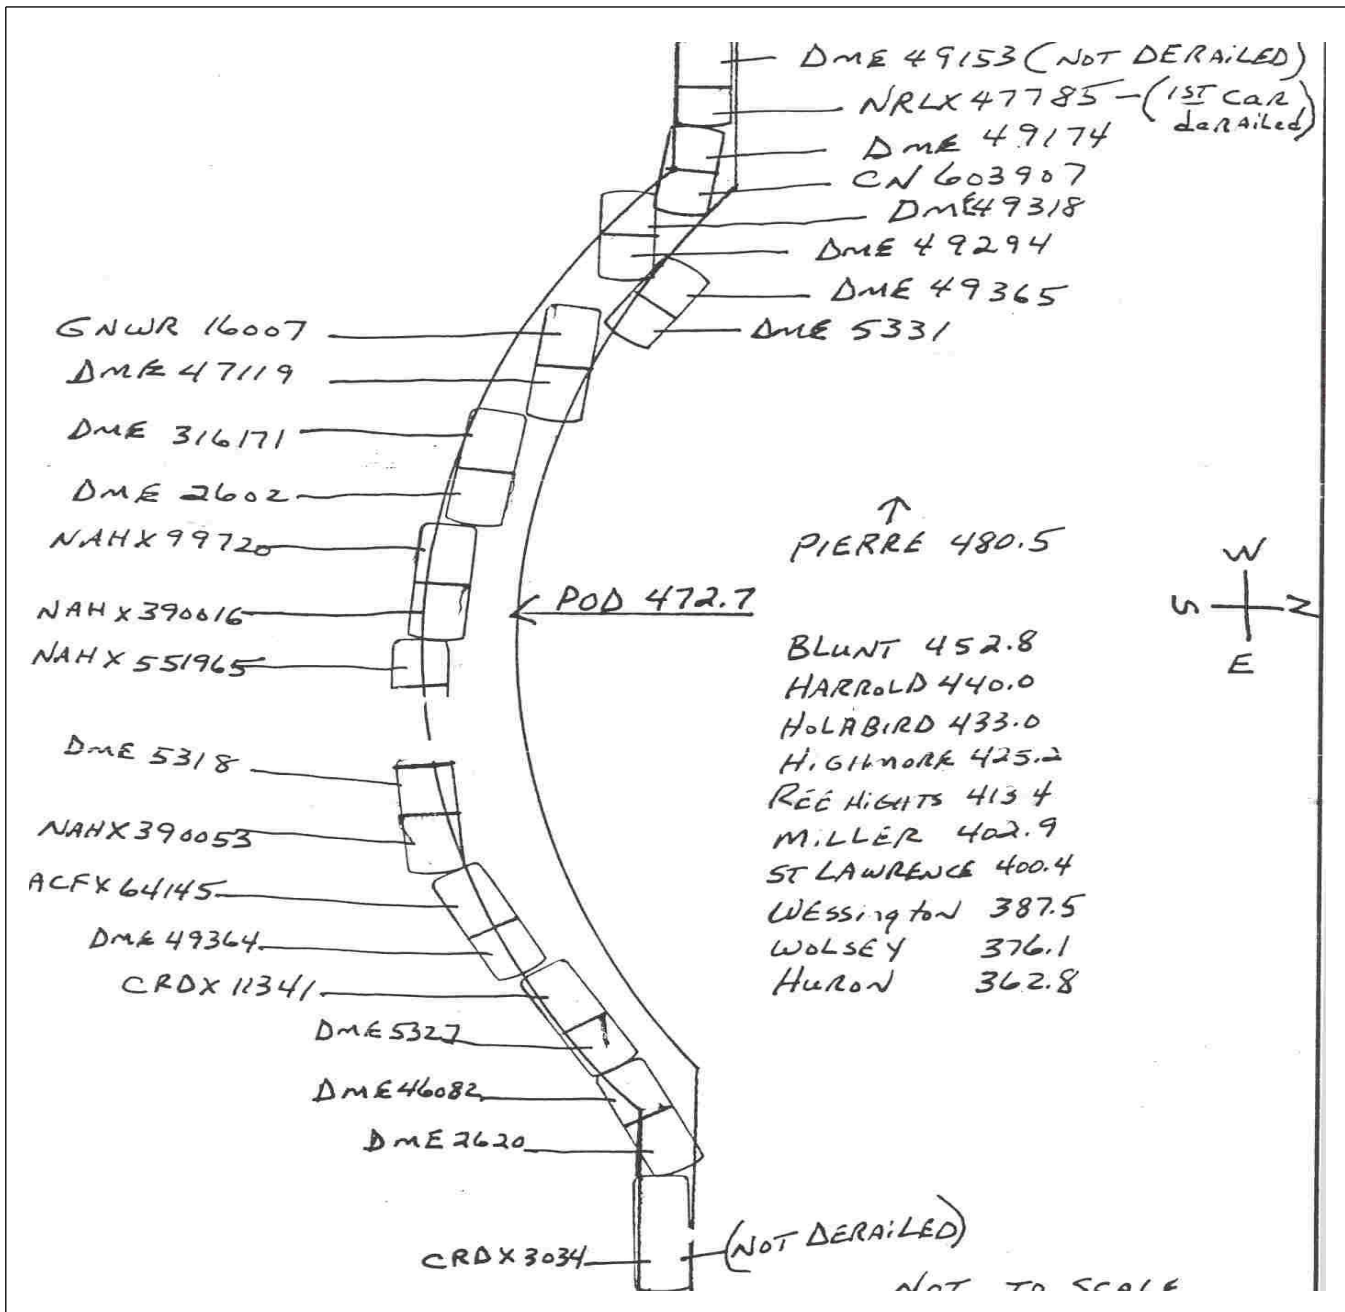
HQ-57-  
Sketch.jpg

108. DRAW A SKETCH OF ACCIDENT AREA INCLUDING ALL TRACKS, SIGNALS, SWITCHES, STRUCTURES, OBJECTS, ETC., INVOLVED.
