# Federal Railroad Administration Office of Safety Headquarters Assigned Accident Investigation Report HQ-2005-60

Amtrak (ATK)/Norfolk Southern (NS) Belton, Montana August 5, 2005

DEPARTMENT OF TRANSPORTATION FRA FACTUAL RAILROAD ACCIDENT REPORT FRA File # HQ-2005-60																			
1.Name of Railroad (	rai i irpinacene code					Railroad Accident/Incident No.													
Amtrak [ATK ]			ATK					097639

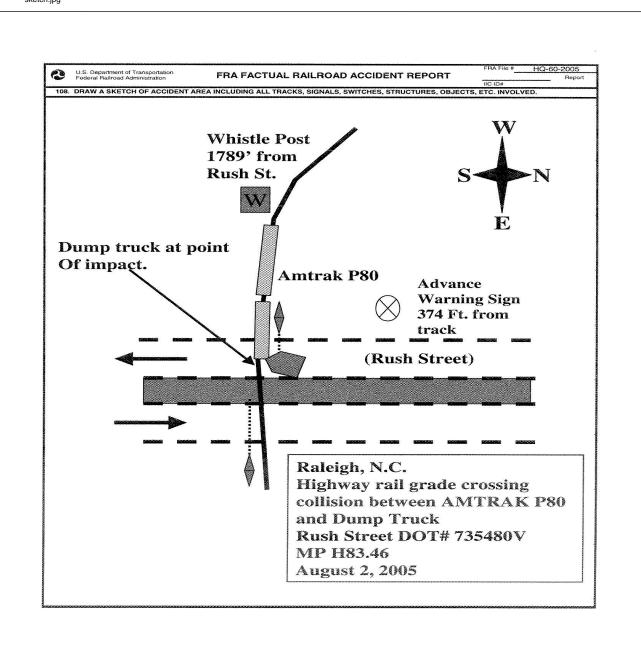
108. DRAW A SKETCH OF ACCIDENT AREA INCLUDING ALL TRACKS, SIGNALS, SWITCHES, STRUCTURES, OBJECTS, ETC., INVOLVED.  $^{\rm HQ-60-}_{\rm 2005}$  sketch.jpg

The dump truck was struck on the passenger side cab door, causing the truck cab to separate from the bed of the truck. The cab of the truck and front axle landed down the embankment on the east side of the roadway, 15 feet north of the main track. The bed of the truck and rear axle were still near the area of impact. The locomotive derailed at the point of impact and traveled east about 300 feet before it stopped. After the accident, the assistant conductor went to the locomotive to check on the engineer while the conductor stayed on the coaches attending to the passengers. The assistant conductor notified the train dispatcher by radio from the cab of the locomotive about the accident.
