***Federal Railroad Administration
Office of Safety
Headquarters Assigned
Accident Investigation Report
HQ-2005-61***

***Burlington Northern Santa Fe (BNSF)
Belton, Montana
August 5, 2005***

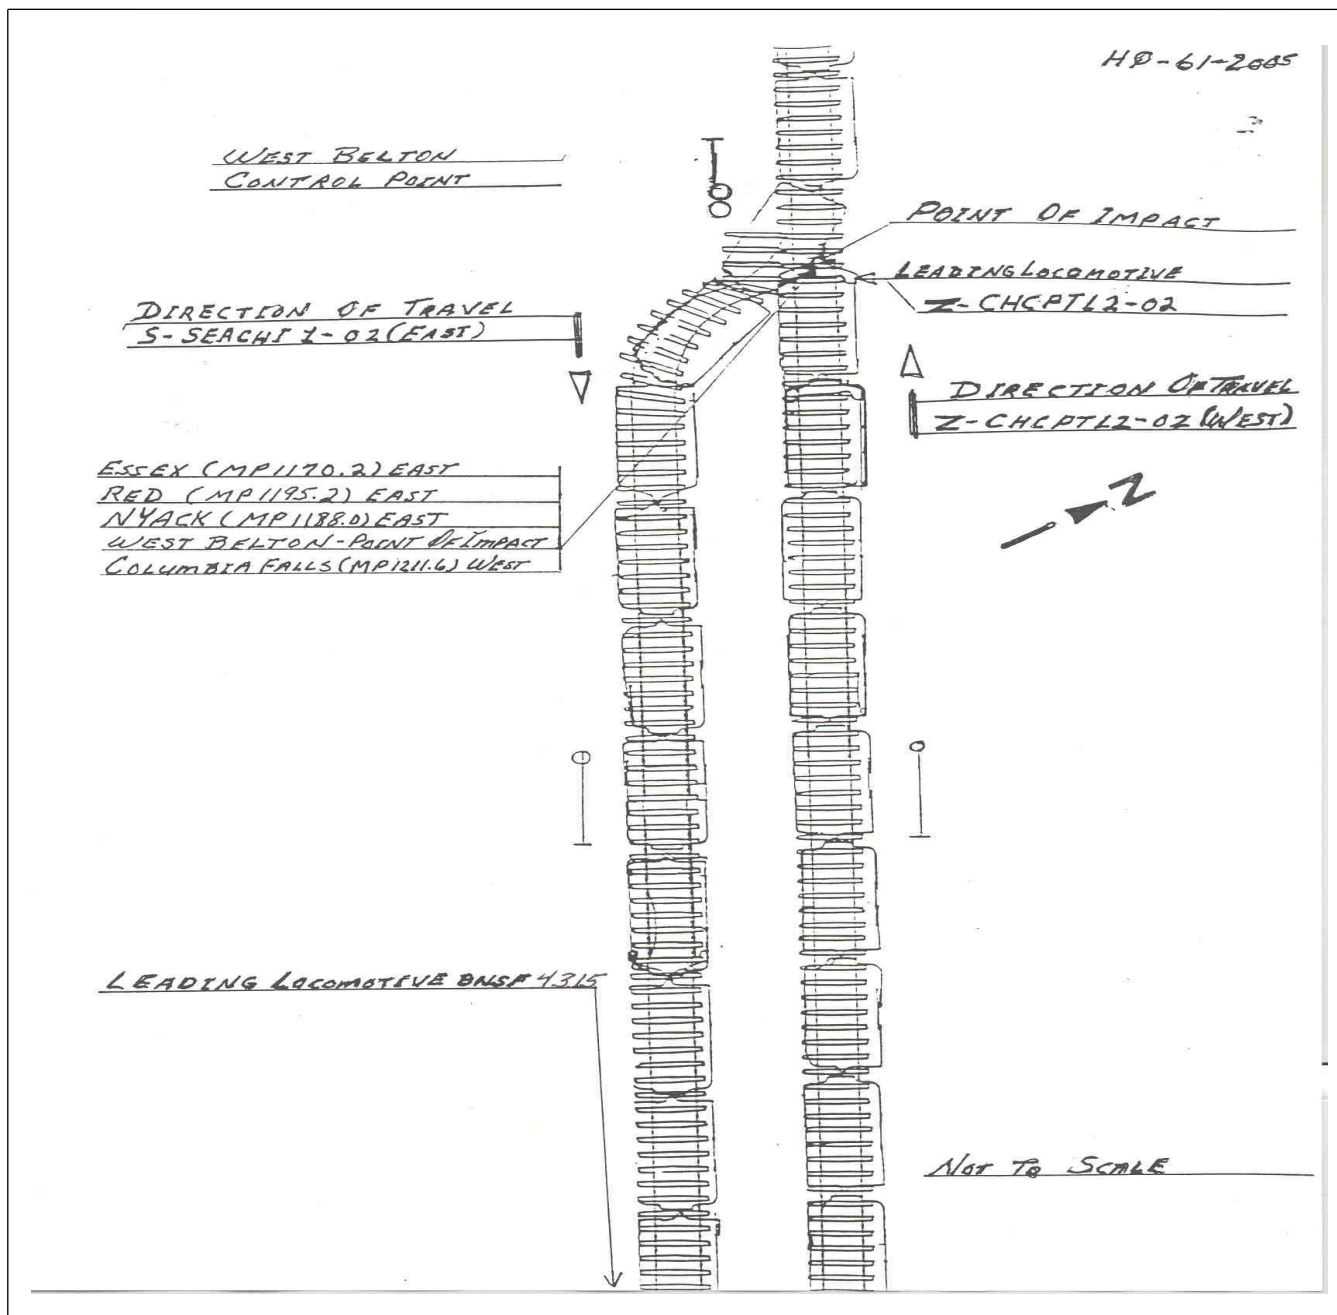
Sketch
HQ-61-
05.jpg

On August 4, 2005, at 2:44 p.m., Mountain Daylight Time (MDT), a westbound BNSF Railway (BNSF) intermodal train, symbol Z-CHCPTL2-02 collided with the side of a standing eastbound intermodal train symbol, S-SEACHI1-02. The collision occurred at the west Belton control point, milepost 1197.1, on the BNSF Montana Division, Hi Line Subdivision, located near Belton, Montana.

As a result of the collision the leading locomotive of the striking train was damaged and derailed staying upright. The standing train had two railcars damaged but not derailed.

The probable cause of the accident was the crew of train Z-CHCPTL2-02 failed to comply with a block signal indication of an approach (yellow) signal.

As a result of the side collision at west Belton control point the BNSF conducted a safety blitz that emphasized signal aspects and the meaning of each. During the blitz special emphasizes was placed on the actions to be placed on a yellow approach signal indication.
