***Federal Railroad Administration  
Office of Safety  
Headquarters Assigned  
Accident Investigation Report  
HQ-2005-78***

***Union Pacific (UP)  
Shepherd, Texas  
September 15, 2005***

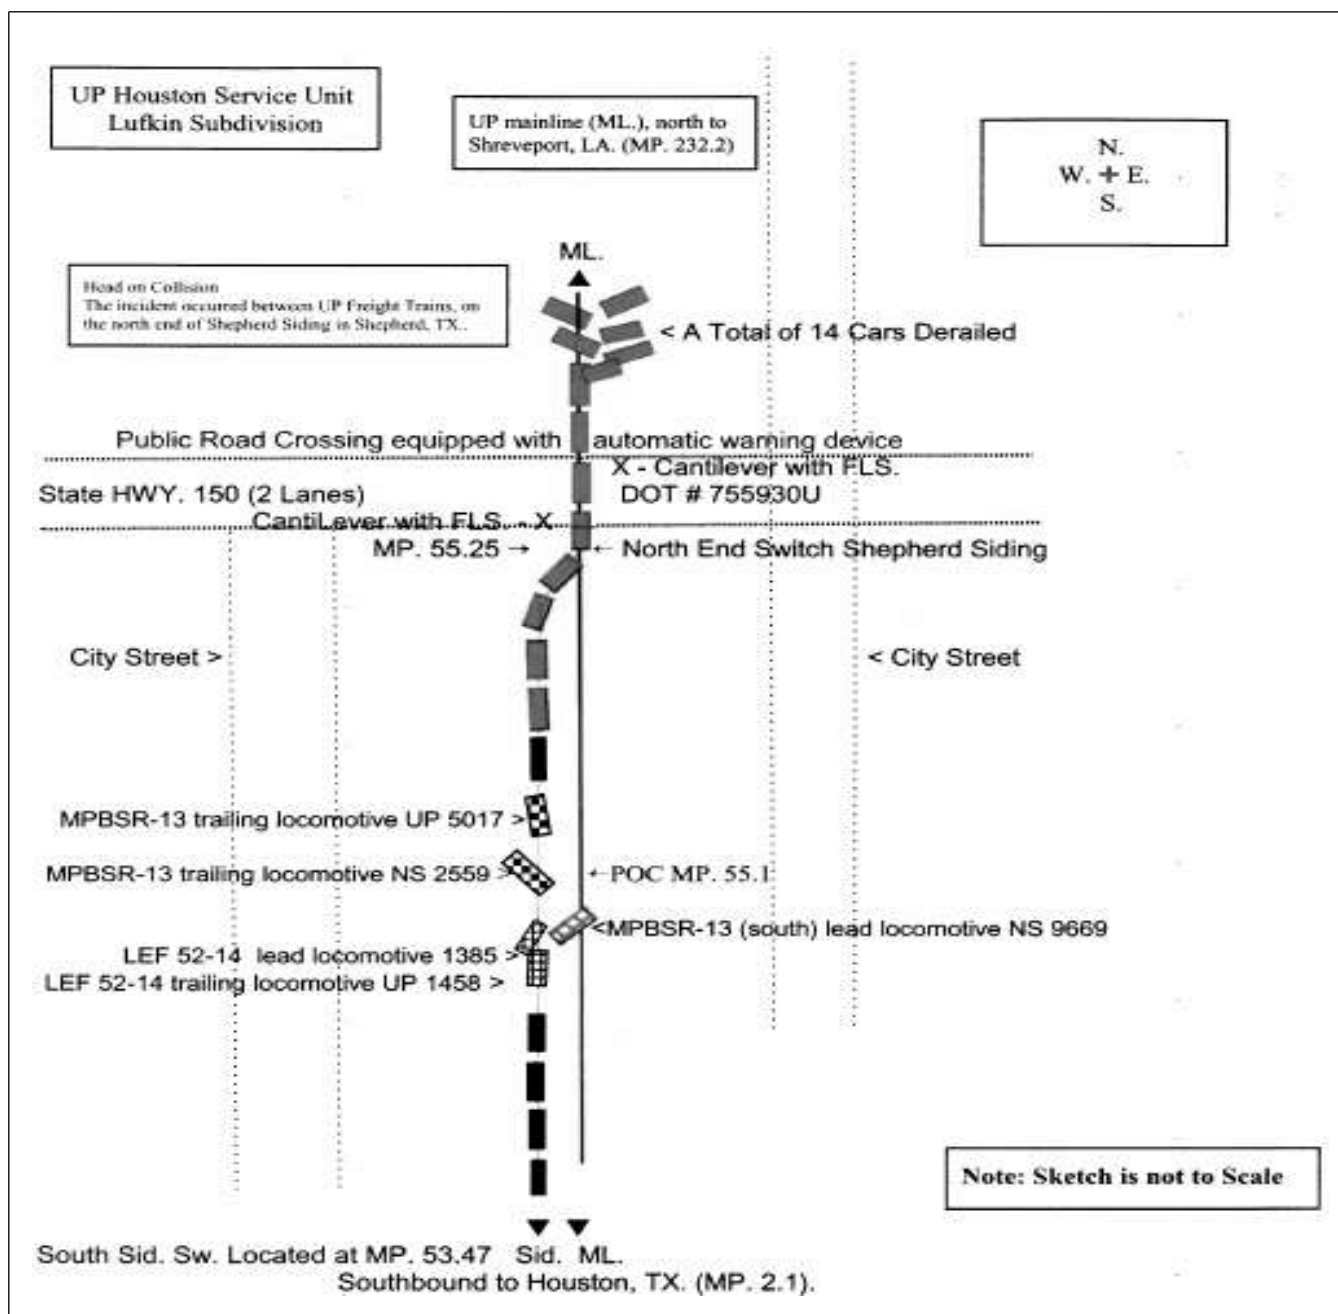
108. DRAW A SKETCH OF ACCIDENT AREA INCLUDING ALL TRACKS, SIGNALS, SWITCHES, STRUCTURES, OBJECTS, ETC., INVOLVED.  
78.bmp

The conductor of the original crew of the train LEF-52-14 keys were found in the lock, lock was not locked and the main track switch was found lined for the siding at Shepherd, Texas.

The crew of the train MPBSR-13, traveling at 38 mph and within their authority struck the train LEF-52-14 standing still in the siding at Shepherd, Texas due to the switch not being line for main track movement.
