***Federal Railroad Administration  
Office of Safety  
Headquarters Assigned  
Accident Investigation Report  
HQ-2005-83***

***Amtrak (ATK)  
New London, Connecticut  
September 28, 2005***

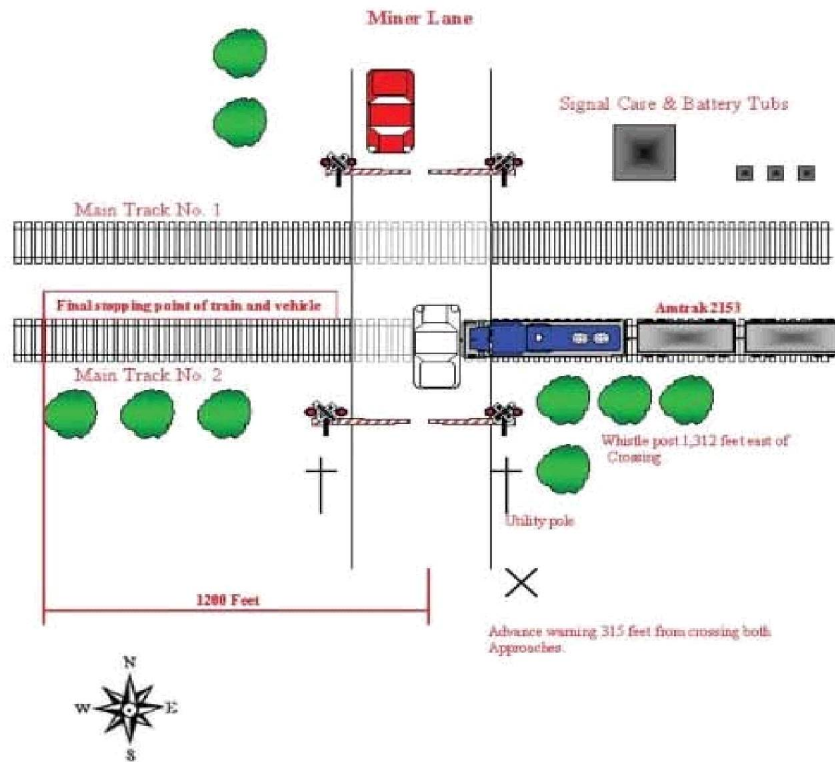
108. DRAW A SKETCH OF ACCIDENT AREA INCLUDING ALL TRACKS, SIGNALS, SWITCHES, STRUCTURES, OBJECTS, ETC., INVOLVED.

The crossing warning system was activated and all gates were in the down position. The automobile traveled under the northbound gate, which is 3 feet 10 inches above the crown of the road surface. The automobile continued north onto Main Track No. 2 and was struck by westbound train 2153, which was traveling at 71 mph. The train came to a stop 1,200 feet west of the crossing with the motor vehicle pinned underneath the nose cone of the power car.
