Federal Railroad Administration Office of Safety Headquarters Assigned Accident Investigation Report HQ-2005-84

CSX Transportation (CSX) Rocky Mount, North Carolina October 1, 2005

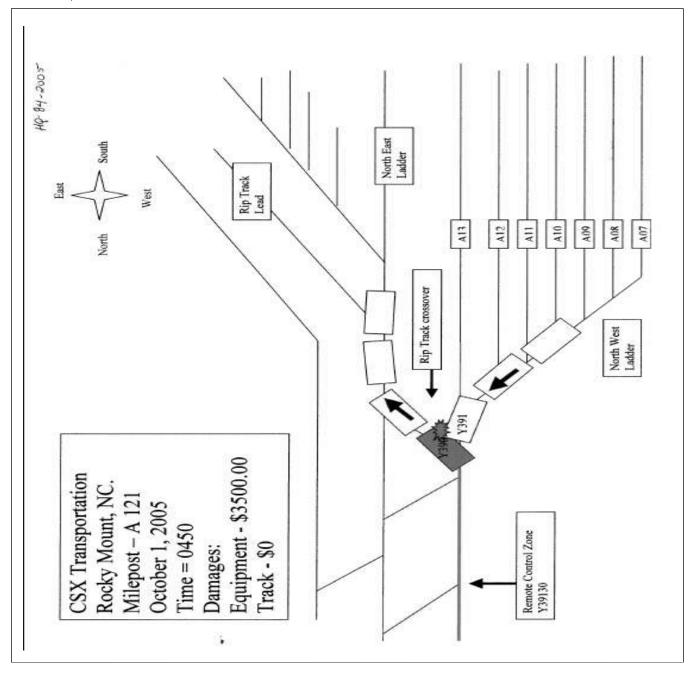
$108.\,DRAW\,A\,SKETCH\,OF\,ACCIDENT\,AREA\,INCLUDING\,ALL\,TRACKS, SIGNALS, SWITCHES, STRUCTURES, OBJECTS, ETC., INVOLVED.\\84.bmp$

About 4:50 a.m., Eastern Standard Time (EST), RCL Y390-30 with Locomotive No. CSXT 6031 and 70 cars, received permission to enter the remote control zone of RCL Y391-30. They were making a cross yard move from Track No. A21 to Track No. A12, using the rip track crossover. After shoving cars into A12, RCL Y390-30 was instructed to hold onto 12 cars and return back to Track No. A21. As they were shoving through the Rip track crossover, RCL Y391-30 with Locomotive No. CSXT 9498 was pulling out of Track No. A02 with 17 cars, striking RCL Y390-30 locomotive as it moved through the crossovers.

The side collision ruptured the fuel tank of Locomotive No. CSXT 6031, leaking about 1,000 gallons of diesel fuel. There was \$3,500 damage to both locomotives. No car derailed and there was no personal injuries or track damage as a result of the impact.
