***Federal Railroad Administration
Office of Safety
Headquarters Assigned
Accident Investigation Report
HQ-2005-92***

***Norfolk Southern (NS)
Millbury, Ohio
October 21, 2005***

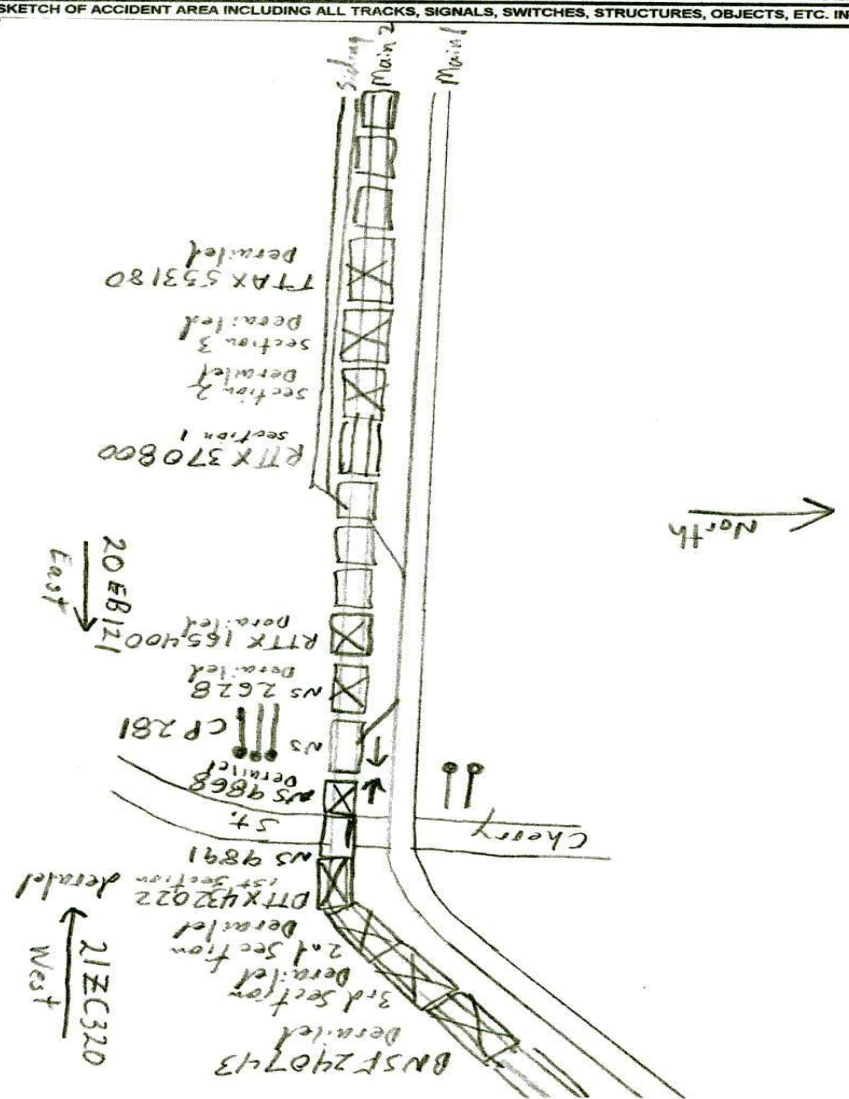
<p>U.S. Department of Transportation Federal Railroad Administration</p>	<p>FRA FACTUAL RAILROAD ACCIDENT REPORT</p>	<p>FRA File # HQ92-2005 70970 Report</p>
<p>108. DRAW A SKETCH OF ACCIDENT AREA INCLUDING ALL TRACKS, SIGNALS, SWITCHES, STRUCTURES, OBJECTS, ETC., INVOLVED.</p>

Eastbound train 20EB-121 passed the stop signal on Main 2 at CP-281. Their train continued on Main 2, thru the interlocking, through a trailing point switch and stopped approximately 15 car lengths past the signal.

Westward train 21Z-320 also located on Main 2, was informed via radio, by train 20EB-121, to stop immediately as they had gone by the signal. Train 21Z-320 immediately placed their train in emergency.

Within a very short undetermined amount of time, hit train 20EB-121 head-on at a recorded 19 MPH.

The NS Train Dispatcher had intended for Eastward train 20EB-121 to stop on Main 2 west of CP-281.

Westward train 21Z320 also on Maine 2, was lined to crossover from Main 2 to Main 1.
