# Federal Railroad Administration Office of Railroad Safety

Accident Investigation Report HQ-2021-1453

Canadian National Railway (CN) Collision Convent, LA October 6, 2021

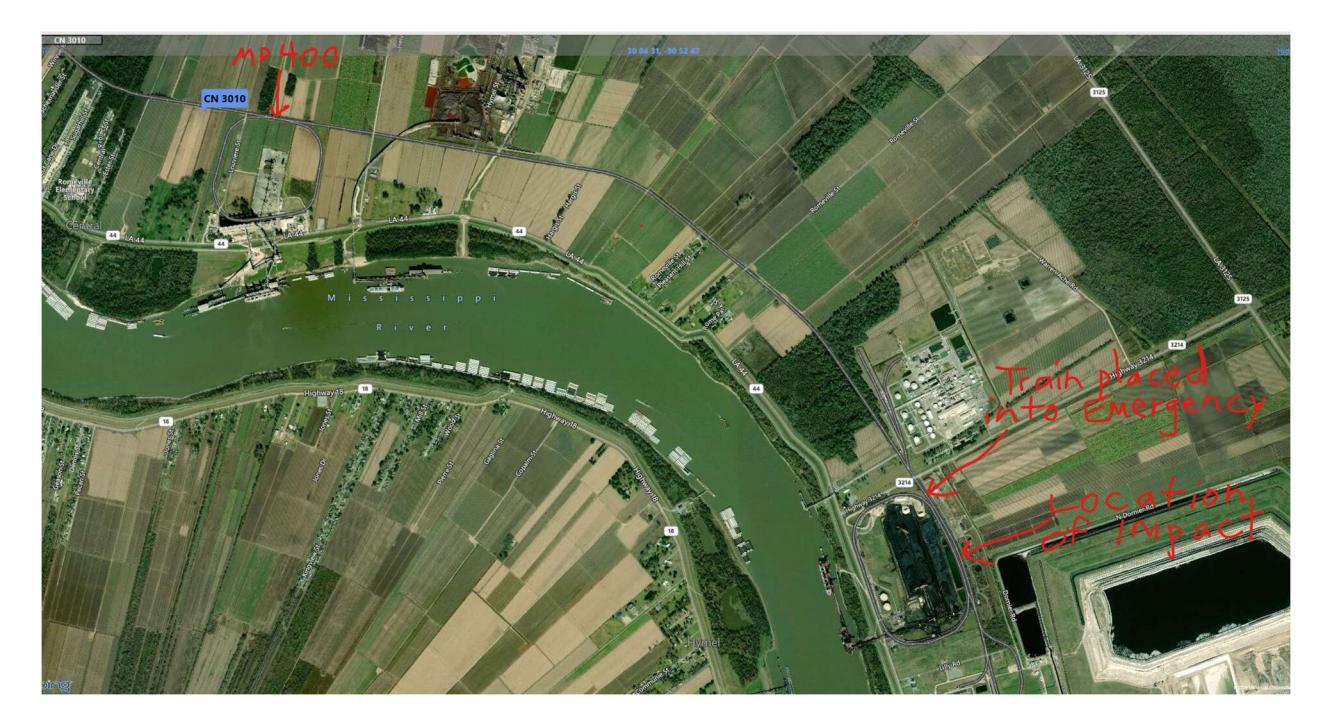
Train speed at the time of Emergency was 27 mph, and speed at Impact shows to be 16 mph. Max speed on this Subdivision is 40 mph. Below is a snapshot of where the train (CN 3010), was located at 3:16 p.m., when Authority was given to train to proceed. Locations I added, are of course, approximate, but help reference the landscape. Please reach out to me if any more information is needed.

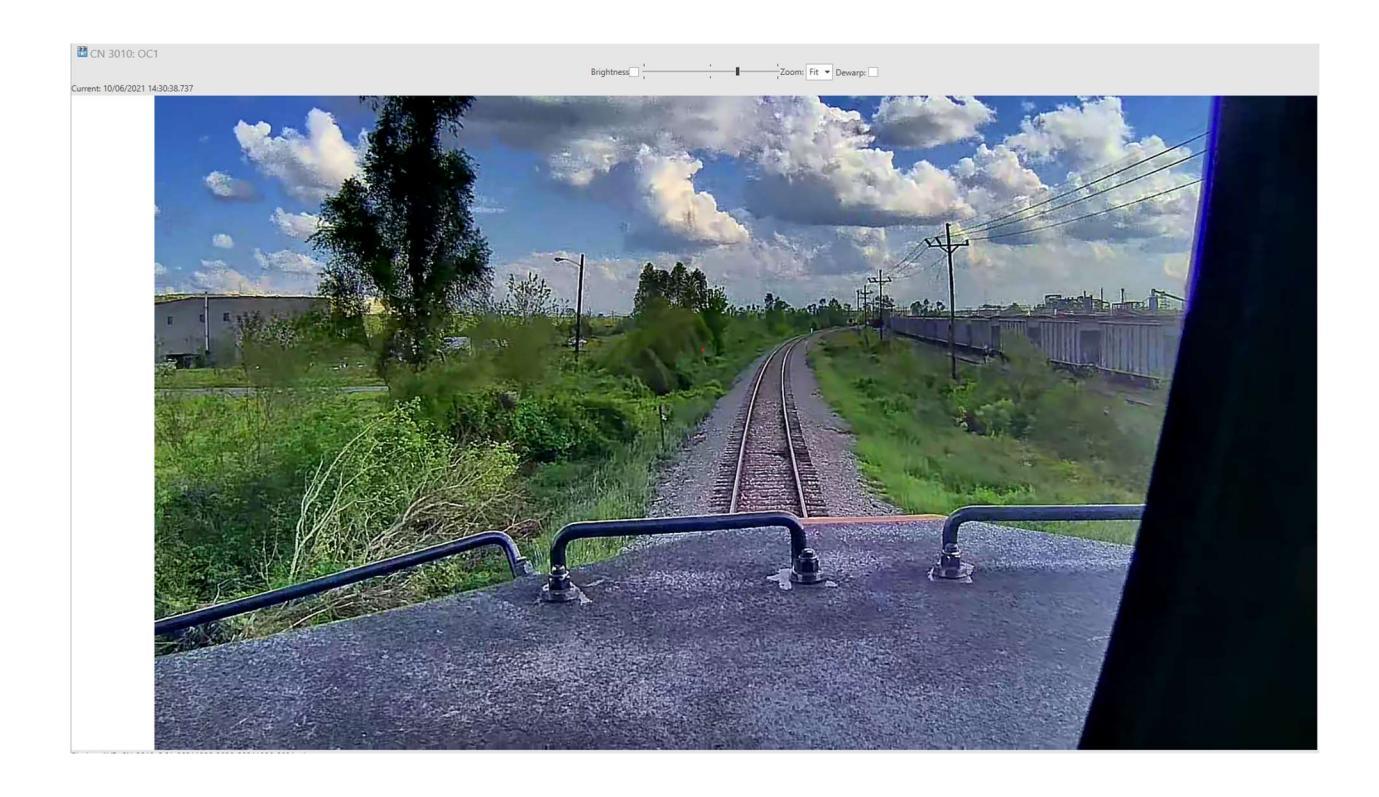
Snapshot of where equipment first came into view. Timestamp is on the upper left hand corner. It is offset by 1 hour. Actual time was 3:30 p.m.

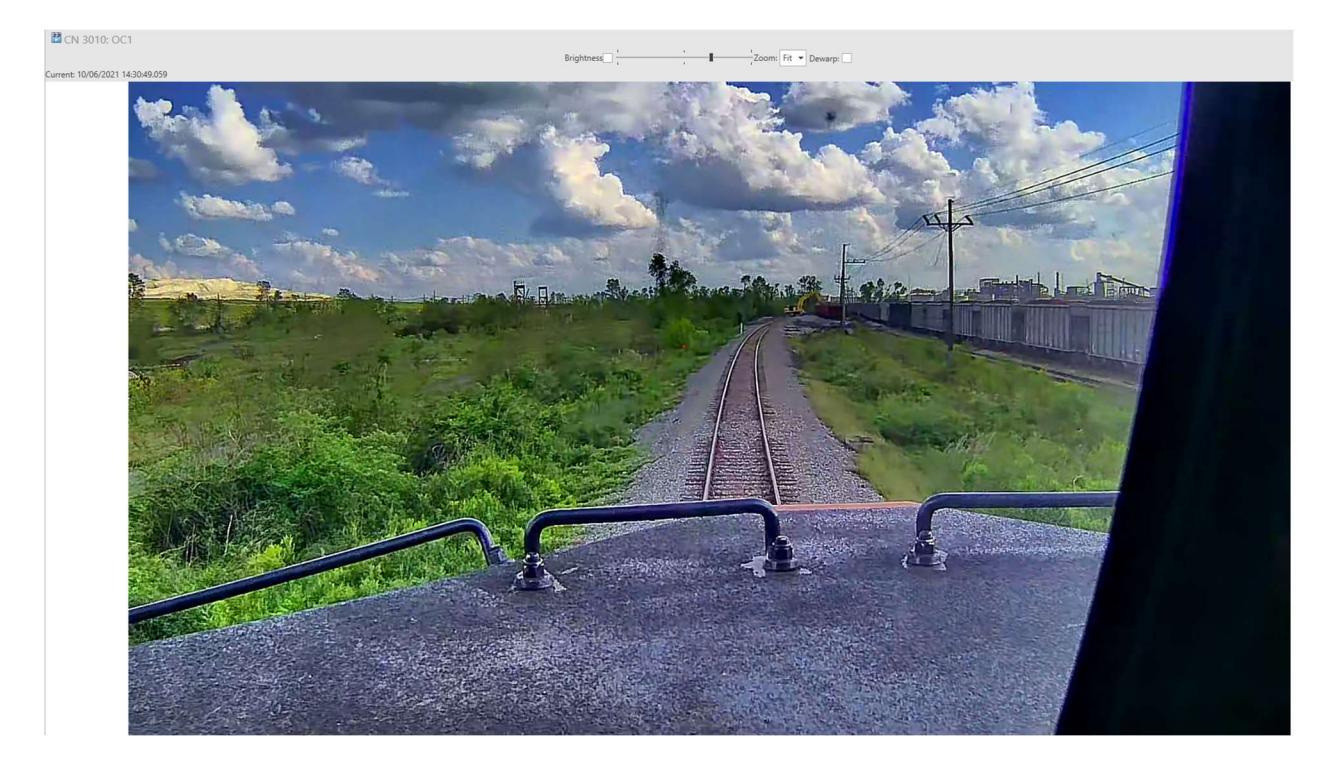
## Snapshot of where Train was placed into Emergency.
