# Federal Railroad Administration Office of Railroad Safety

Accident Investigation Report HQ-NS-2022-0305-1543

Norfolk Southern Railway Corporation (NS) Perryman, Maryland March 5, 2022

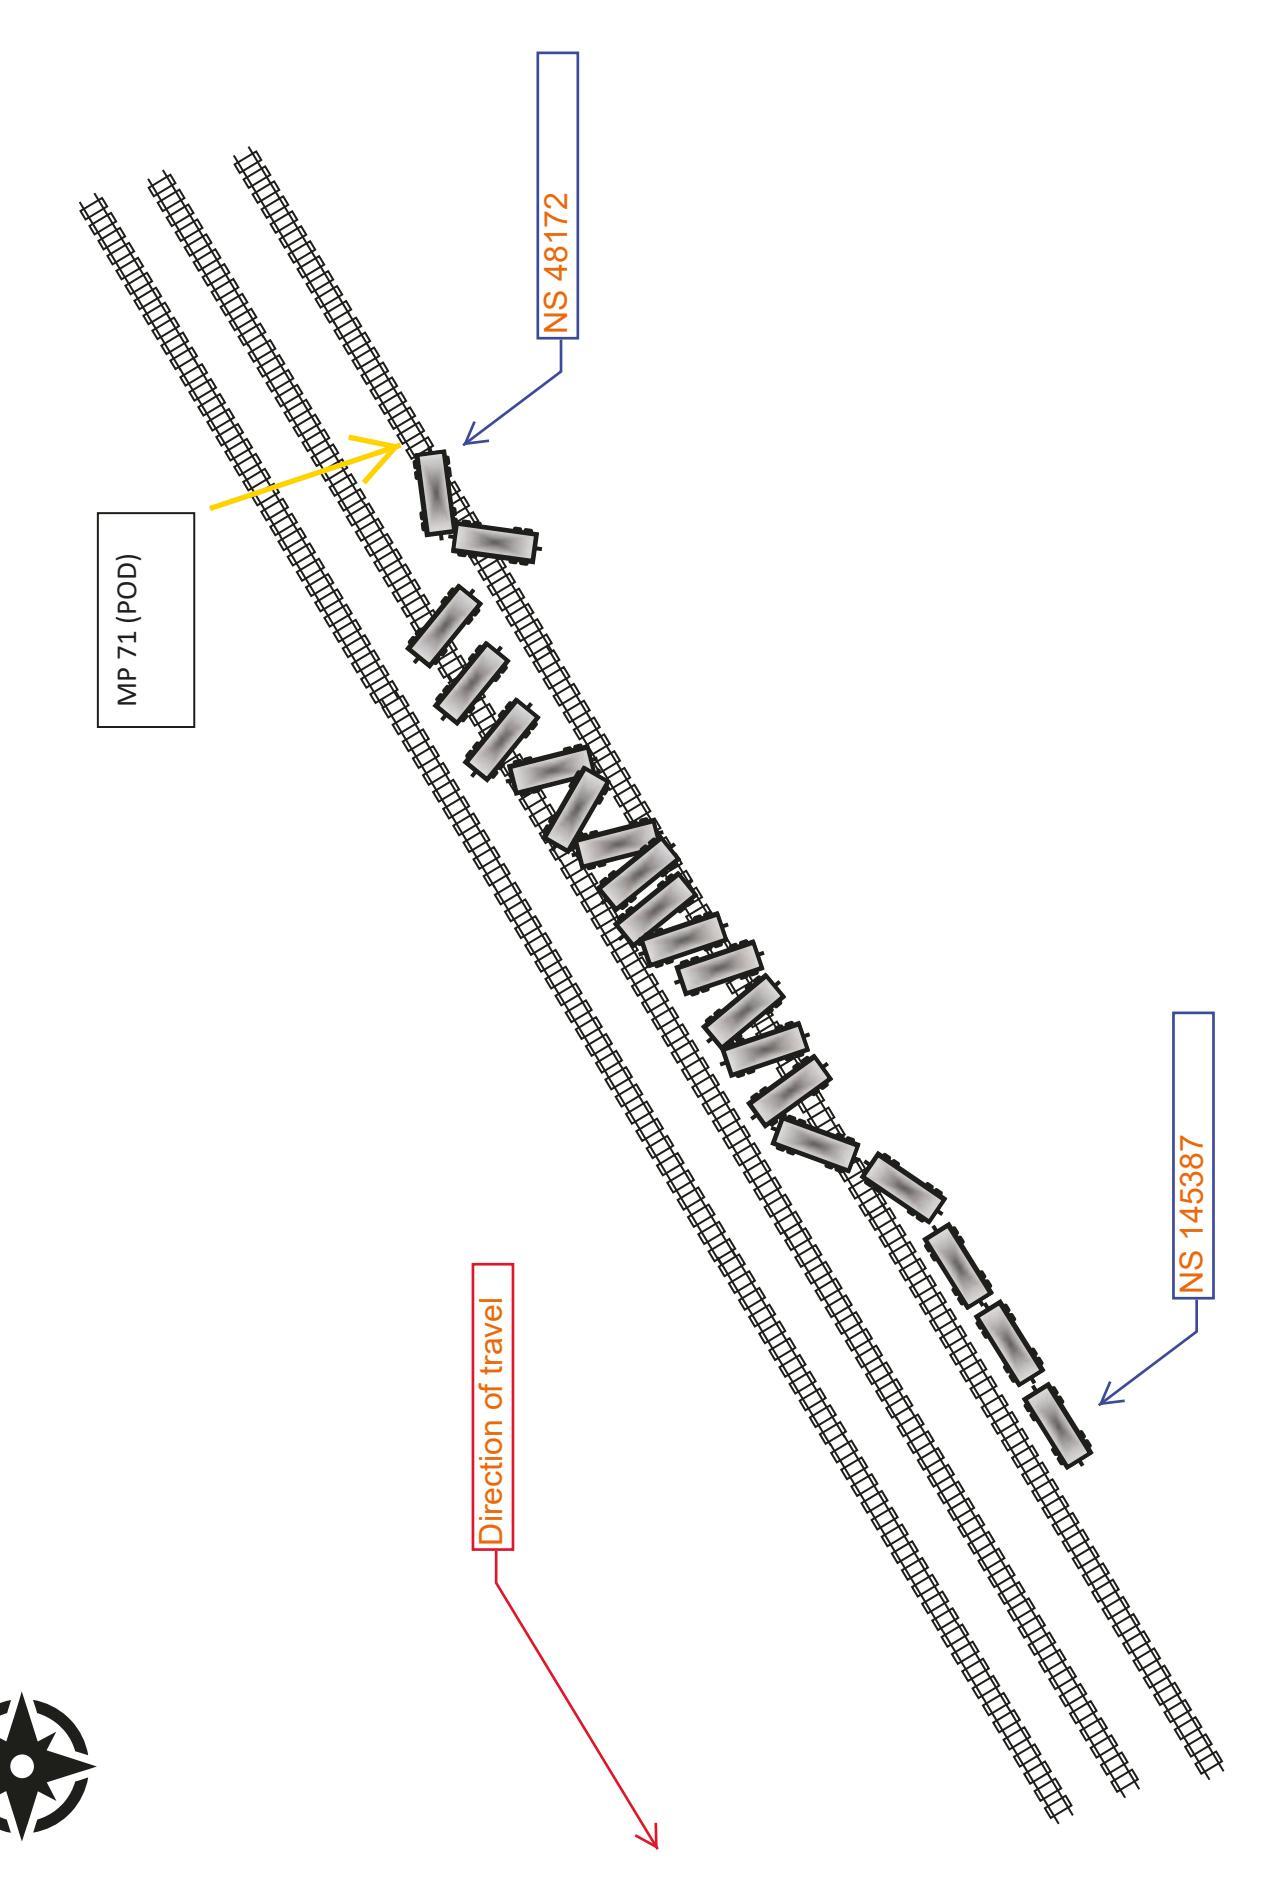
Sketch 1

The first mark of the broken wheel was located at MP 70.4 (GPS 39.45007 -76.21746). The following anomalies were noted South of MP 70.4 at the stated distances from the first broken wheel mark (reference Map 1 and Sketch 1):

The first broken rail was 1,845.6'.

The second broken rail was 2,343.7'.

The general pile up was 2,820.8', located at MP 71 (39.44518, -76.22516).

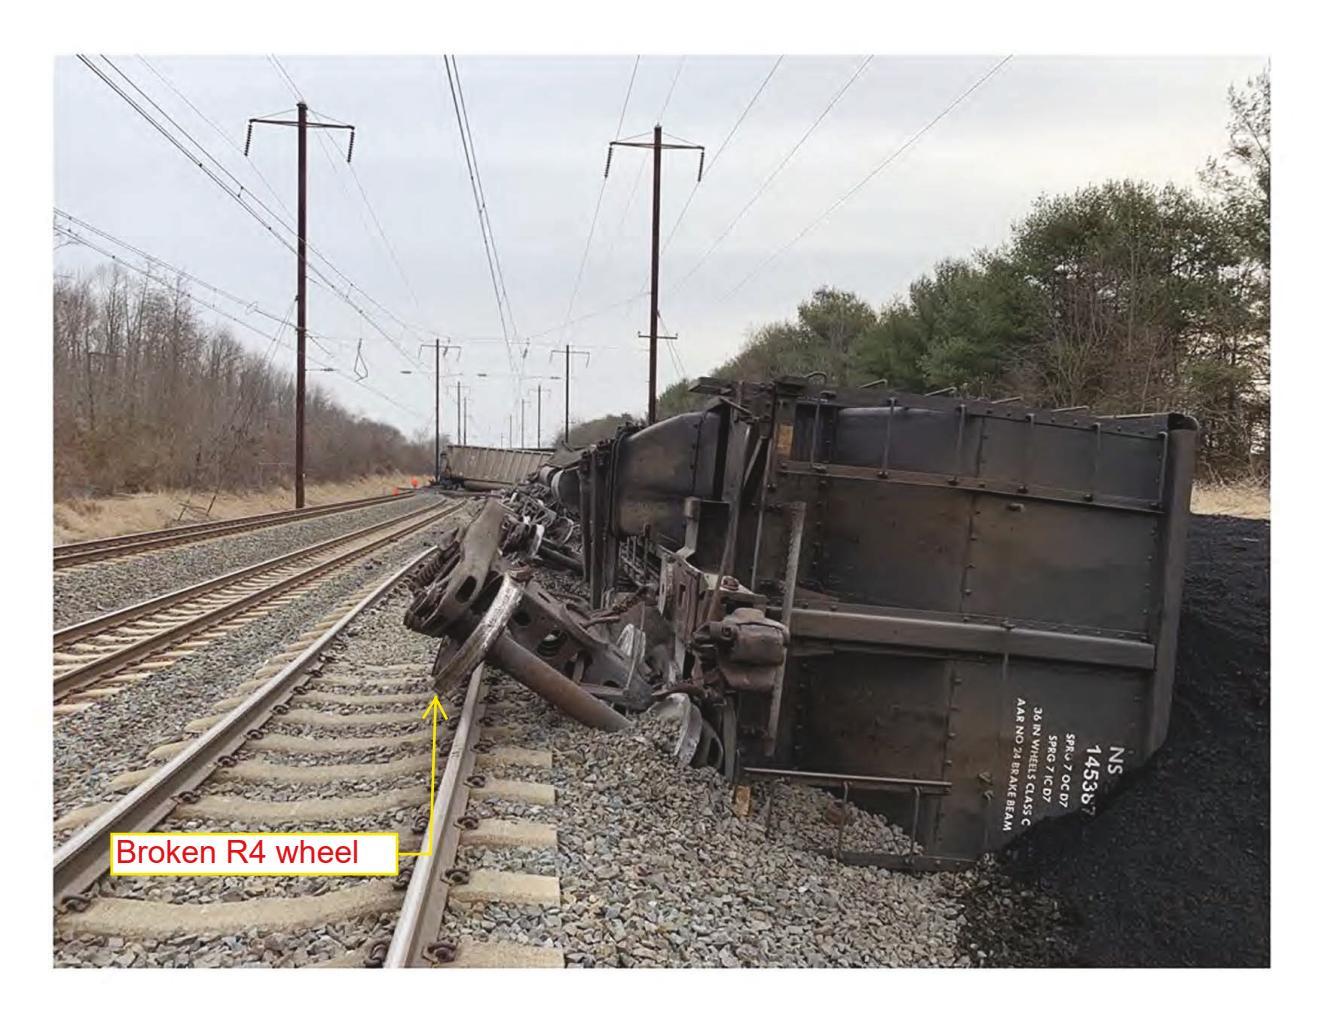
The NS 145387 was the first (lead) derailed car (reference Picture 1). It was the 80th piece of rolling equipment (the 78th car) from the head end in Train 1. The A-end truck was photographed before any wrecking or clearing operations commenced. It was apparent that the R4 wheel on the NS 145387 had suffered a catastrophic failure (reference Pictures 2 and 3) as the wheel had broken apart while the train was in motion. A large portion of the break (approximately 50 percent) was determined to be old by assessing the amount of rust discoloration at the break.

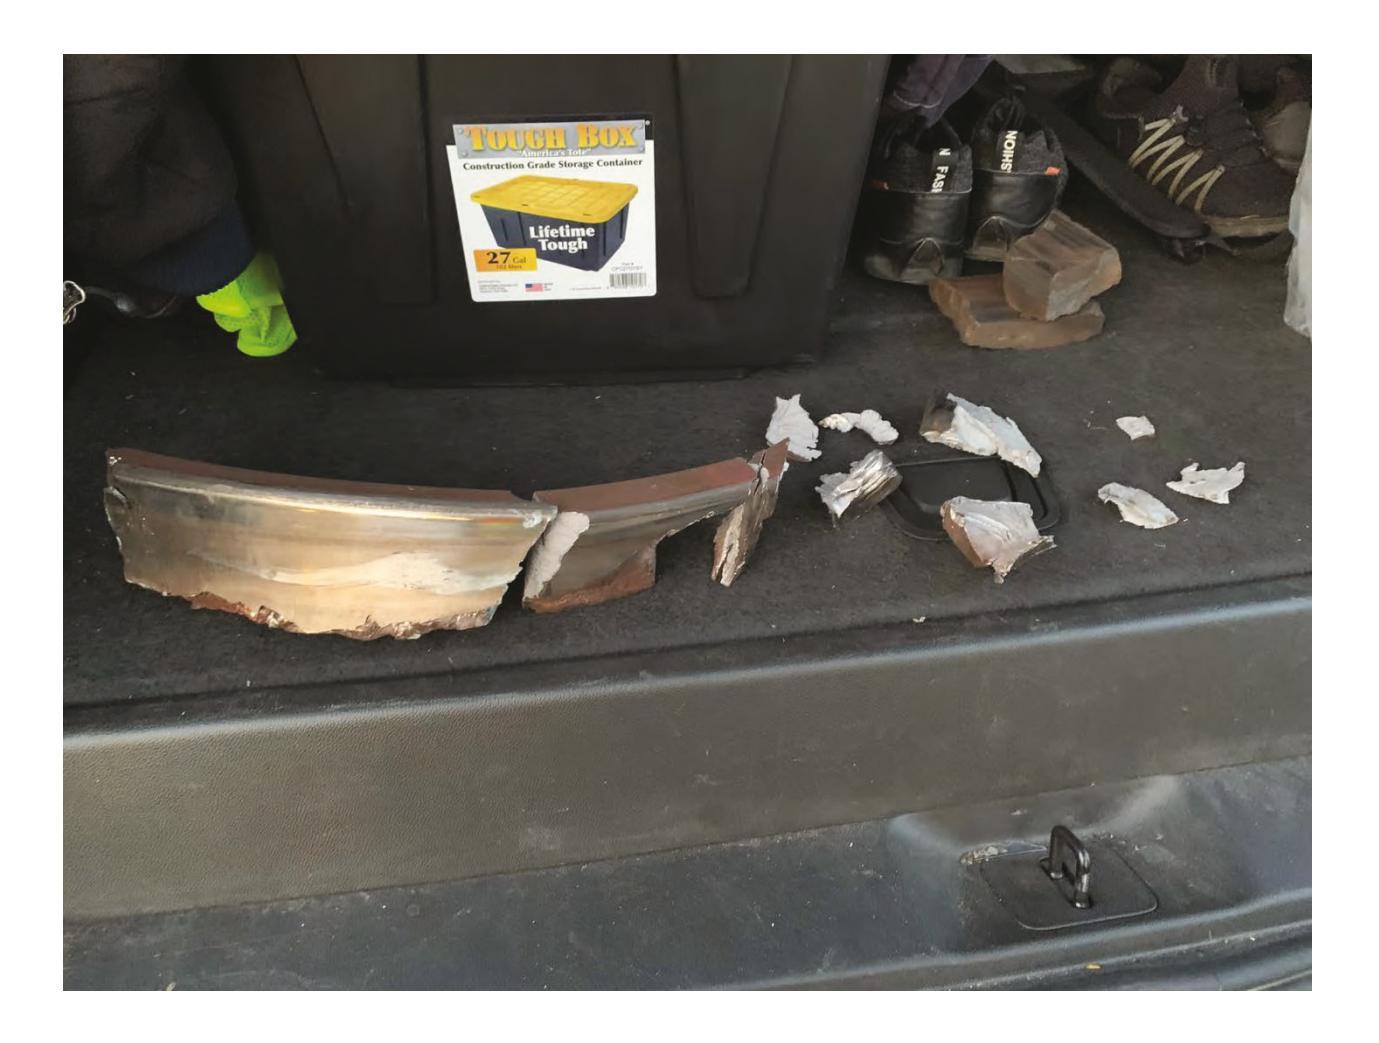
Several large fragments of broken wheel were recovered from the Main 2 track right-of-way between MP 70.4 and MP 71.0. The fragments were collected by NS and set aside to be assessed by NS's research and test department. FRA photographed the wheel fragments (reference Picture 4).

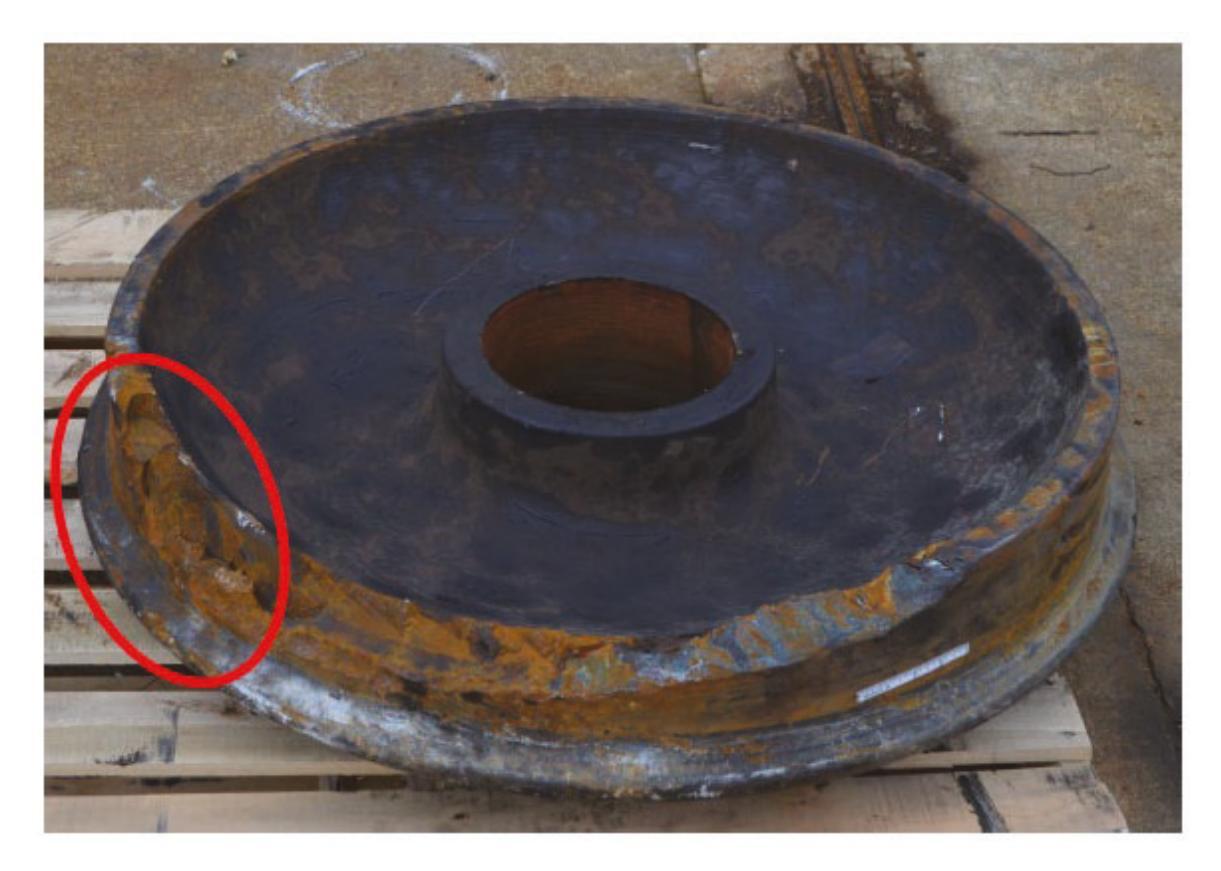
Sourced from NS Research & Test analysis

On May 9, 2022, the NS research and test department issued a report summarizing conclusions reached after assessment of the broken R4 wheel from NS 145387 (reference Pictures 5 and 6). The report concluded that heat checks were present on the wheel tread surface and that the wheel failed as result of a "shattered rim". The heat checks were determined to be non-detrimental.

The nature of the wheel defect that caused this accident can be very difficult to detect during traditional in-person "walking" inspections of rolling equipment. The MP&E team recommends the following potential countermeasures regarding this issue: • Inspect trains more frequently than required by FRA regulations -- Train 1 received no further inspections before it left Bailey Mine. Had the train been reinspected by designated inspectors (as defined in 49 CFR § 215.11) prior to it departing the mine, the defective R4 wheel on NS 145387 may have been detected thereby preventing this accident.

• X-ray railroad wheels (or conduct some other form of metallurgic testing) with the same frequency as required by SCABT regulations -- the defective R4 wheel on NS 145387 may have been detected by way of periodic X-ray or ultrasonic testing. All freight cars are required to receive SCABT no less than every 5 years per 49 CFR § 232.305(c). Metallurgic defect testing of in-service wheels could be performed while SCABTs are performed.
