Federal Railroad Administration Office of Railroad Safety Accident and Analysis Branch

Accident Investigation Report HQ-2015-1062

Kansas City Southern Railway Company (KCS) Vivian, LA July 3, 2015

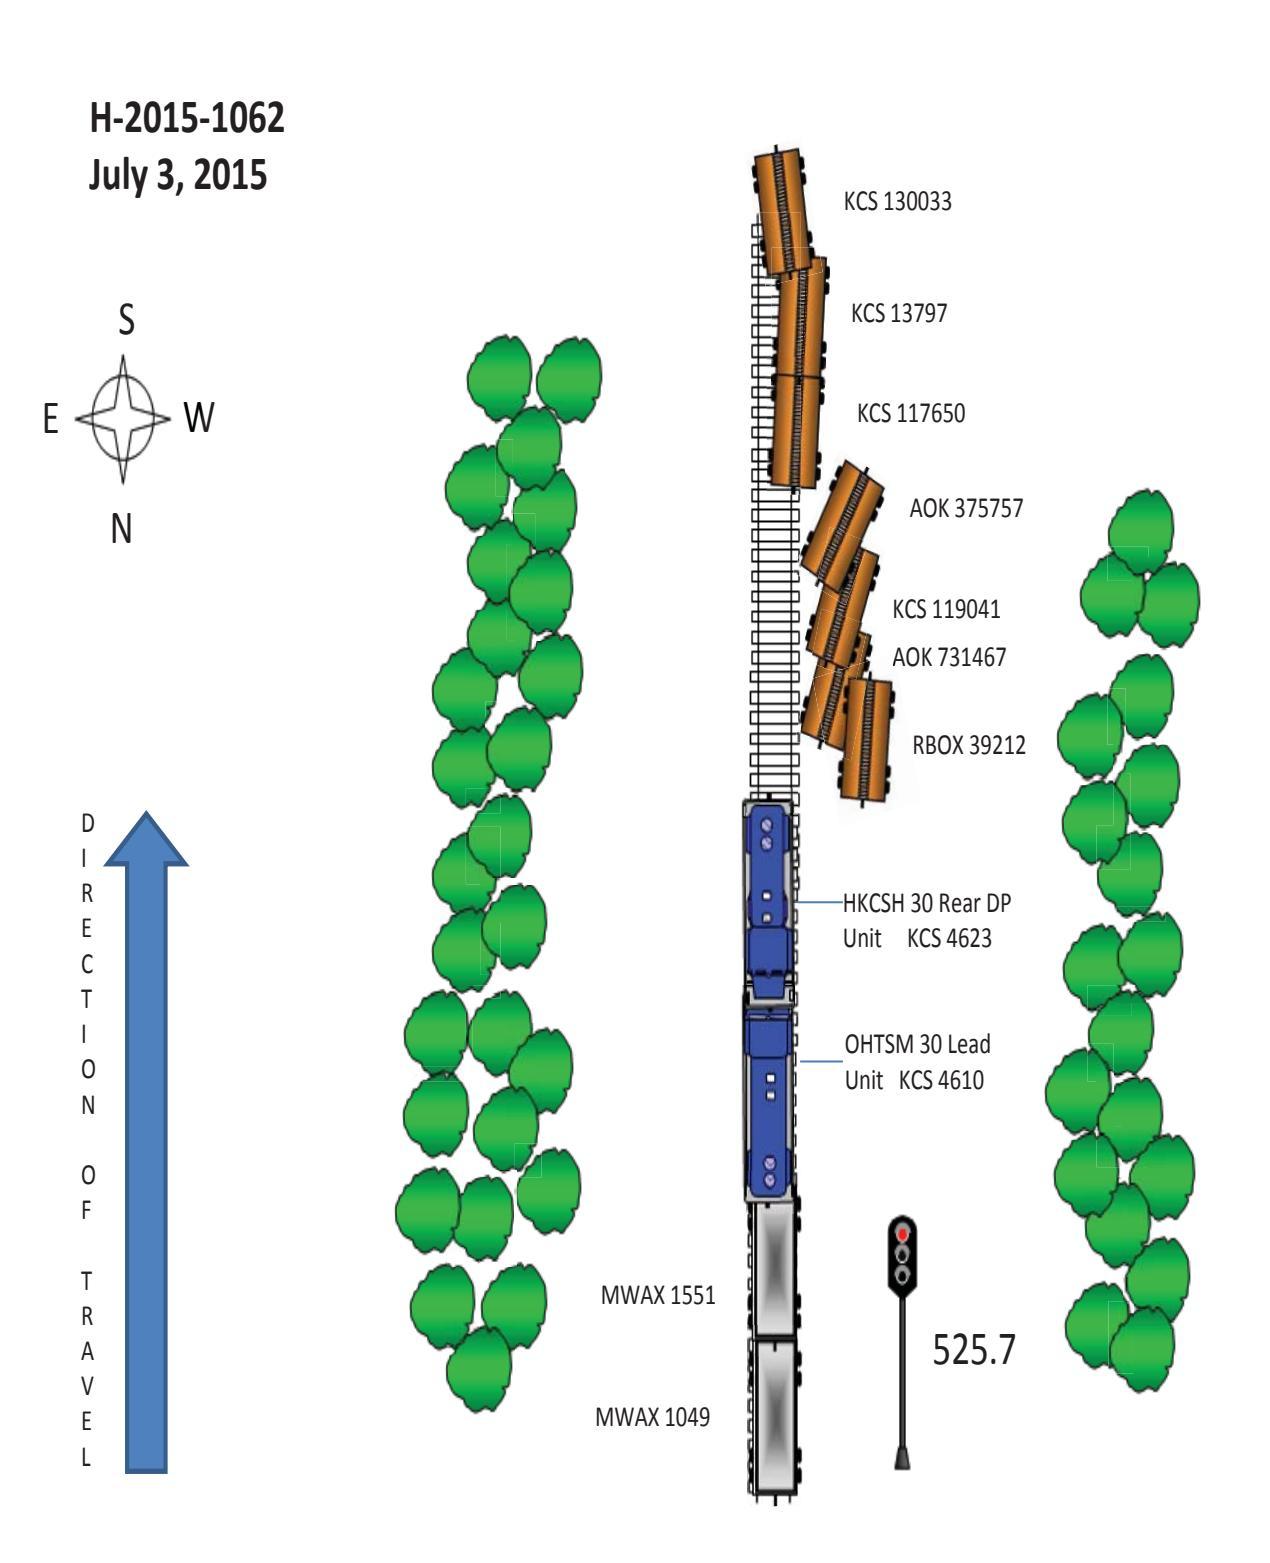
Overhead Drawing

The collision occurred north of Vivian, Louisiana, on the Shreveport Subdivision at Milepost 525.7 on single main track. Movements on this part of the railroad are governed by centralized traffic control, with maximum authorized speed of 55 mph through the town of Vivian.

No equipment was derailed from Train OHTSM 03. Derailed equipment from Train HKCSH 30 included the rear seven cars. The rear DPU, which was the first equipment struck, did not derail. Track damage was estimated at \$4,000. There was no signal damage, and equipment damages were estimated at \$159,289. There were two reported injuries to crew members of Train OHTSM 03. There was no release of hazardous materials.
