# **REPORT NO. FRA/ORD-79/09.1**

# **POSTMORTEM INVESTIGATION OF** THE KANSAS TEST TRACK

**NOVEMBER 1979** FINAL REPORT

**U.S. DEPARTMENT OF TRANSPORTATION** FEDERAL RAILROAD ADMINISTRATION Office of Research and Development Washington, D.C. 20590

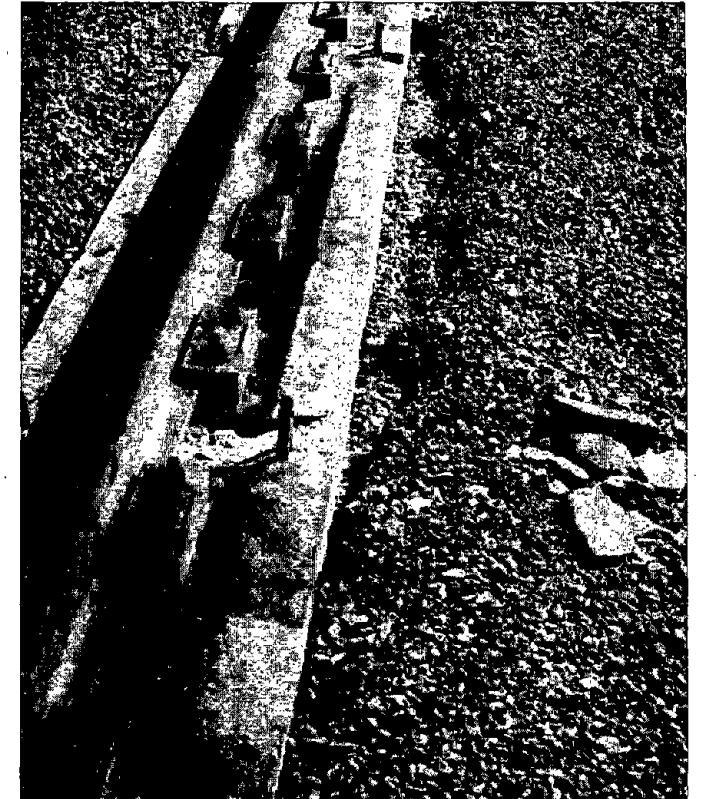
Upper limit (FRA Class 5) profile and gage irregularities, as measured by a track survey device, occurring in the nonconventional structures (twin beams in Track Sections 4 and 7) were the first evidence of more serious problems to follow. Cracking of the beams at vertical construction joints and spalling at the joint cracks also occurred. While these conditions were not cause for immediate concern, the appearance of mud pumping through the ballast certainly was. Examples of spalling and pumping in the nonconventional structures are shown in Figure 2. During the spring thaw and rains of 1975, pumping

FIGURE 2. EXAMPLES OF PUMPING AND SPALLING AT CONTROL POINTS OF THE NONCONVENTIONAL TRACK STRUCTURES

conditions were in evidence at many locations, being particularly severe in Track Sections 1, 4, 6, and 7 after heavy downpours. Typical conditions in the conventional track structures are illustrated in Figure 3. Two kinks in the KTT track occurred on 6 June 1975; these kinks were located in Track Sections 1 and 2, respectively, and were attributed to loss of lateral tie support in the mud-fouled ballast. These and other operational problems prompted FRA to close the KTT permanently on 11 June 1975.

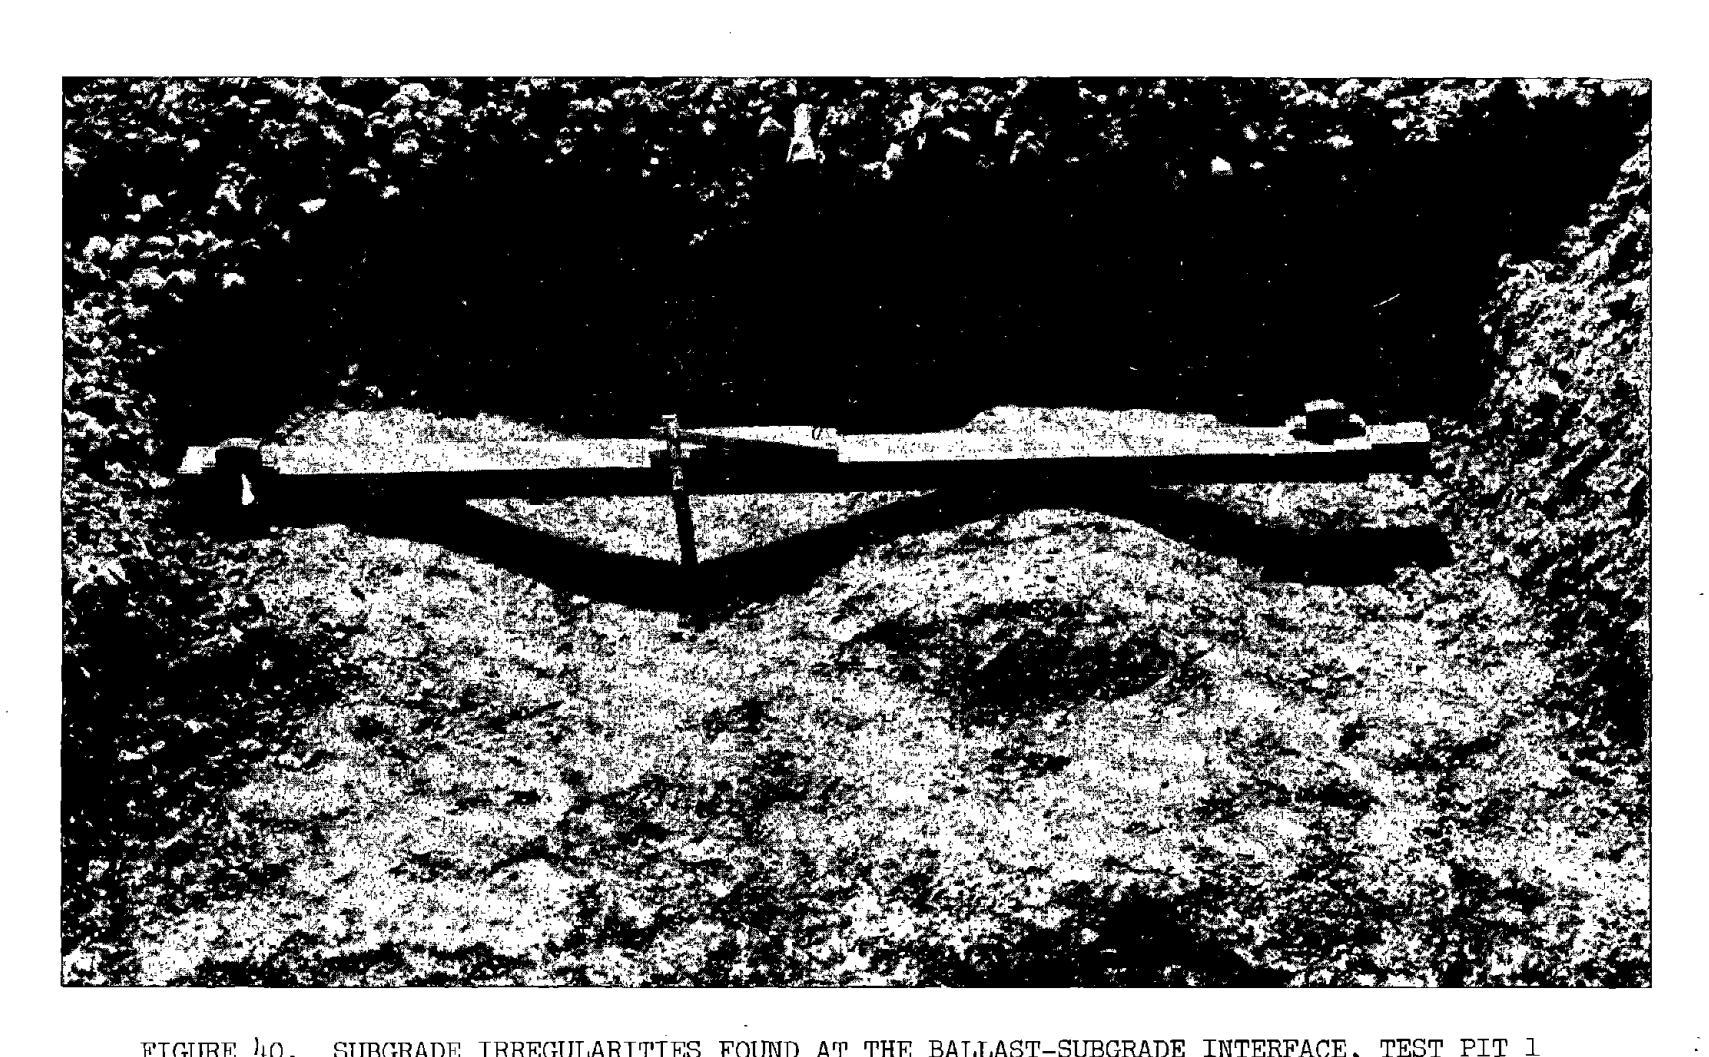
FIGURE 40. SUBGRADE IRREGULARITIES FOUND AT THE BALLAST-SUBGRADE INTERFACE, TEST PIT 1 (TRACK SECTION 1)

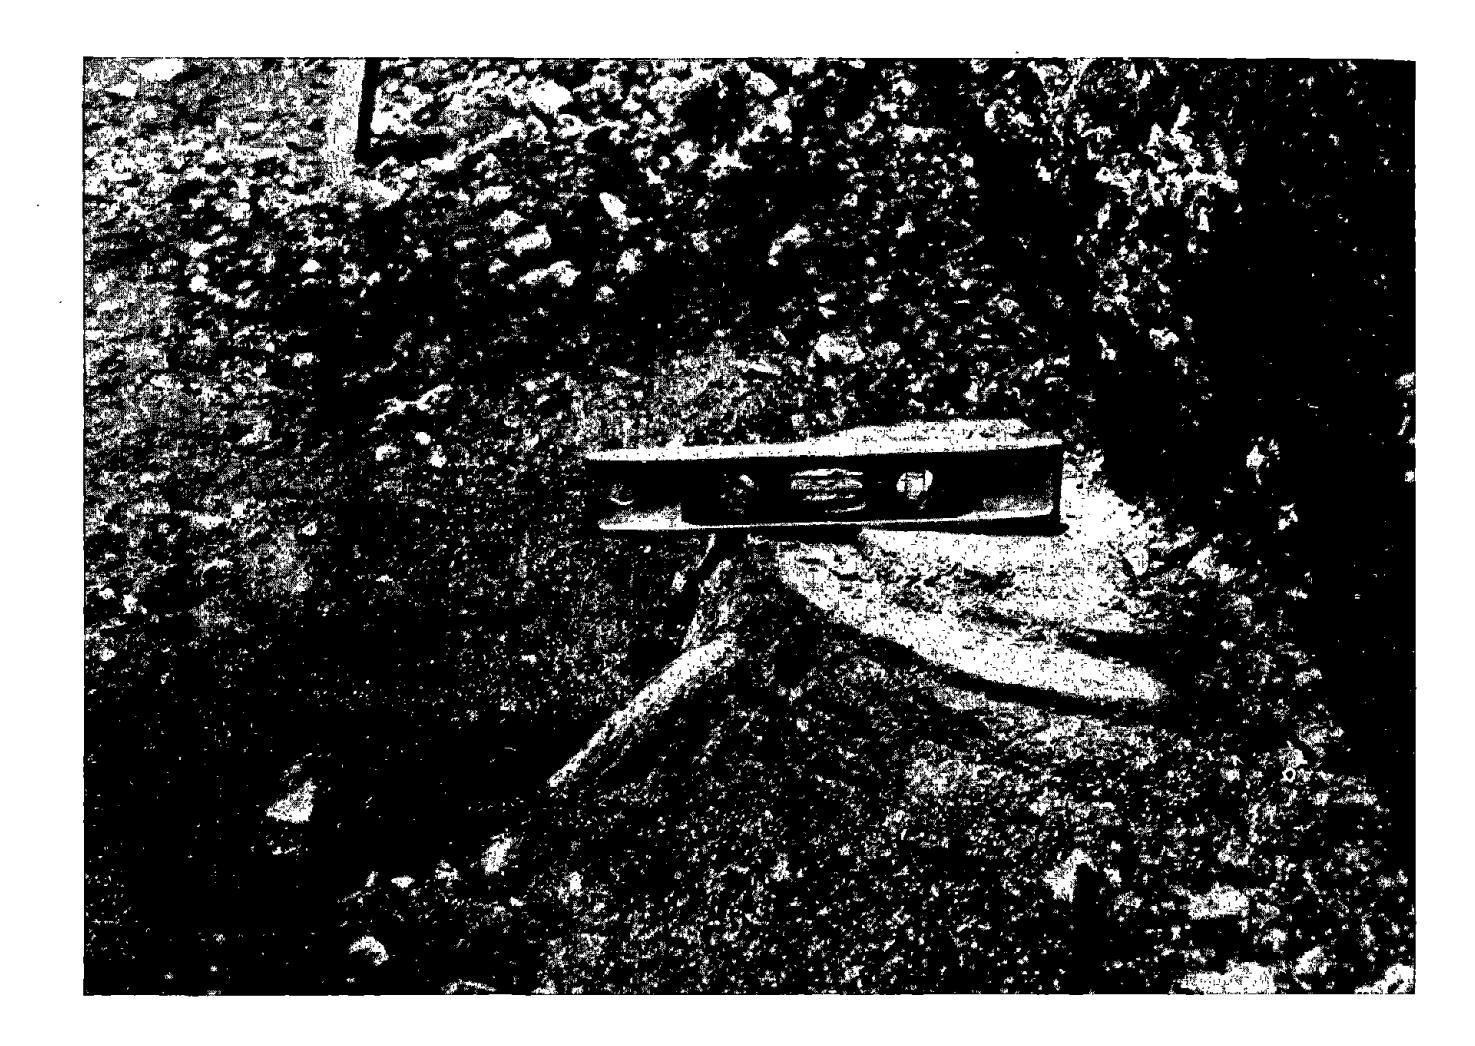
FIGURE 55. VERTICAL EXTENSOMETER TILT OBSERVED IN TEST PIT 9 (TRACK SECTION 9)

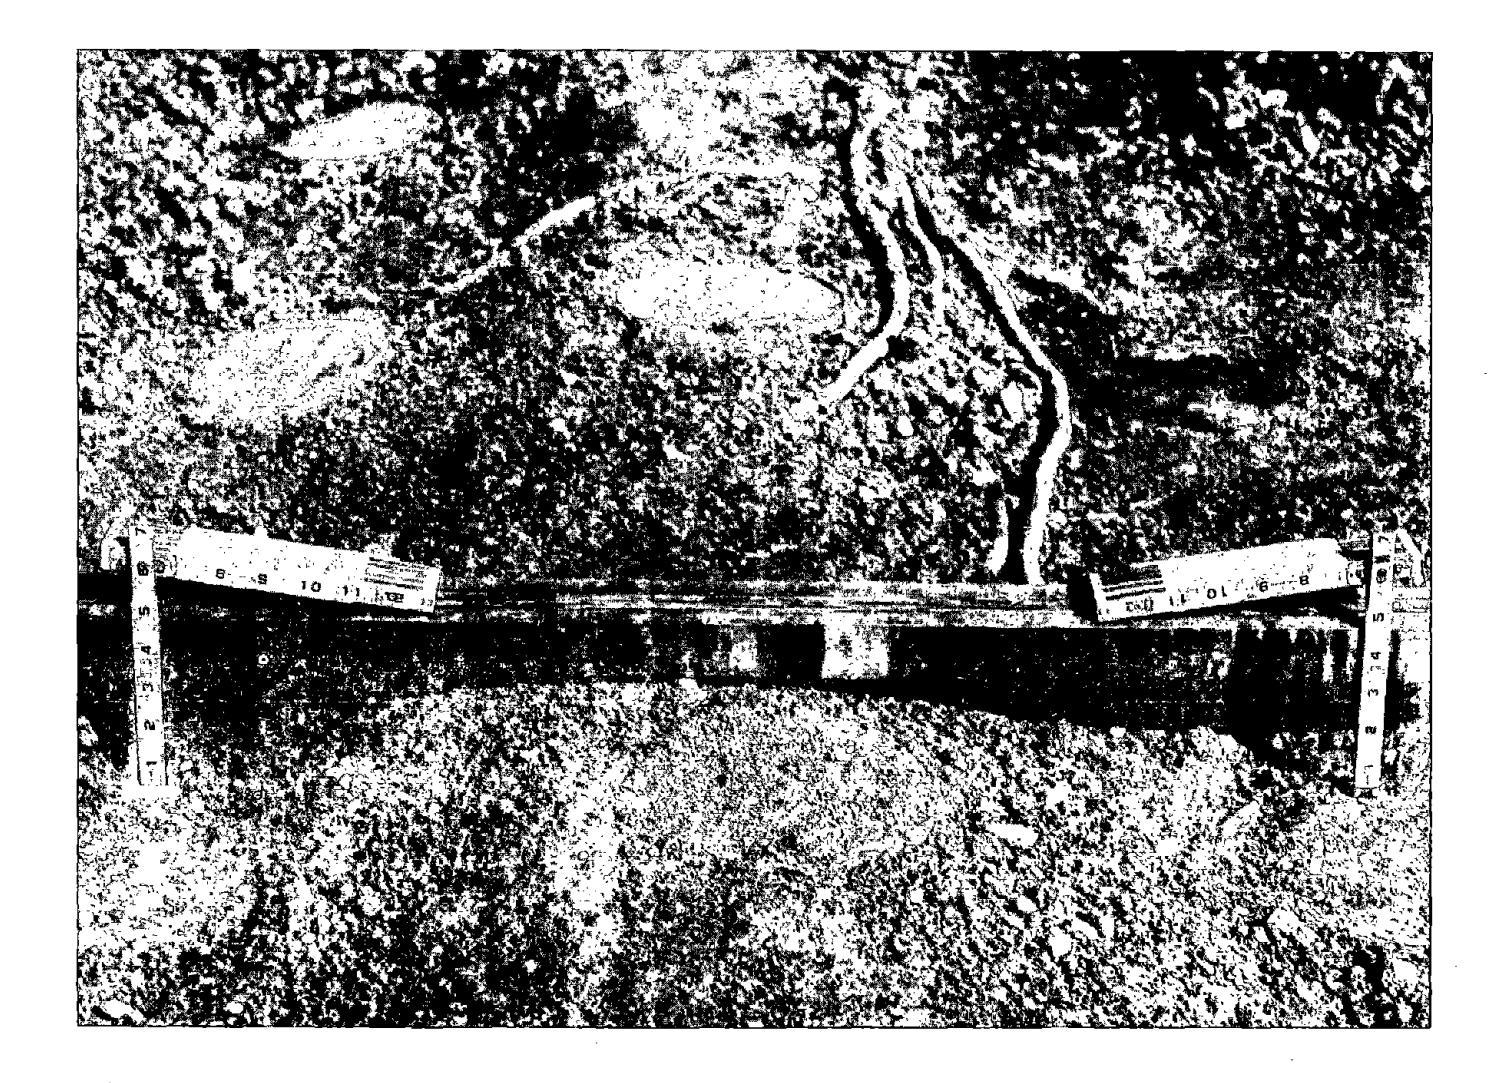
FIGURE 56. CONDITION OF PCA PRESSURE CELLS (LOCATION JUST BENEATH THE BALLAST SUBGRADE INTERFACE, TRACK SECTION 3)

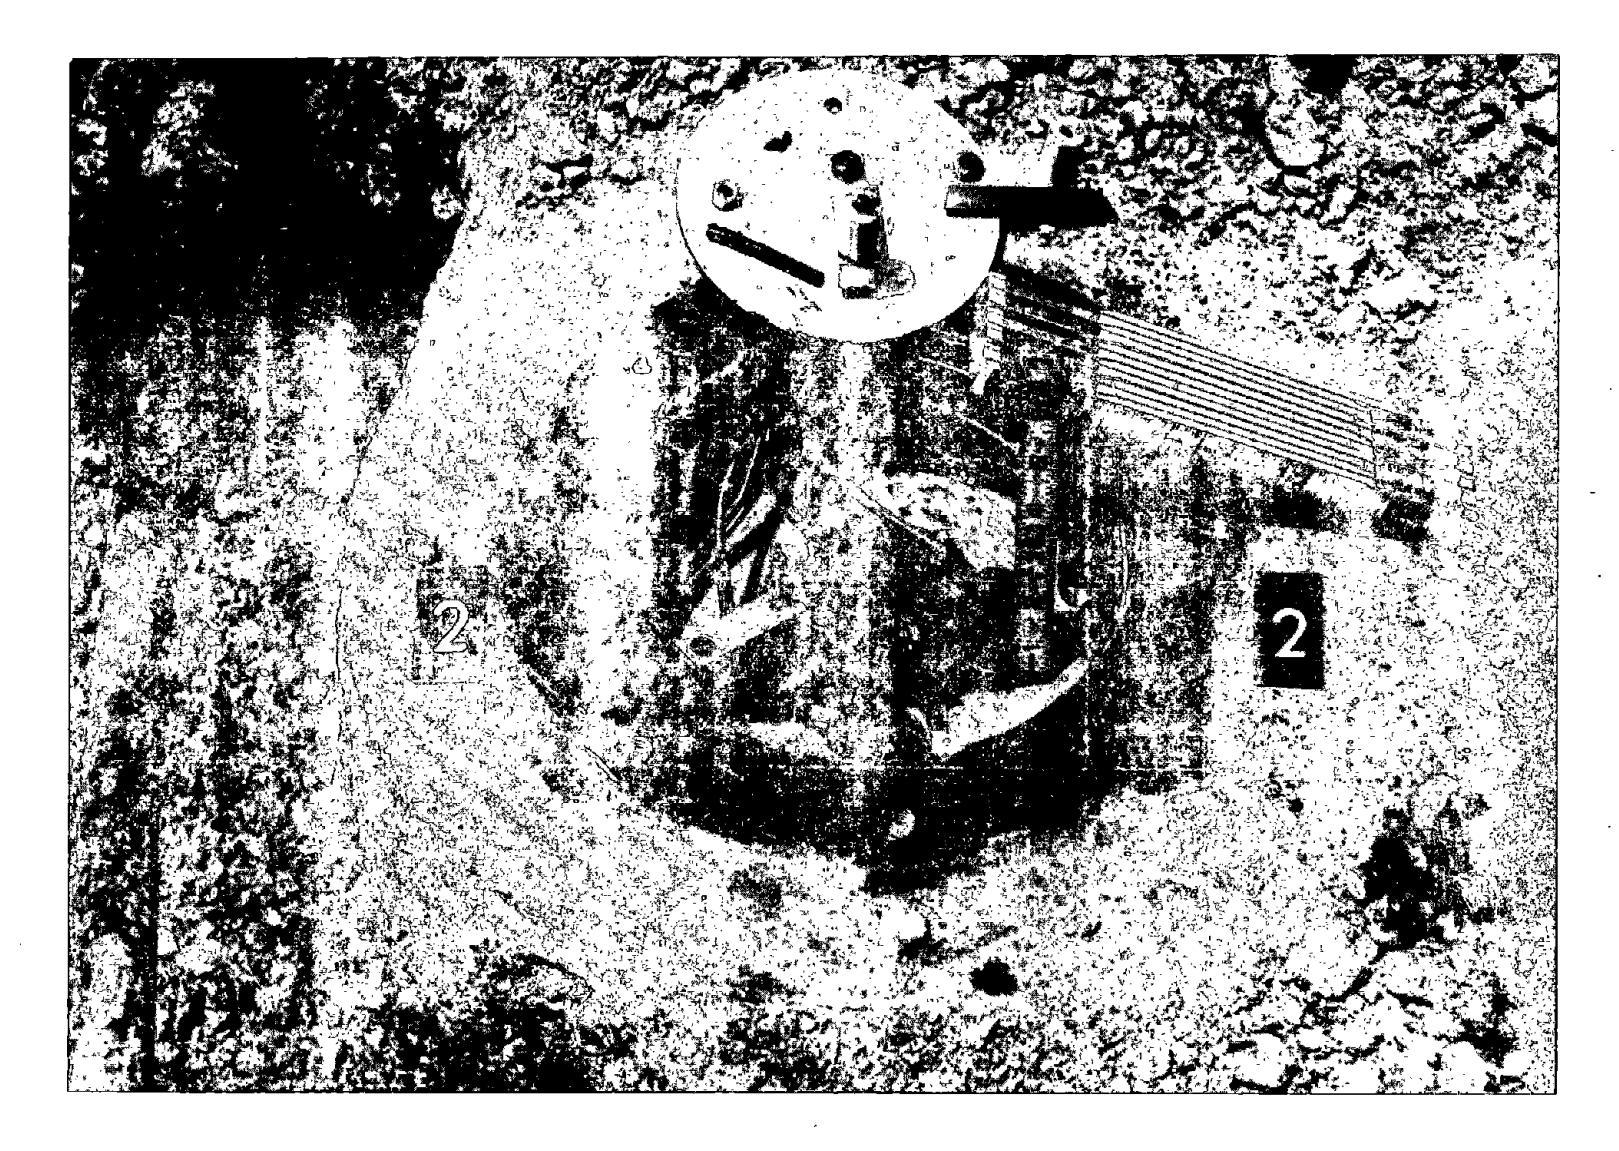
FIGURE 57. EXAMPLE OF INTERNAL DAMAGE TO MAIN ARRAY VERTICAL EXTENSOMETER (TRACK SECTION 2)

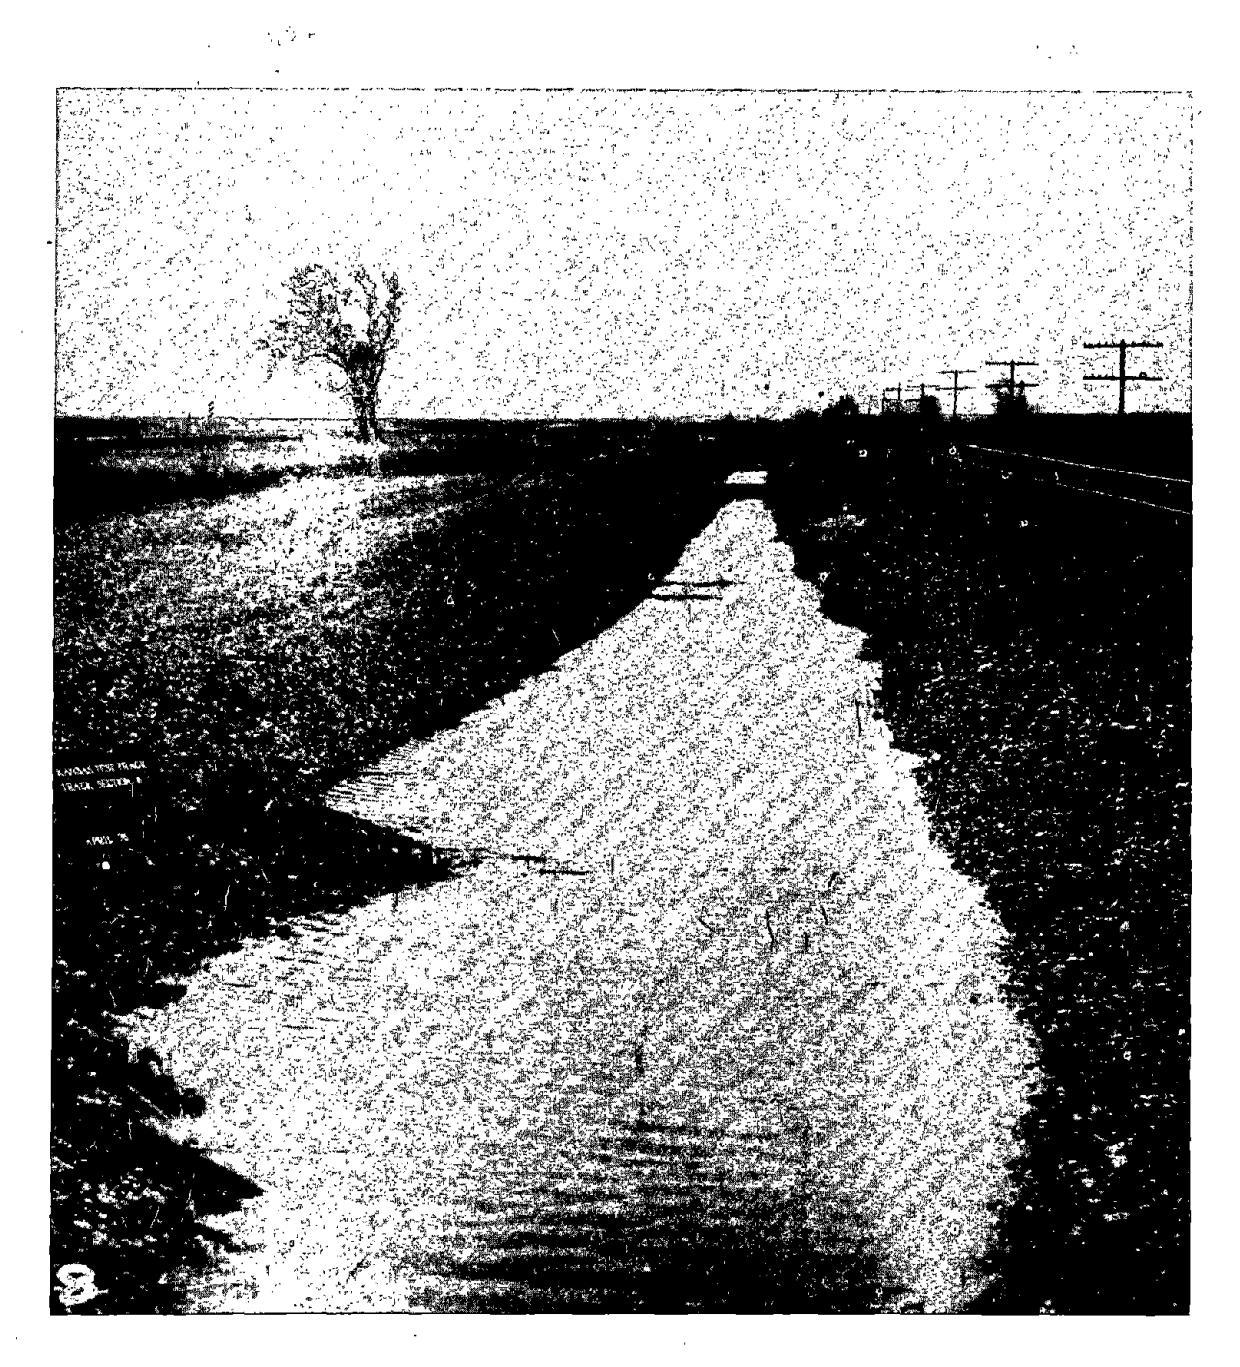
FIGURE 72. PONDING OF SURFACE WATER IN THE DRAINAGE DITCH BETWEEN THE KTT AND ATSF MAINLINE TRACK (VIEW LOOKING EASTWARD TOWARD TRACK SECTION 7)

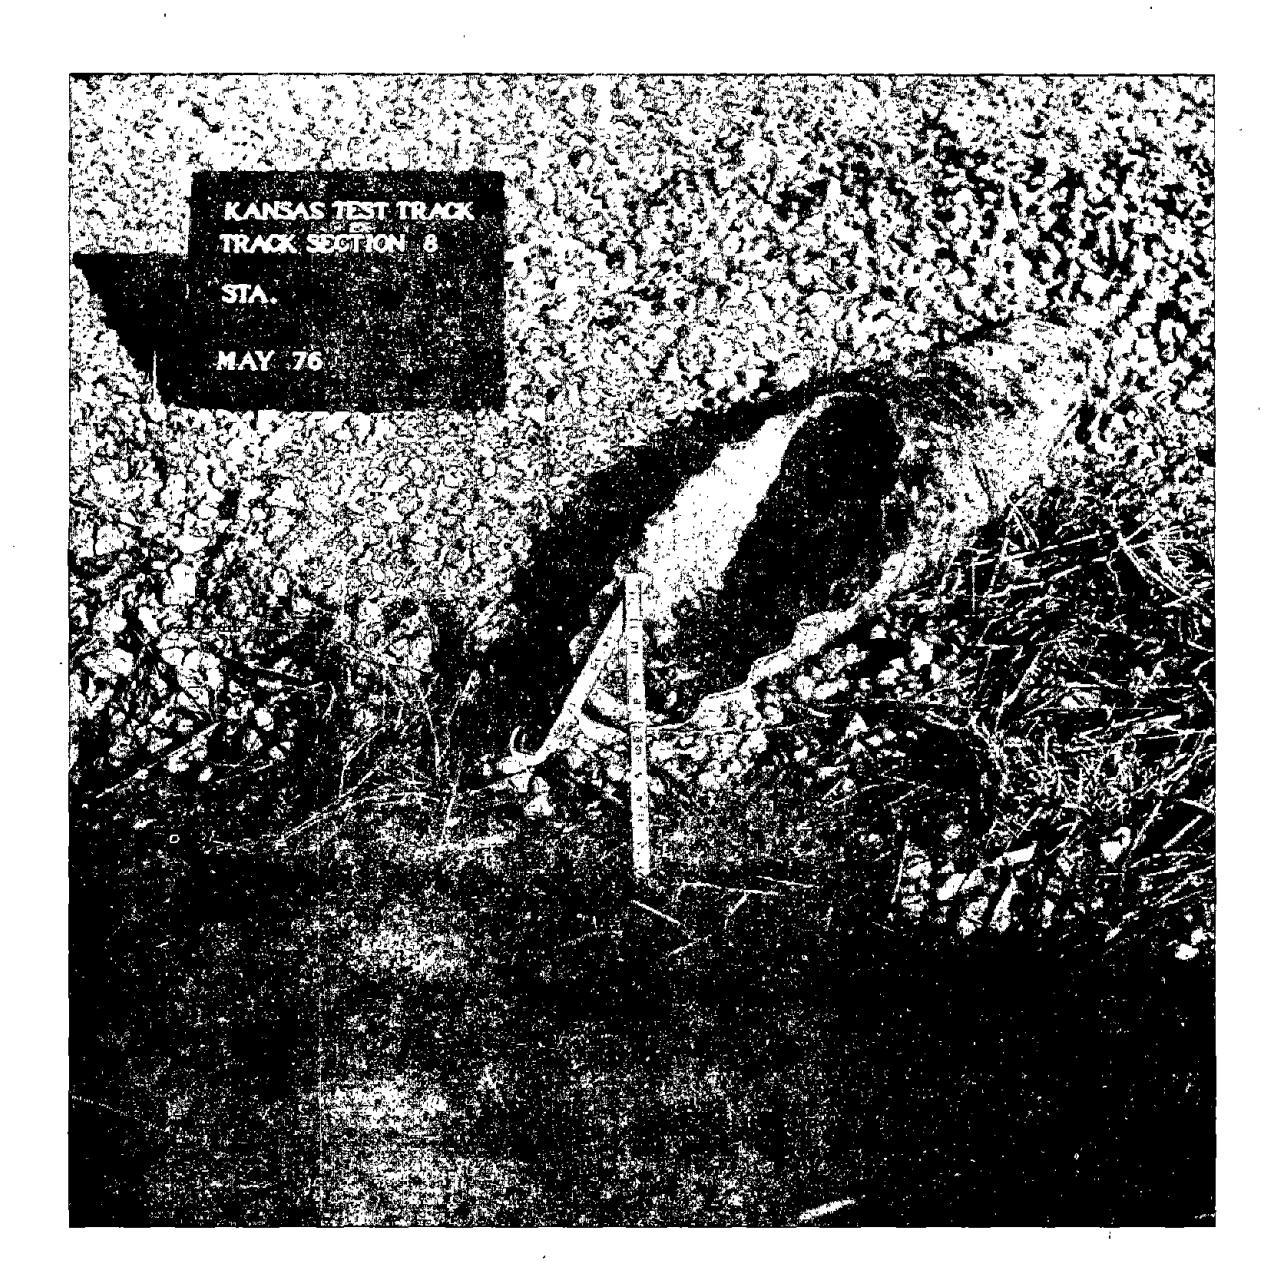
FIGURE 73. LATERAL DRAINAGE CULVERT (TRACK SECTION 8, ADJACENT TO GRADE CROSSING). NOTE LOCATION OF INLET WITH RESPECT TO DITCH

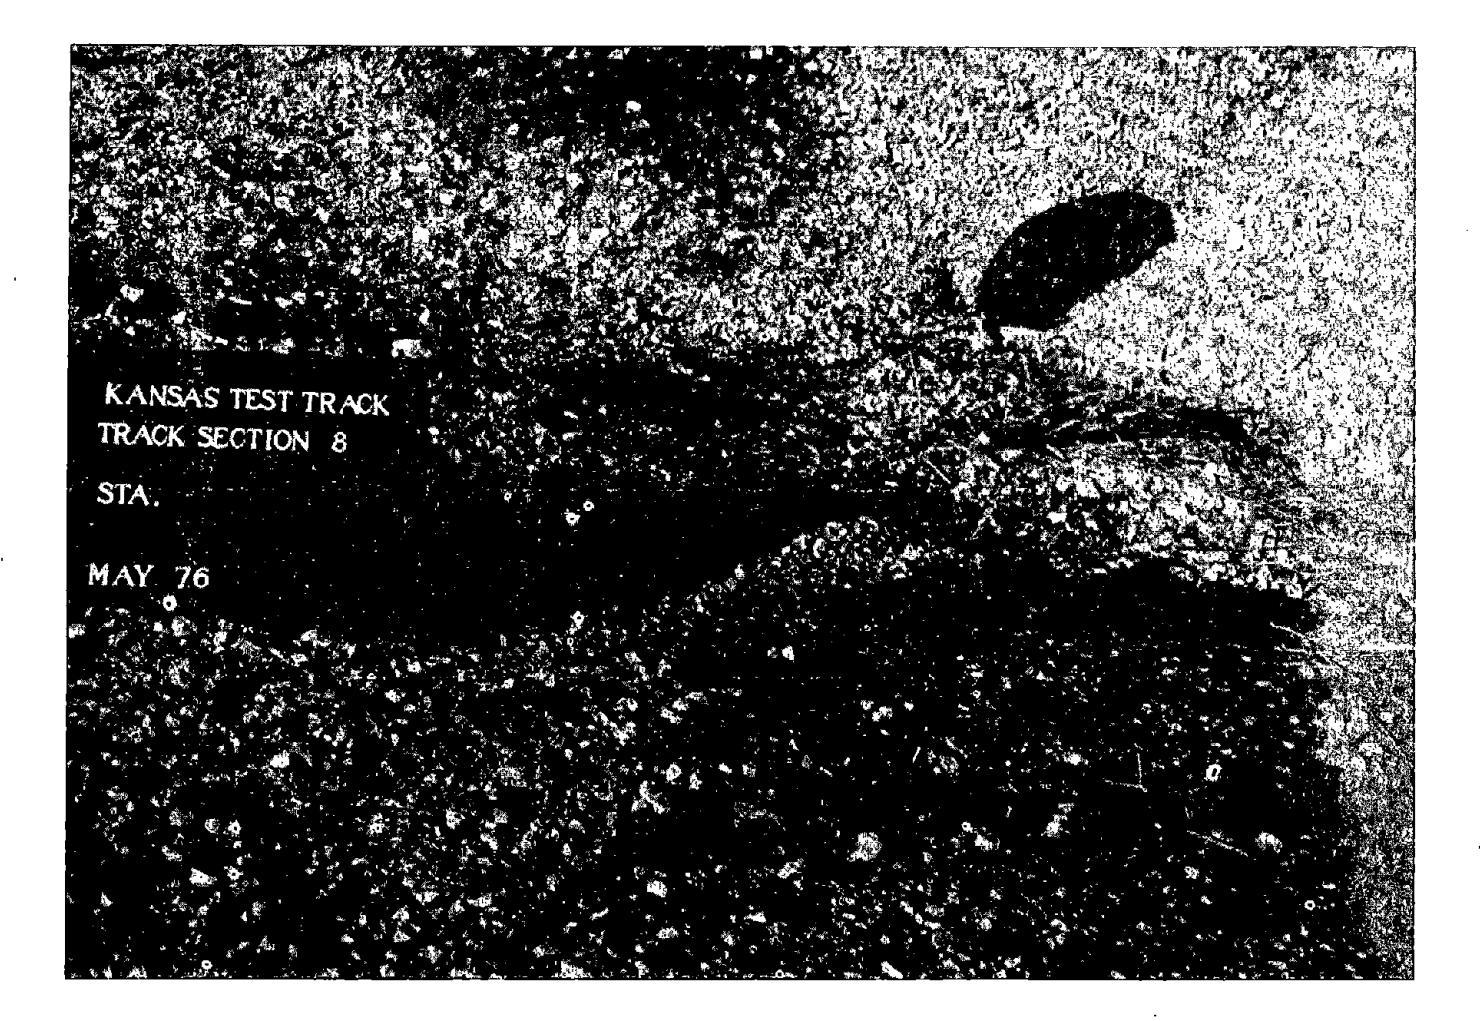
FIGURE 74. DRAINAGE CULVERT UNDER TRACK SECTION 8 (NOTE PARTIAL CLOSURE THROUGH SILTING)
