Federal Railroad Administration Office of Railroad Safety Accident and Analysis Branch

Accident Investigation Report HQ-2017-1184

Union Pacific Railroad Company (UP) Hearne, TX February 3, 2017

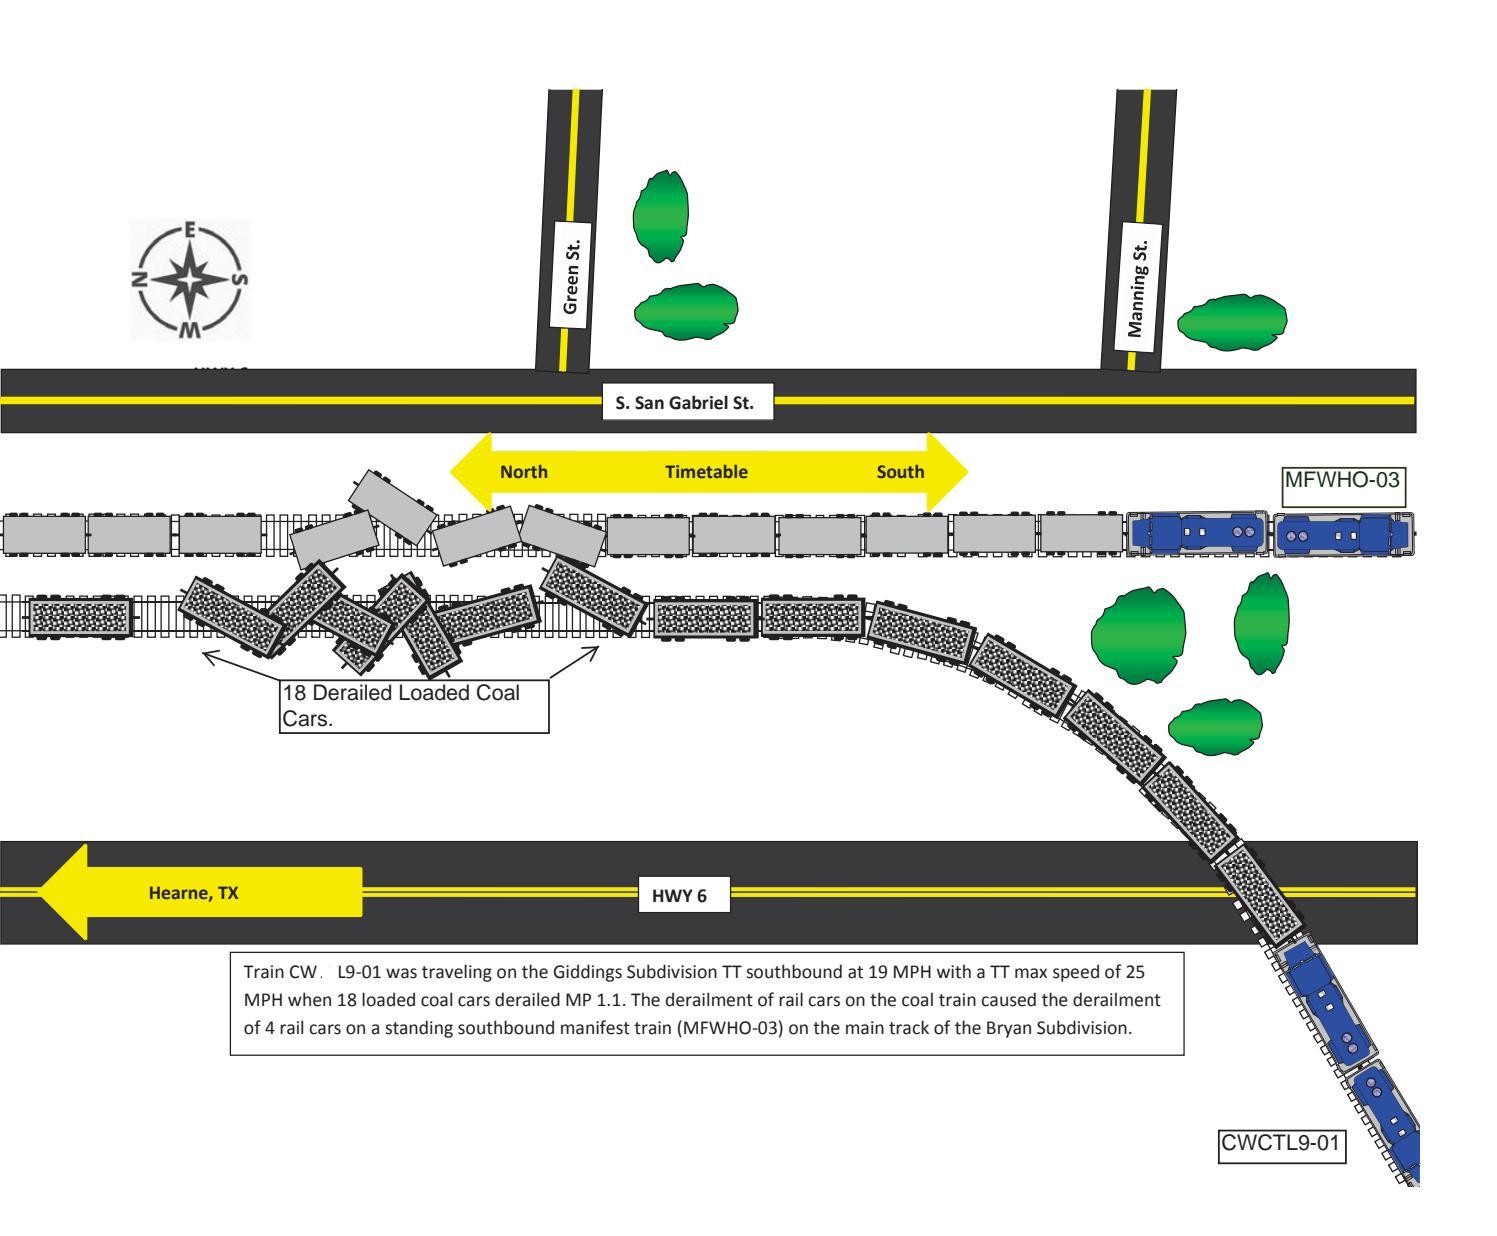
Hearne TX Sketch 2

Train CWTCL9-01, traveling southbound at a recorded speed of 19 mph, experienced an undesired emergency brake application at 8:55 p.m. The undesired brake application was due to 18 loaded coal cars derailing at MP 1.1 on the Giddings Subdivision. A southbound manifest train, MFWHO-03, had just initiated movement at MP 119.5 on the Bryan Subdivision, which is adjacent to the point of derailment (POD). Cars from the 18-car derailment collided with four cars of the southbound manifest train causing
