Federal Railroad Administration Office of Railroad Safety Accident and Analysis Branch

Accident Investigation Report HQ-2017-1232

BNSF Railway Company (BNSF) Williston, ND October 13, 2017

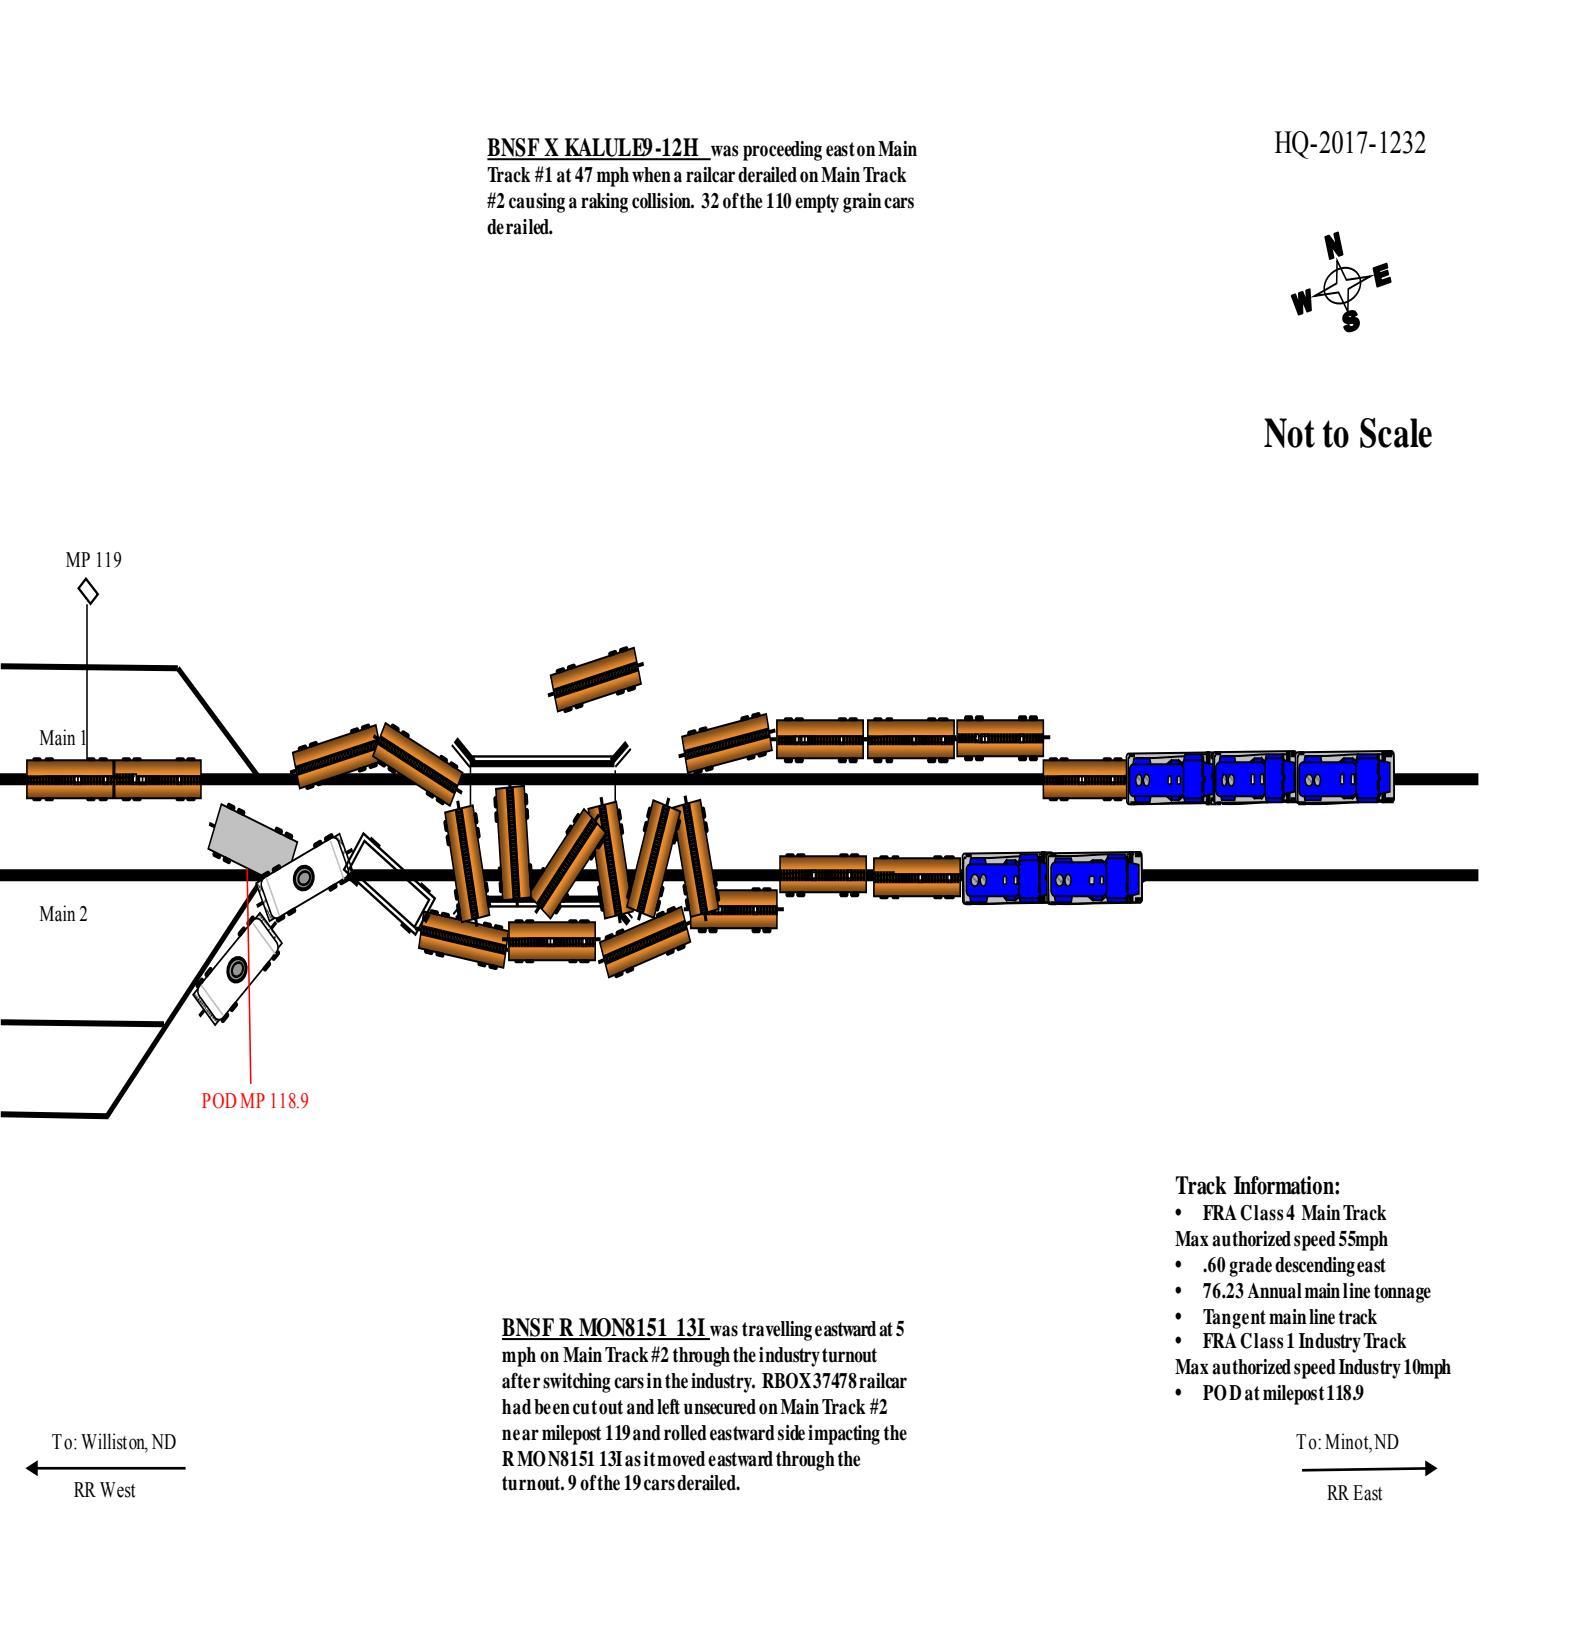
HQ-2017-1232 Sketch

On October 13, 2017, at approximately 5:00 p.m. MDT, a single rail car rolling uncontrolled impacted a BNSF Railway Company (BNSF) "road switcher" Freight Train R-MON8151-13I (train 1) as the train was traversing from the Red River Industries' track onto BNSF's Main Track No. 2. The side collision occurred at milepost 118.9 on the BNSF's Glasgow Subdivision, of the BNSF's Montana Division, near the city of Williston, North Dakota. Upon impacting the side of train 1, the striking rail car, RBOX 37478, derailed to the north causing a raking collision with the side of an eastbound BNSF Empty Grain Train, Train X-KALULE9-12H (train 2), which was passing by on Main Track No. 1. The side collision and subsequent raking collision resulted in the derailment of 10 cars (1 loaded, 9 empties) from train 1 and 32 cars from train 2. At the time of the accident, train 1 consisted of 2 locomotives on the head end, 19 empty rail cars, and 4 loaded rail cars, with 1,215 trailing tons. The train was traveling eastward, at an estimated speed of 5 mph when it was impacted by the unattended rail car (RBOX 37478). Train 2 consisted of three leading locomotives and 110 empty grain cars, with 3,413 trailing tons, and a length of 6,666 feet. Train 2 was traveling eastward on Main Track No. 1 at a recorded speed of 47 mph.

while the conductor was applying hand brakes to the cars they had spotted in the industry track. After spotting cars in the Red River Industries track, train 1 began to pull eastward from the industry with their 2 head-end locomotives and 18 rail cars onto Main Track No. 2 at an estimated speed of 5 mph. At this time the unattended rail car on Main Track No. 2, Car RBOX 37478, began free-rolling eastward and impacted the side of train 1 at the east industry switch (milepost 118.9) as they were pulling east through the switch onto Main Track No. 2. Upon impact, Car RBOX 37478 derailed to the north of Main Track No. 2 and fouled Main Track No. 1, striking train 2 as it was passing at a recorded speed of 47 mph. The unsecured car caused both trains to derail near the industry switch and at points further east including over a small bridge. Ten cars from train 1 derailed on or to the south of Main Track No. 1 and onto Main Track No. 2, with the remaining 24 cars derailing on their sides to the north of Main Track No. 1.
