Federal Railroad Administration

DOT/FRA/ORD-19/38

Final Report October 2019

1. AGENCY USE ONLY (Leave blank)		2. REPORT DATE 3 October 2019		3. REPOR	3. REPORT TYPE AND DATES COVERED Technical Report April 2016 – August 2017	
4. TITLE AND SUBTITLE A Study of Environmental and Track Factors that Contribute to Abrasion Damage of Concrete Ties					5. FUNDING NUMBERS DTFR53-16-C-00009

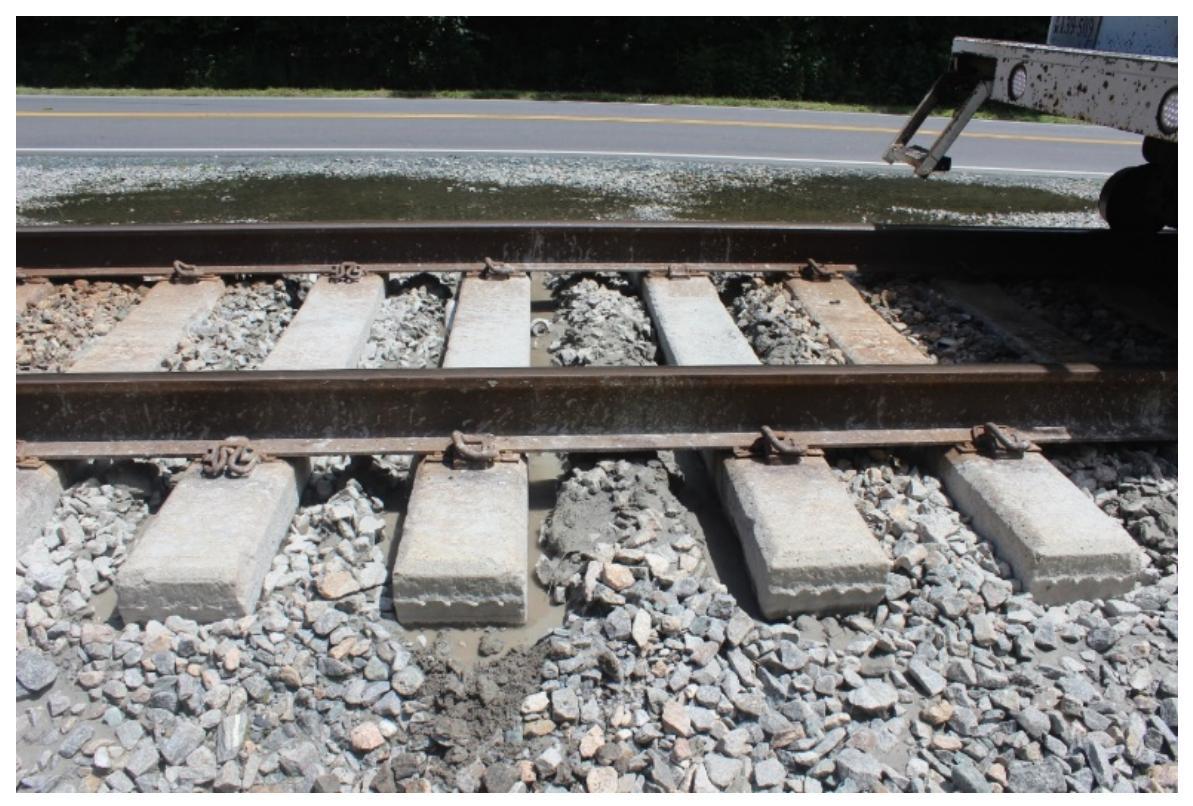
Pumping was seen in four locations with low amounts of abrasion damage, such as described in appendices <u>Sections C.4</u>, <u>D.1</u>, <u>E.4</u>, and <u>E.7</u>. These sites did not contain gray mud and had shallow ballast layers, giving much different support conditions. This indicates that pumping by itself is not sufficient to cause bottom tie abrasion.

Figure 3-5: Water ponding in track, contributing to mud pumping

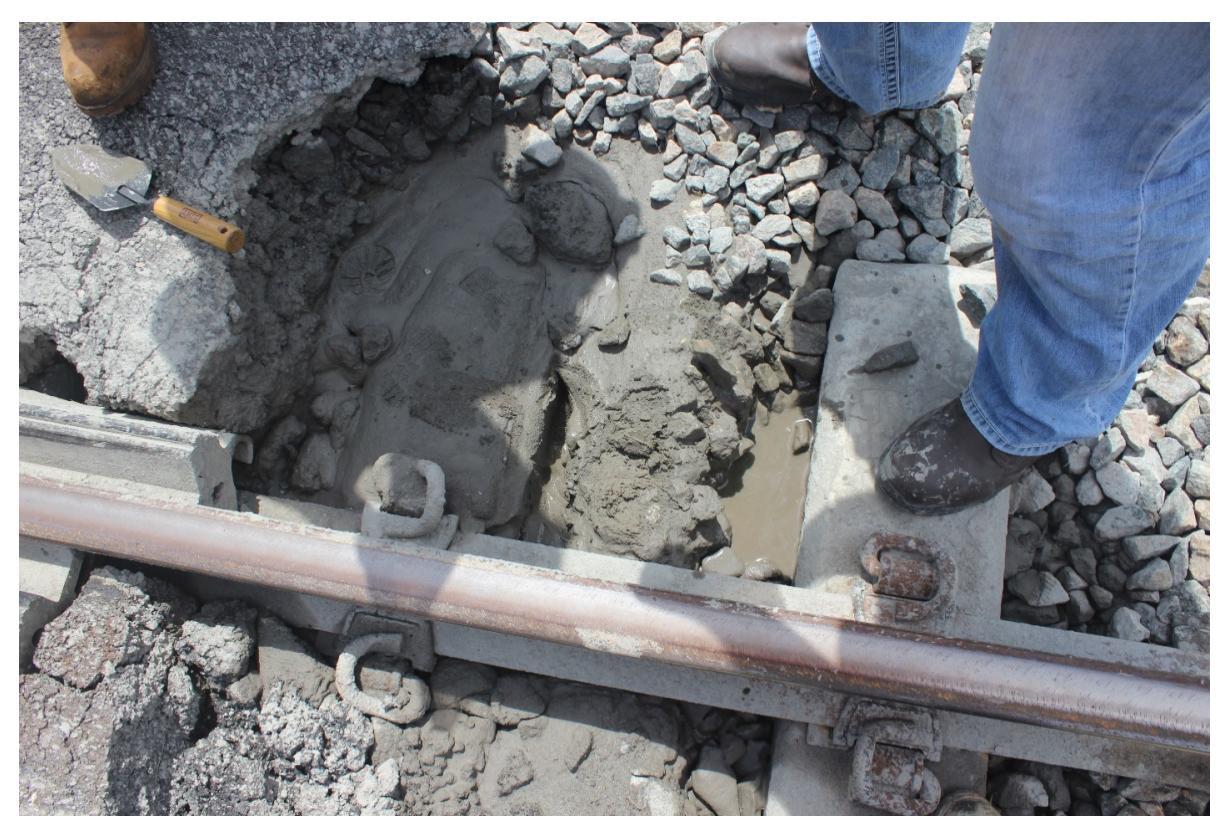
Sudden changes in track stiffness, or discontinuities in rail or support conditions, cause vertical movement of railcars. This phenomenon is well known in the highway industry. Bumps at bridge approaches can cause vertical vehicle movement and increase impact loads on the bridge. Bumps can cause an increase in train wheel loads during the downward motion of the train. Once the train experiences significant vertical acceleration from the bump, the train can experience harmonics that may create a few locations of increased wheel loads after the original bump before the train vertical acceleration is damped and returns to normal conditions. The repeated increased wheel loads could cause increased ballast stress and breakdown. This can exacerbate drainage issues, cause mud pumping, and contribute to concrete tie wear. Common locations where these dynamics occur include: bridge abutments and transition areas, insulated joints, transitions from wood-to-concrete ties, and railroad crossings. Figure 3-6 is a close-up view of a mud spot at an asphalt crossing. Asphalt fines were found mixed in with ground concrete and ballast. The sticky nature of the asphalt particles could help agglomerate fines and limit drainage, accelerating the rate of deterioration. Sites with multiple mud spots near each other in track were found in 13 of the 36 sites visited. It is likely that most of these sites will have multiple mud spots as conditions deteriorate over time. Figure 3-7 shows examples of this phenomenon in track. The road master on this site indicated that the number of locations with mud pumping adjacent to each other grew with time. The size of each spot with gray mud also grew with time as damage accumulated. He also indicated that the damage spread wider under the ballast surface. Fouling under the surface causes additional ballast and tie breakdown, causing mud spots to grow along the track.

Figure 3-6: Mud spot at an asphalt crossing

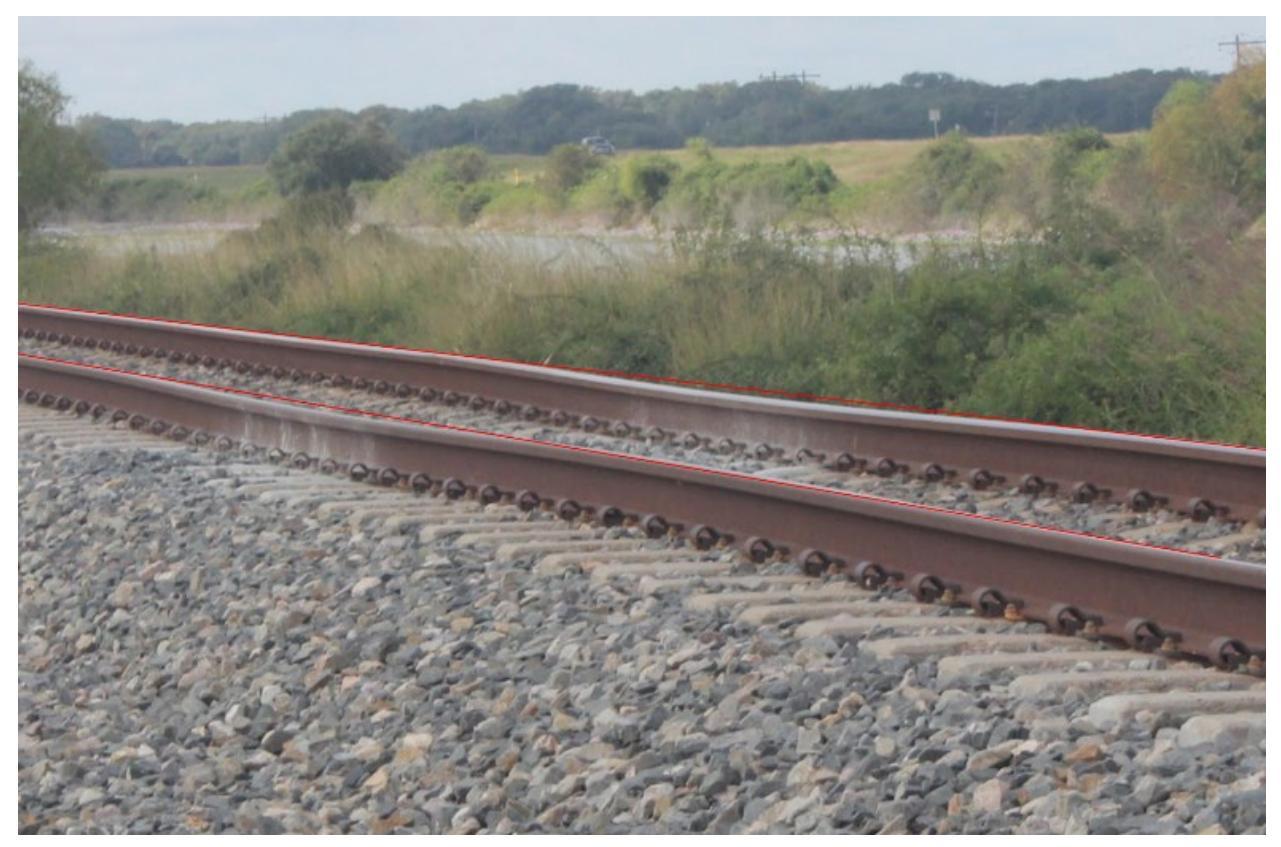
Investigators measured large amounts of tie deflection at Signal #2 as shown in Figure 3-11, and for Crossing #5 and Tangent Track #6. A large rail surface profile variation was seen at a mud spot location with abraded ties, Figure 3-17. High levels of rail and tie deflections during loading can fatigue the rail and contribute to rail breaks. Rail welds were commonly found at locations with abrasion damage.

Figure 3-17: Rail surface profile variation for track built on an old concrete highway. Red lines show the more than 1.3 in. of surface profile variation measured by the ATIP geometry car approximately 2 years before the picture was taken

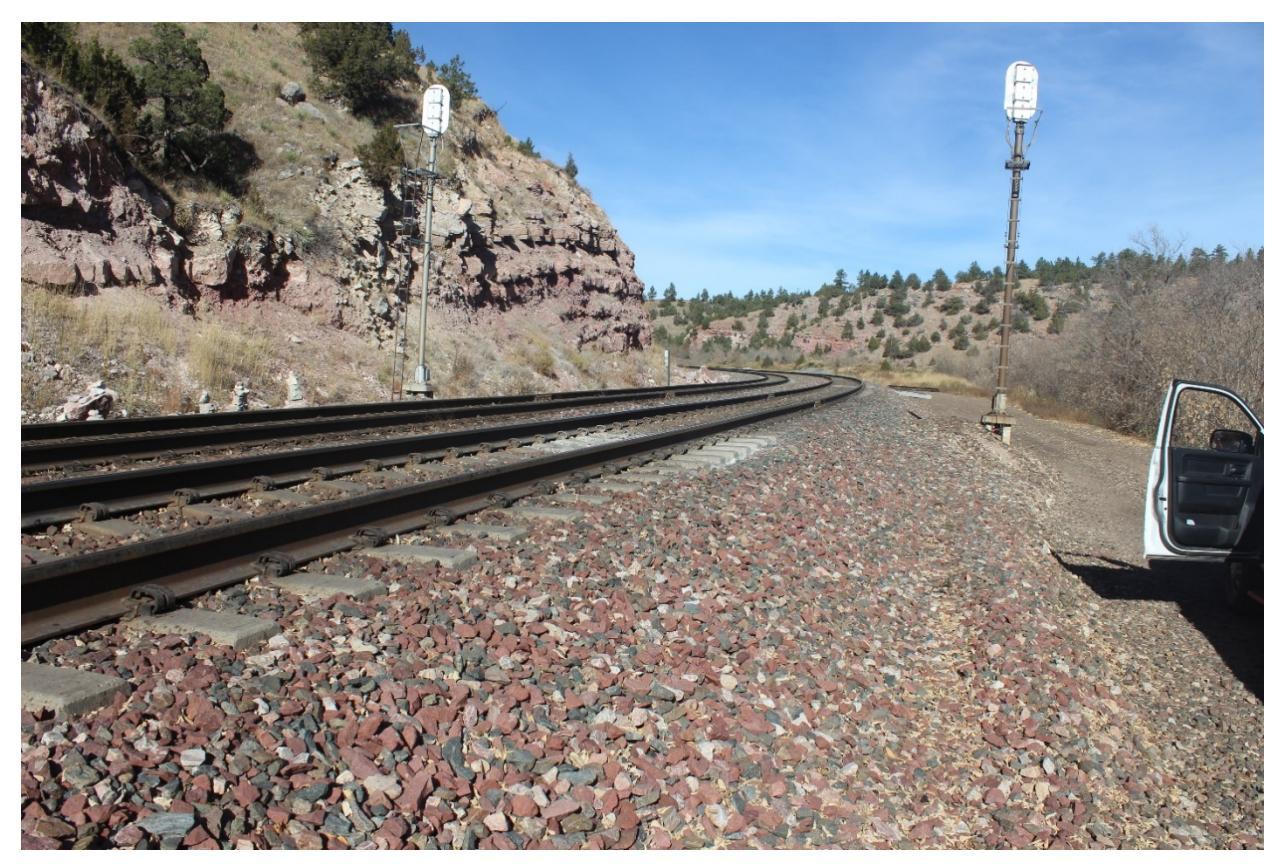
Figure 3-18: Curve #4

Concrete tie abrasion may contribute to track alignment instability as shown in Curve #4, described in <u>Appendix D.4</u>, and shown in Figure 3-18. The ties in this location were scheduled for replacement because the ties were having difficulty keeping the curve radius constant during rail temperature changes. Ties in Curve #4 were made without scallops and had minor abrasion damage that may have reduce the lateral stability of the curve. Scallops may help prevent track misalignment.

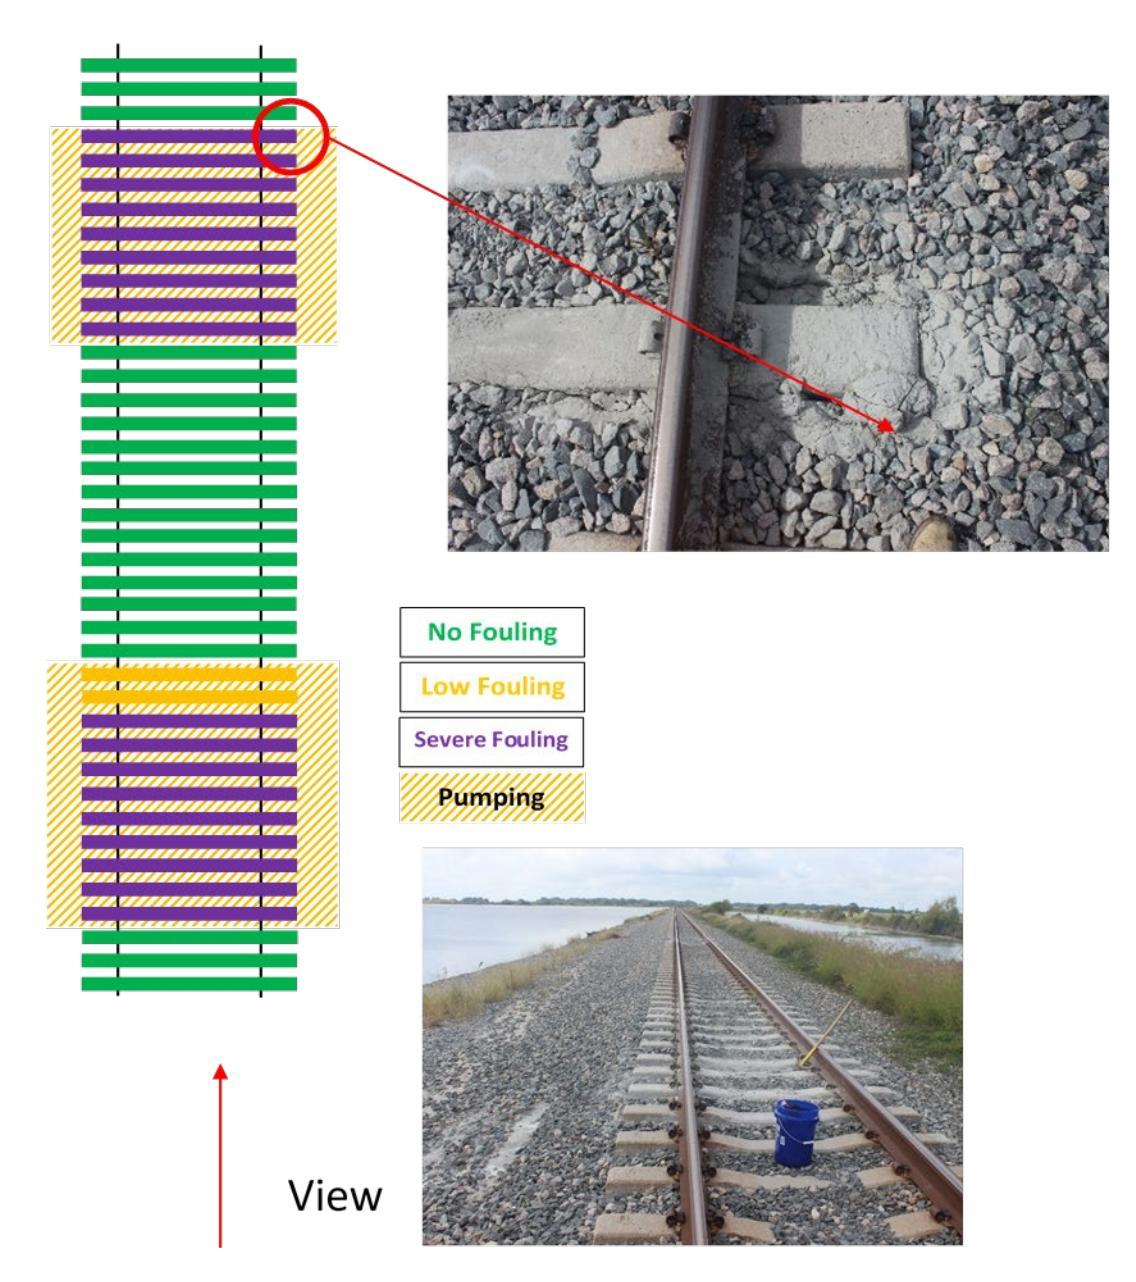
Track stiffness appears to be an important contributing factor to concrete abrasion damage. Locations with known high stiffness had significant numbers of abraded ties. These locations included the three bridges described in <u>Appendix A, Sections A.1</u> through <u>A.4</u>, and the track built an old concrete highway described in <u>Appendix A, Section A.5</u>, and shown in Figure 3-17 and Figure 3-19.

Figure 3-19: Abrasion damage at Bridge Approach #2

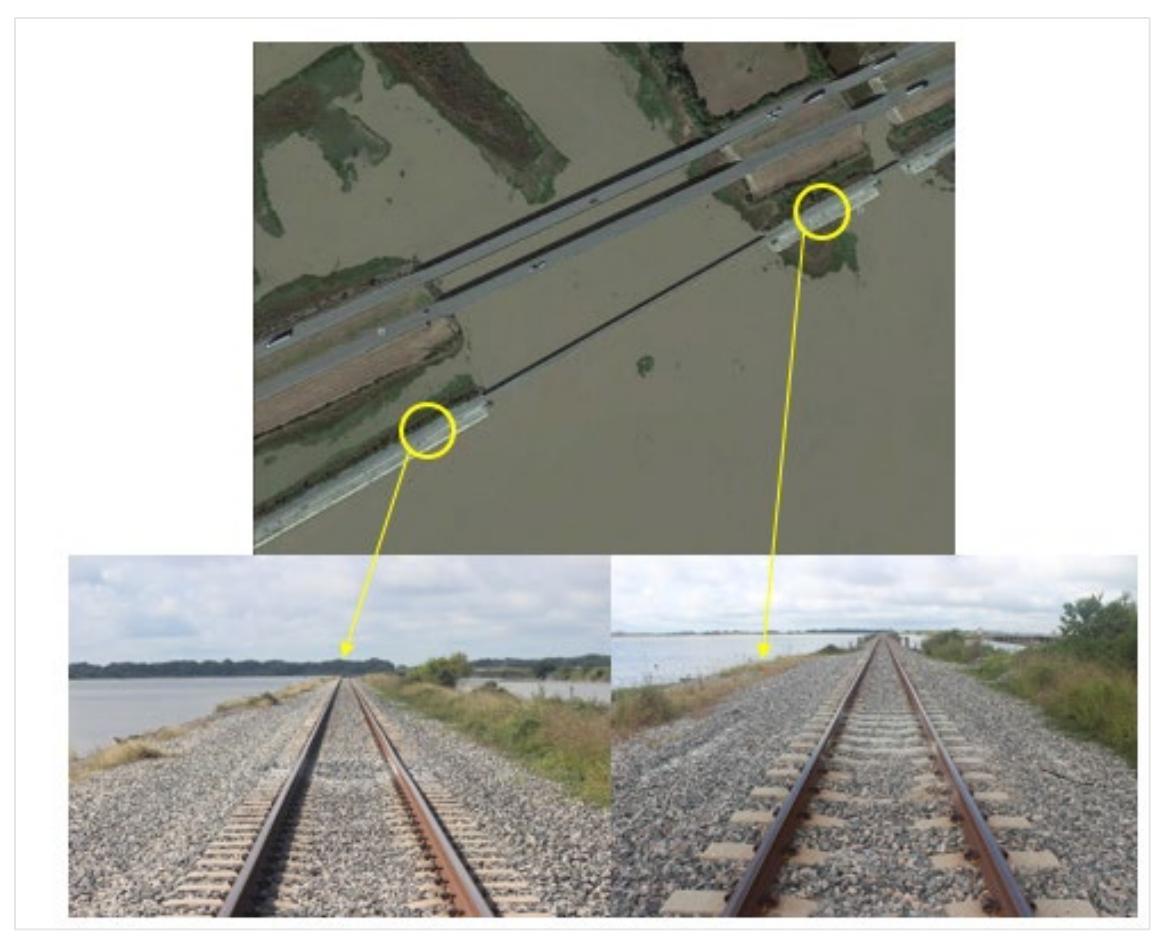
Figure 3-20 shows locations with tie abrasion damage in relation to a bridge (Bridge Approach #2, <u>Appendix A, Section A.5</u>). For the track section built over the old concrete highway, fines in track could not have come from mud or sub-ballast because of the presence of the highway in the track structure. In these locations, the ballast fouling was clearly caused by ballast and concrete tie breakdown. The fines were comprised of crushed ballast and ground concrete. Additionally, these locations have a thinner ballast layer. The thinner ballast yields higher ballast stress levels and consequently more ballast breakdown.

Figure 3-20: Bridge Approach #2, built over old concrete highway

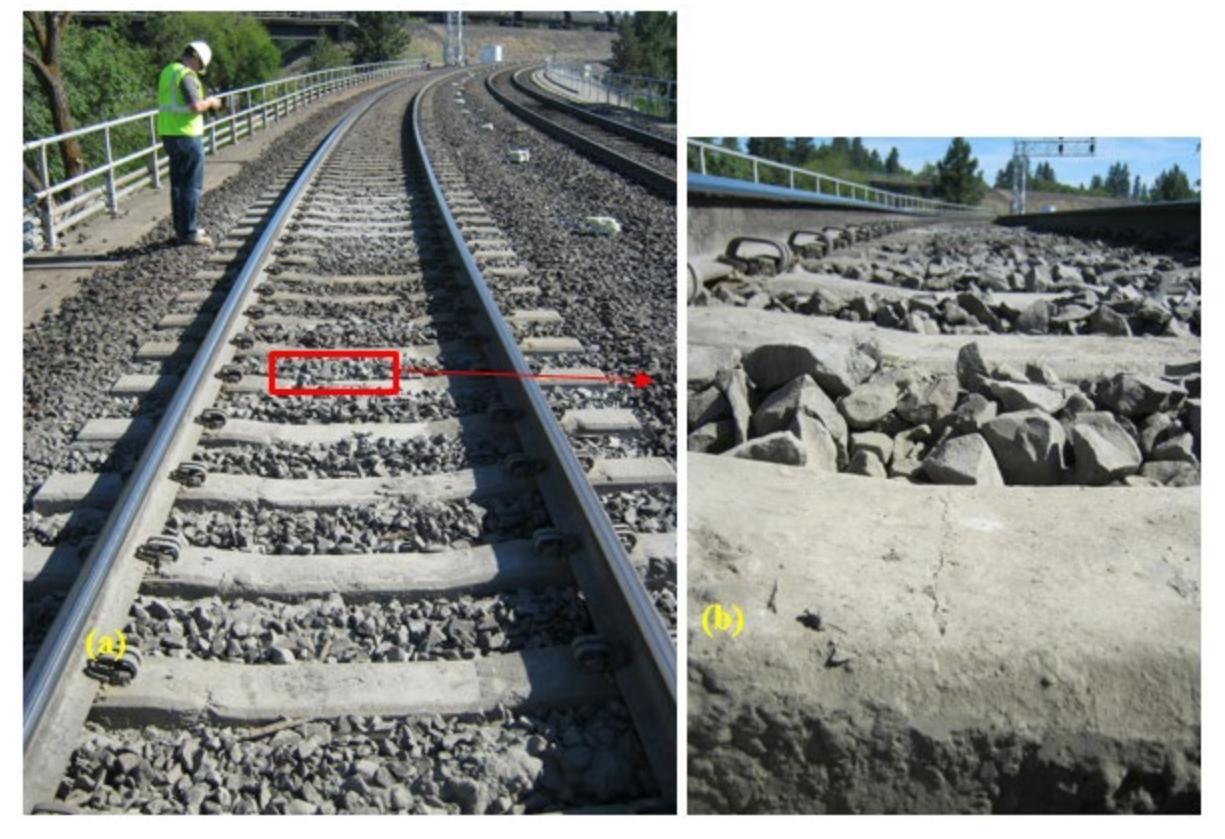
Figure A-4: Moderate binding cracking on ties, Bridge #1

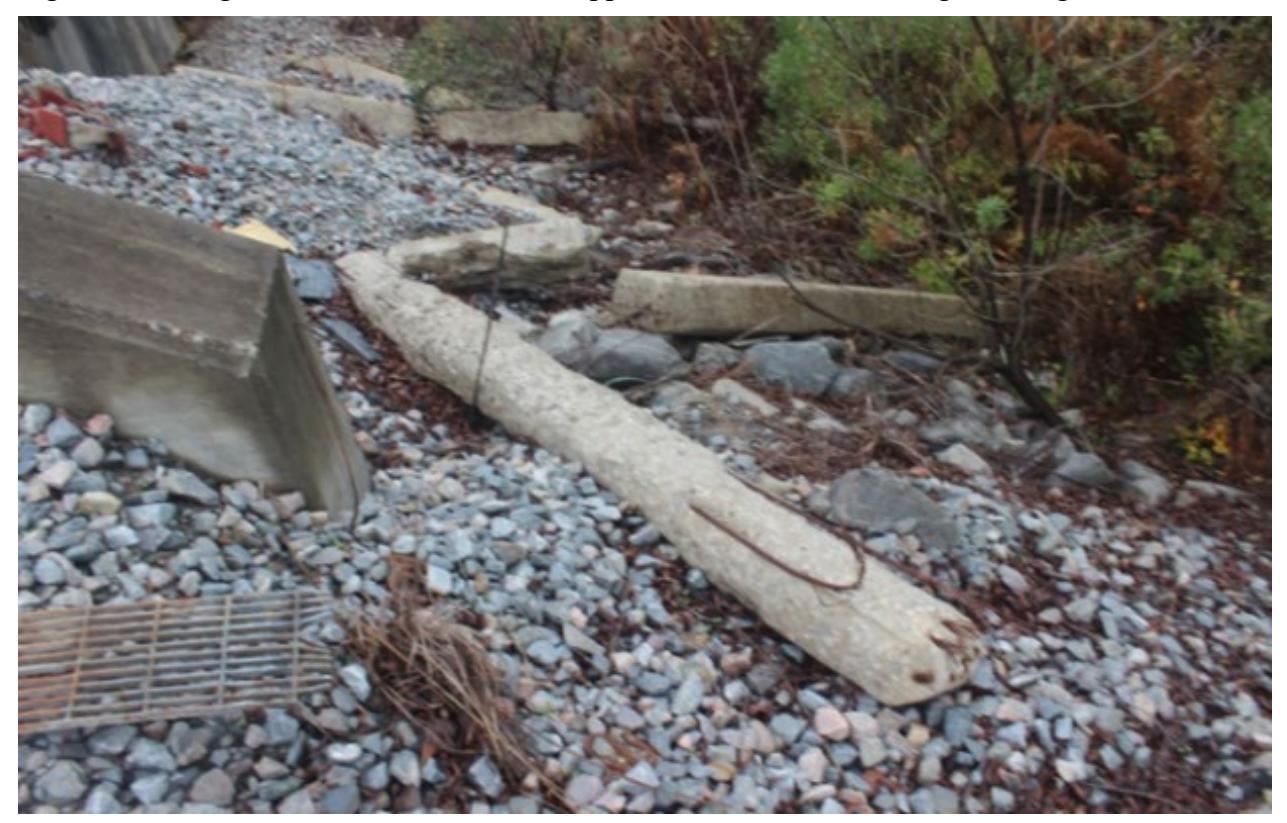
Figure A-14: Discarded tie with high abrasion, Bridge #3

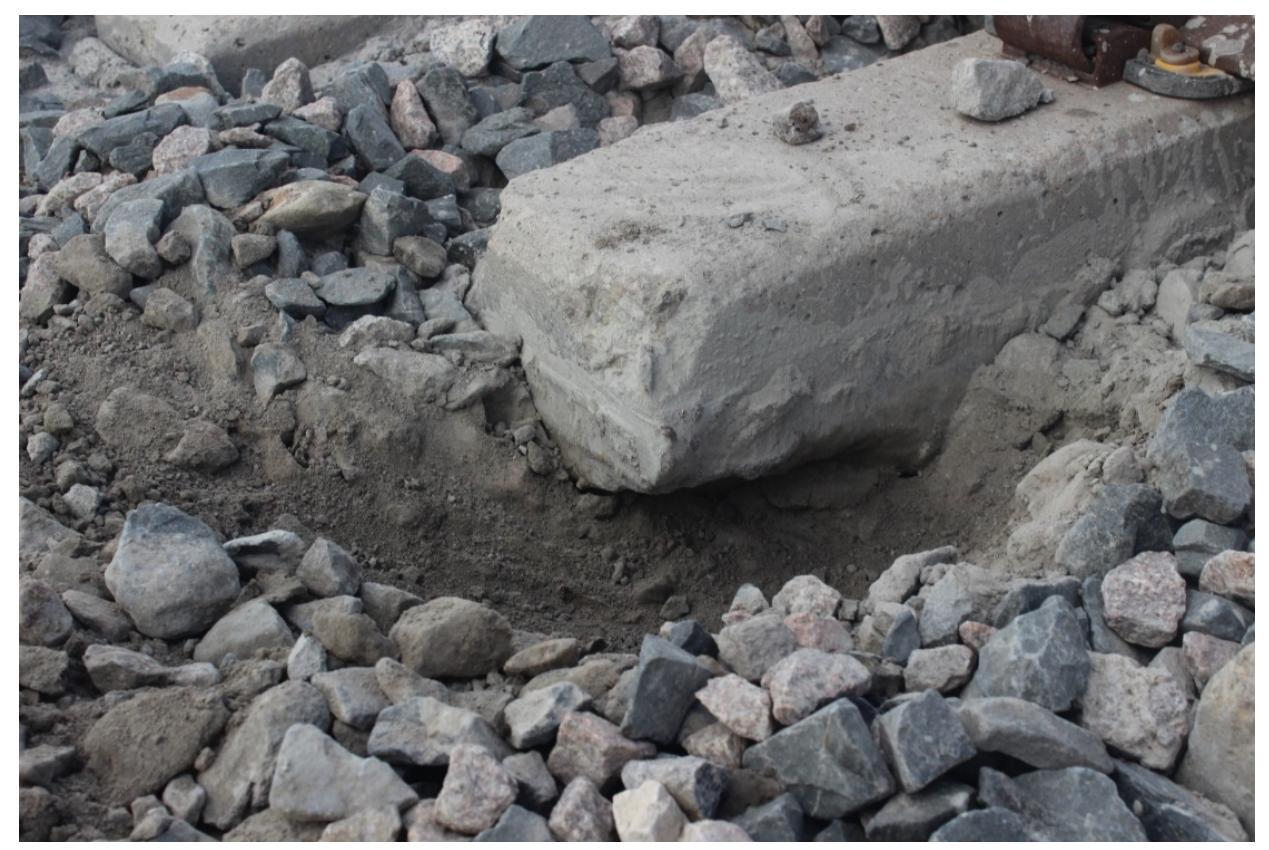
Figure A-23: Rounding of tie bottom, Bridge Approach #2

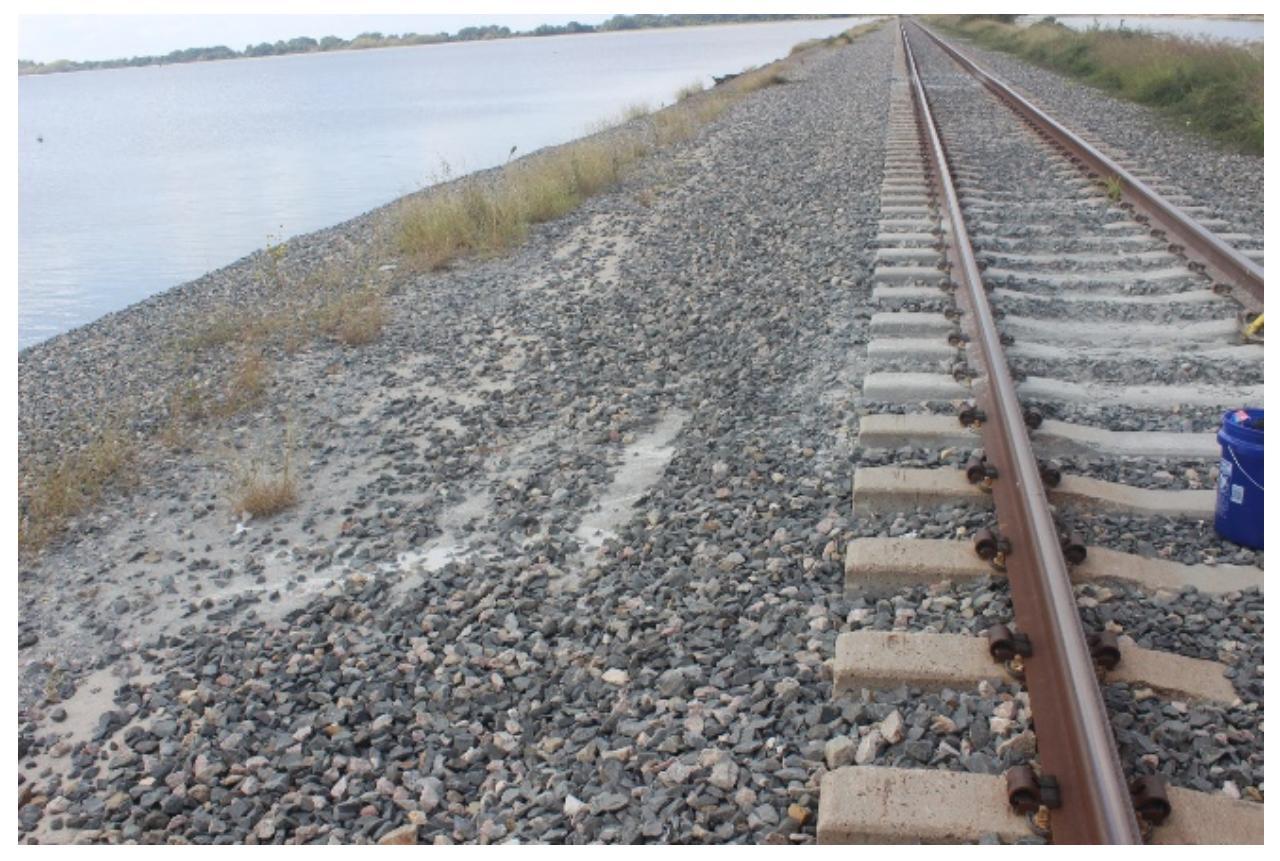
Figure A-24: Fines on the side of track, Bridge Approach #2

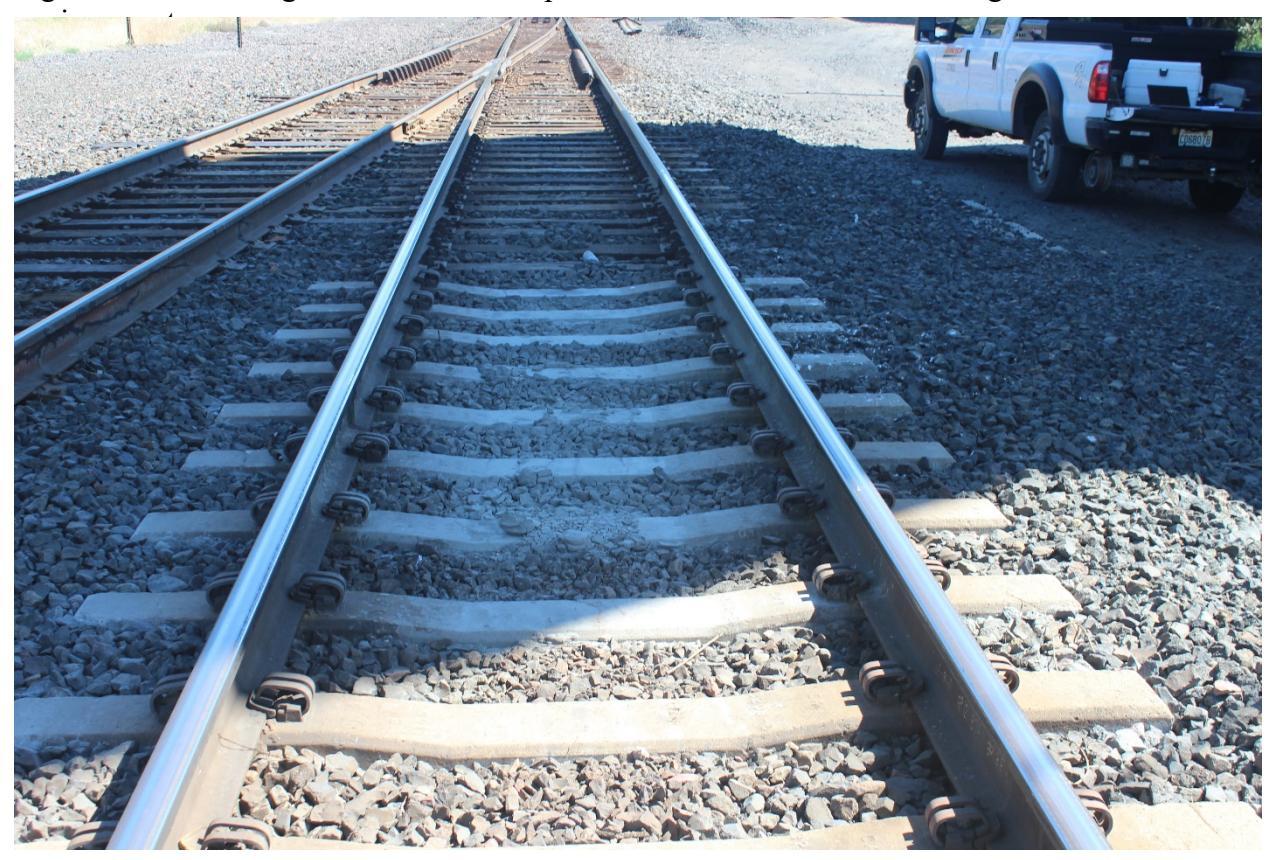
A section of track right after the transition from wood ties showed evidence of fouled ballast and center-binding cracking, as shown in Figure B-2. Center-binding cracking was seen in seven ties after the transition. This is indicative of variations in track stiffness and support conditions often present at transitions. Figure B-2 also shows the shadow from the bridge. It is likely that water flowing off the bridge causes an increase in water availability in track. Some moisture was seen in ballast at the tie bottom. Water loving grass and plants were seen next to track as shown in Figure B-3, indicating that water is more present in this location than in the general

Figure B-2: Fouled ballast immediately after wood-to-concrete tie transition, Switch #1

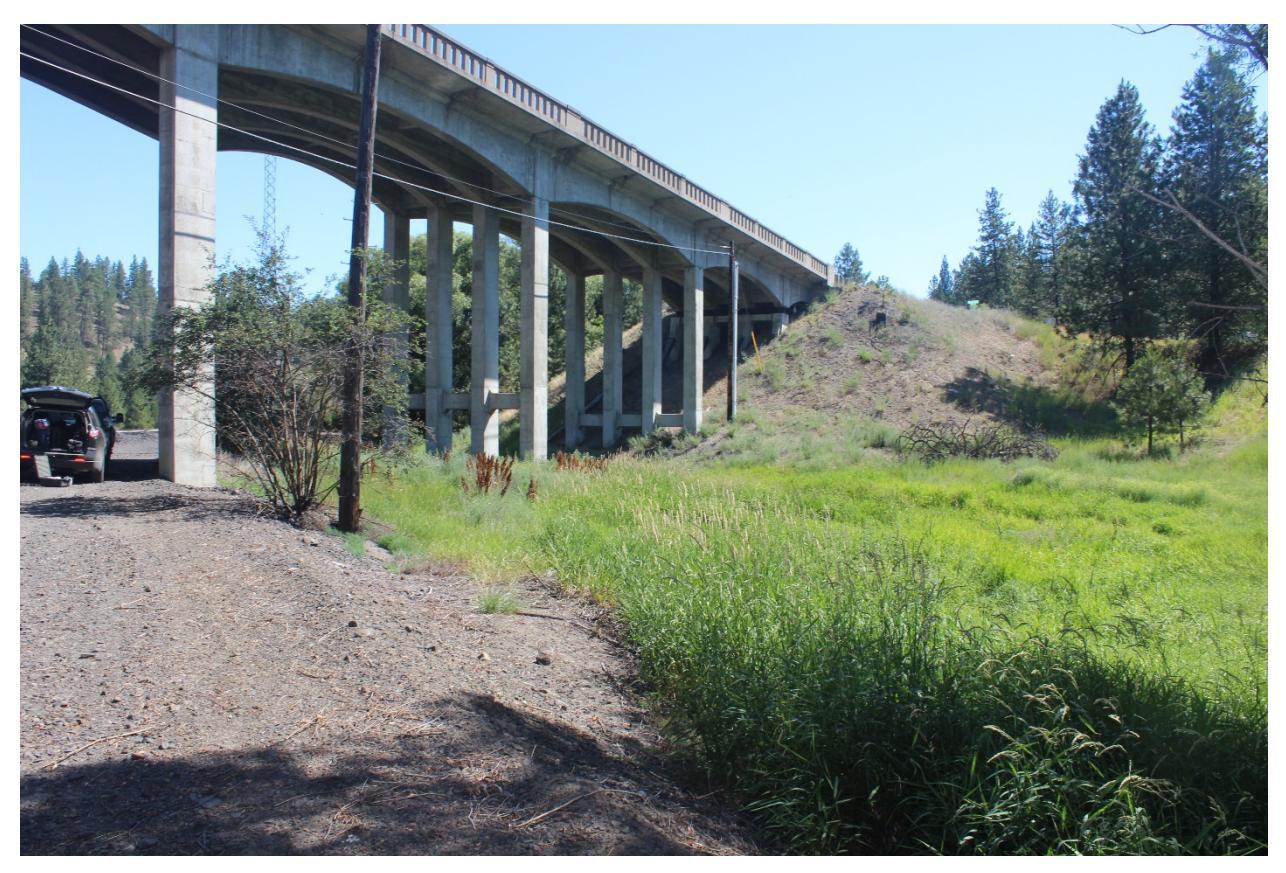
Figure B-3: Water-loving plants next to track, Switch #1

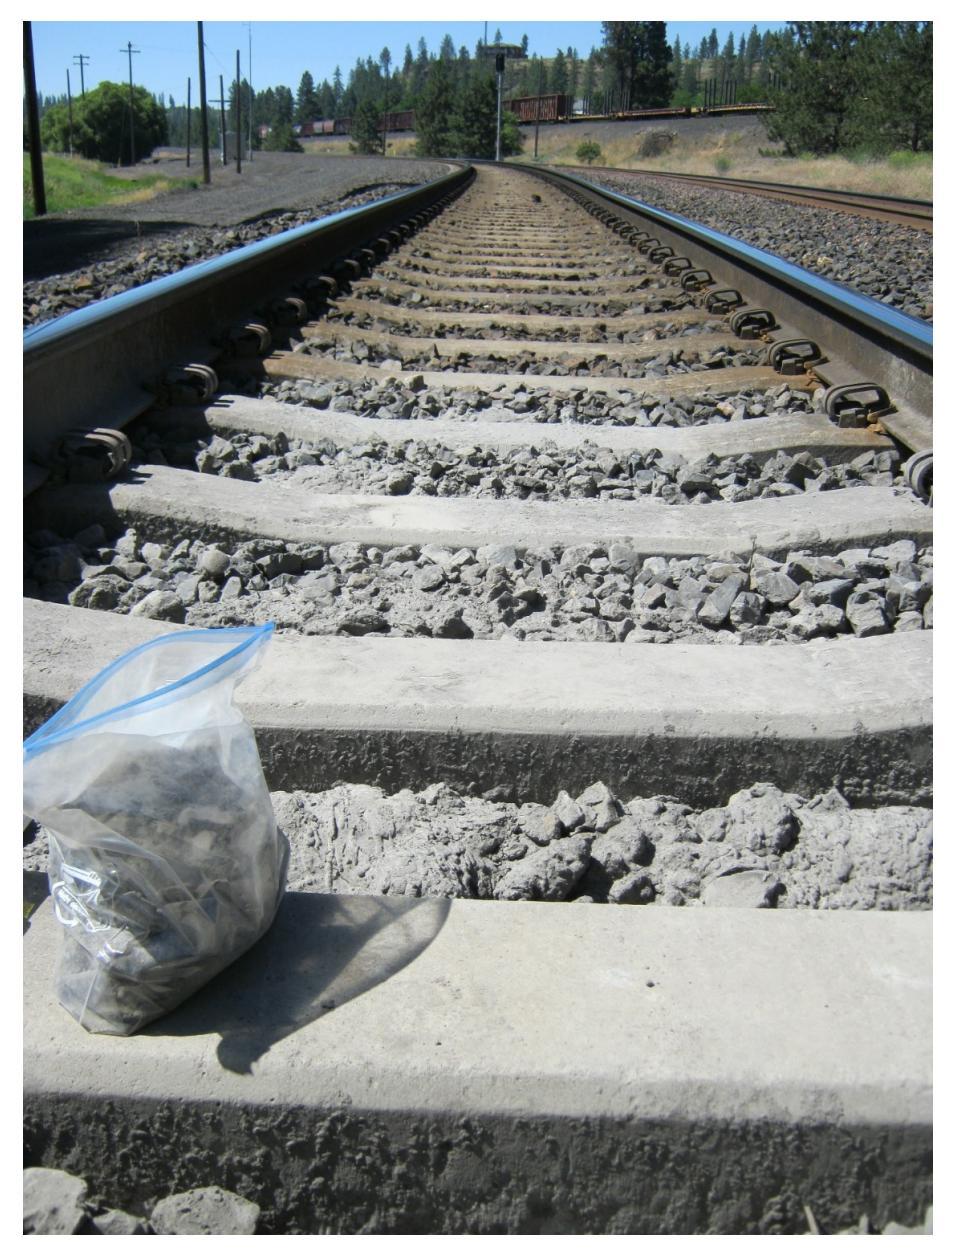
A second gray-mud section of track was seen a short distance away from the switch, as shown in Figure B-4. It is possible that the change in track stiffness seen at the transition caused train vertical movement that caused large vertical forces on the track at the second fouled ballast location.

Figure B-4: Gray mud in track, Switch #1

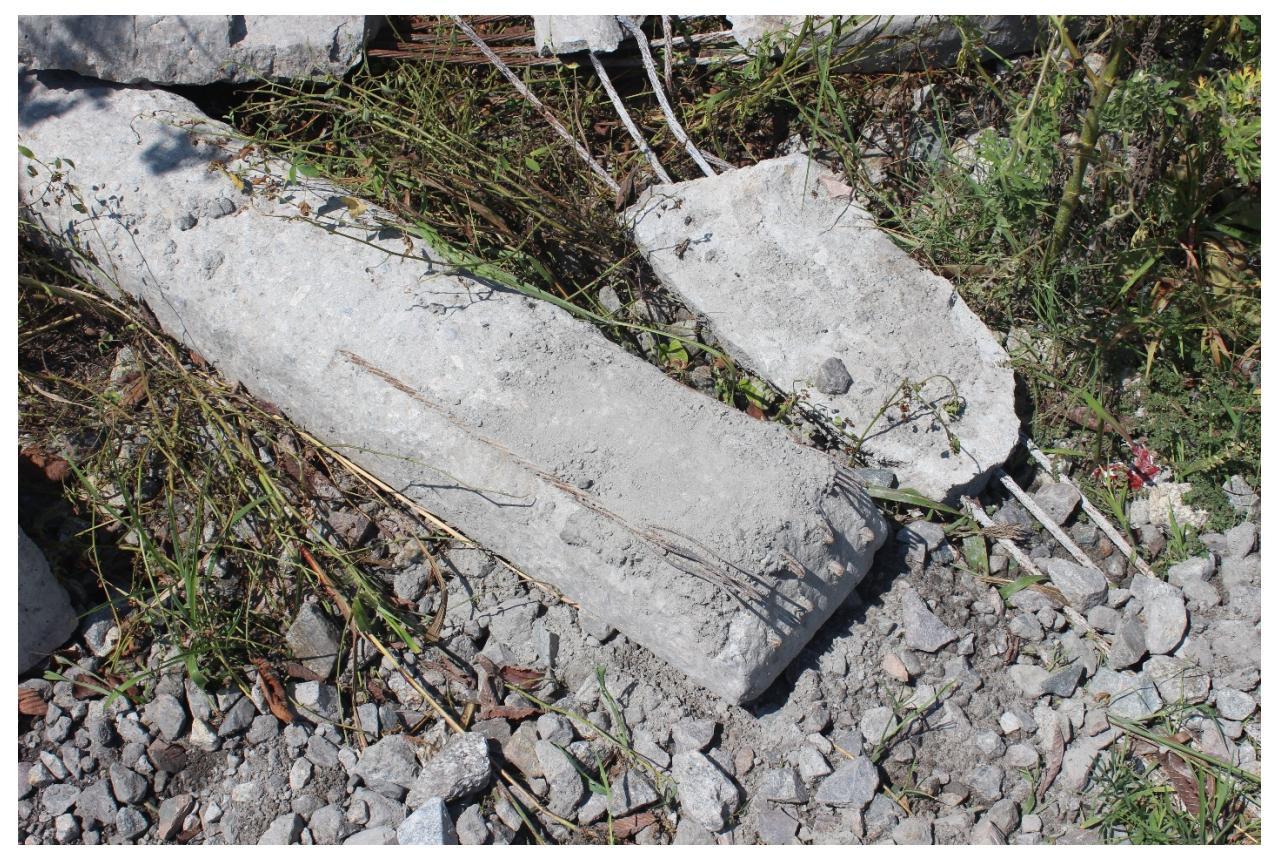
Several ties were replaced the week before the site visit and were still on the side of the road. These ties had large amounts of abrasion damage on the bottom and sides, see Figure B-13.

Figure B-13: Removed ties with abrasion damage, Signal #2

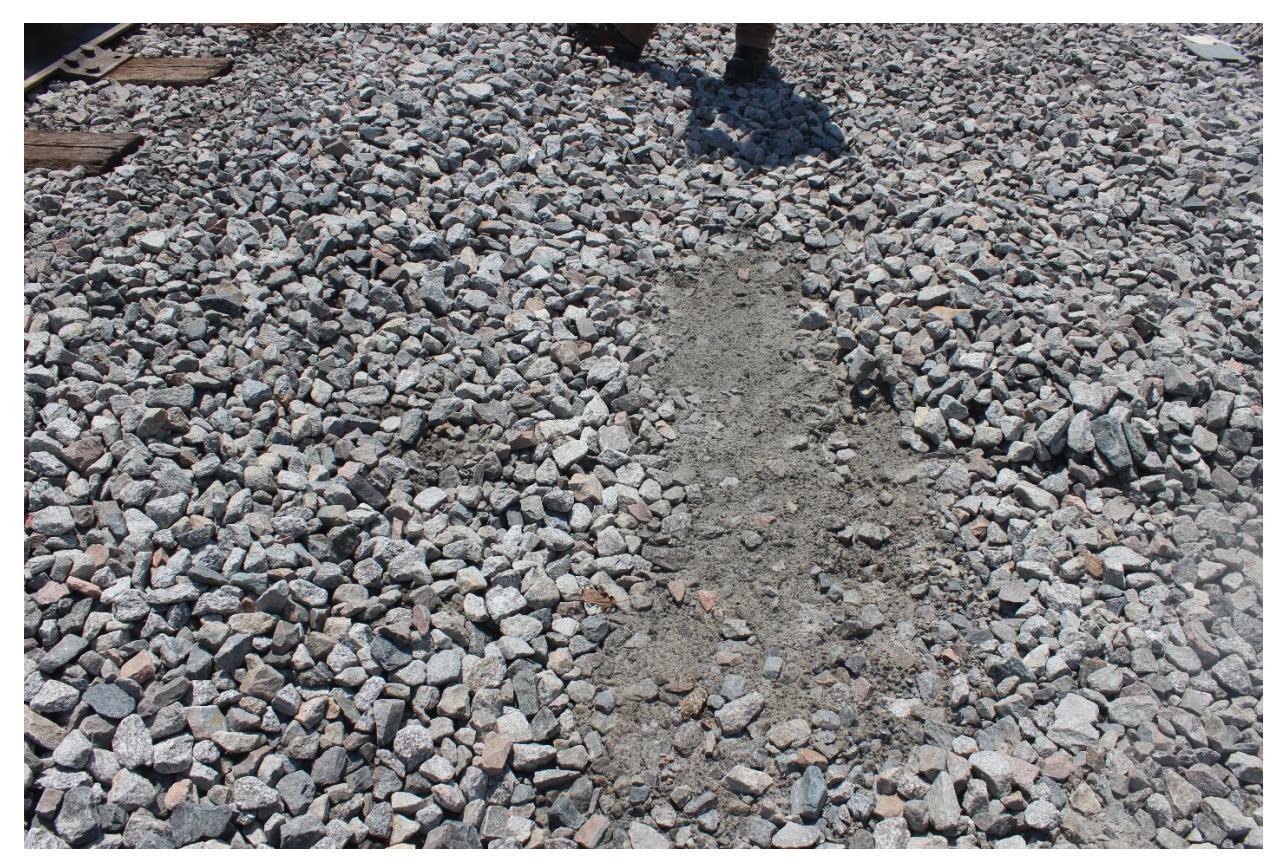
Figure B-15: Mud pumping in adjacent ballast, Signal #2

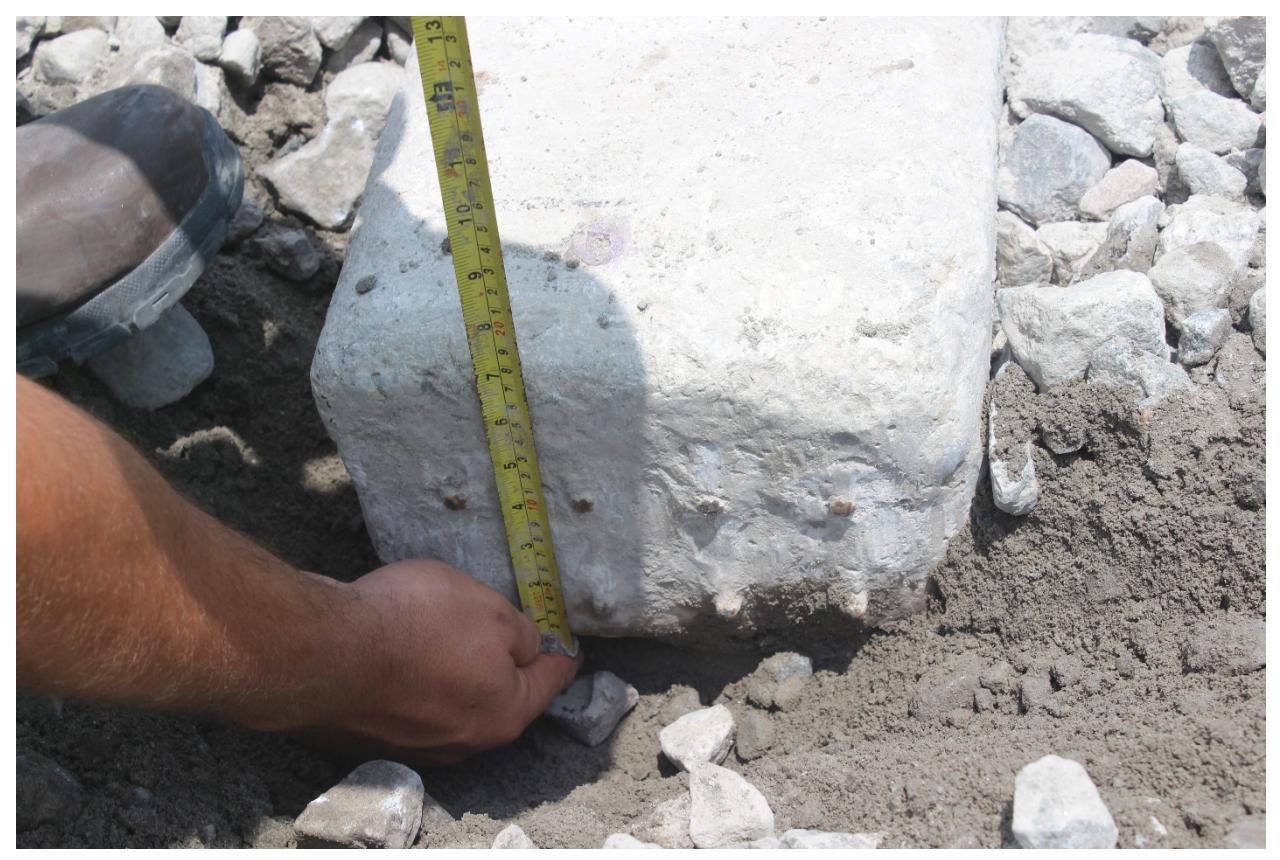
abrasion wear. One tie end had 1 in. of abrasion wear, see Figure B-16. A second tie was taken from track the following day and measured by the research team. The tie thickness for the second tie is shown in Table B-5.

Figure B-16: One-inch tie abrasion, Signal #2

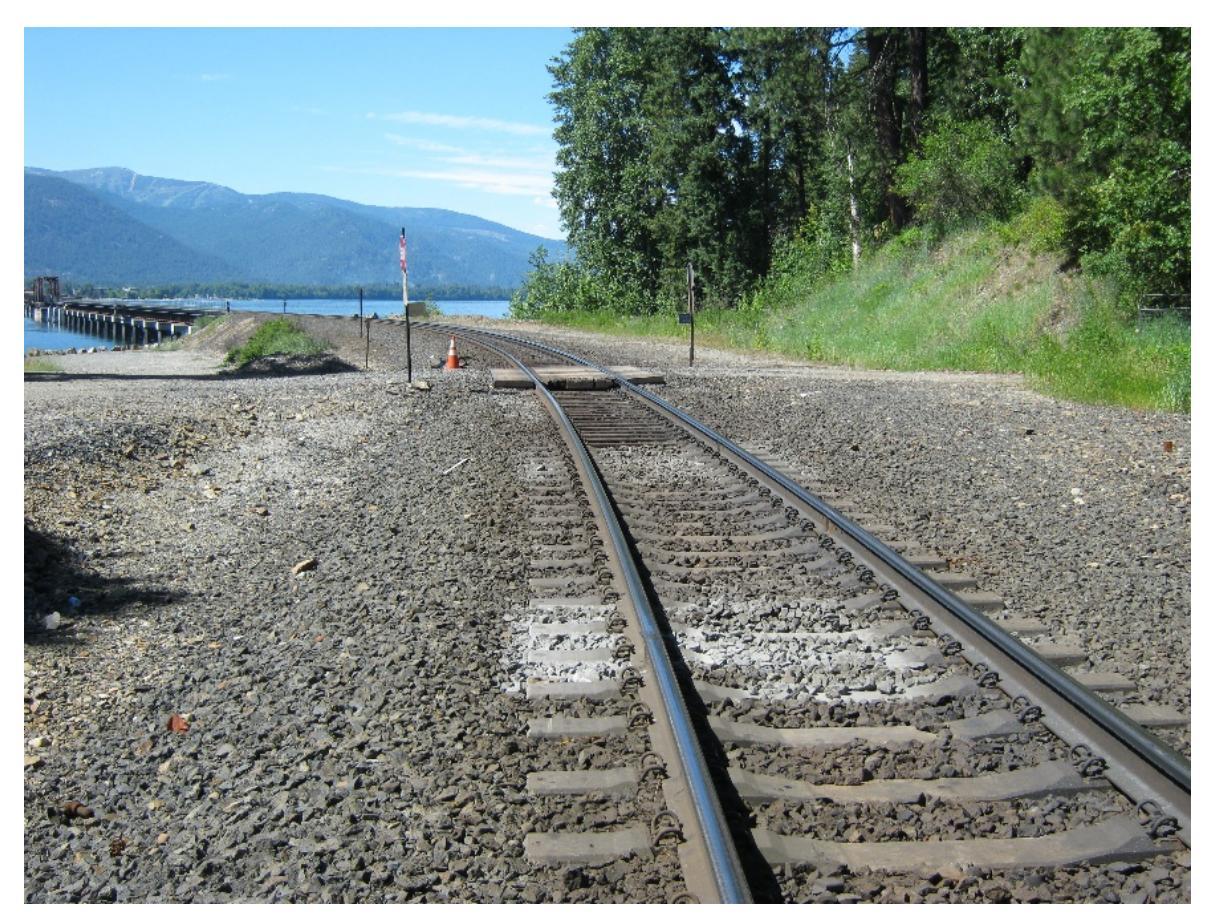
Figure C-3: Pumping area near curve, Crossing #1

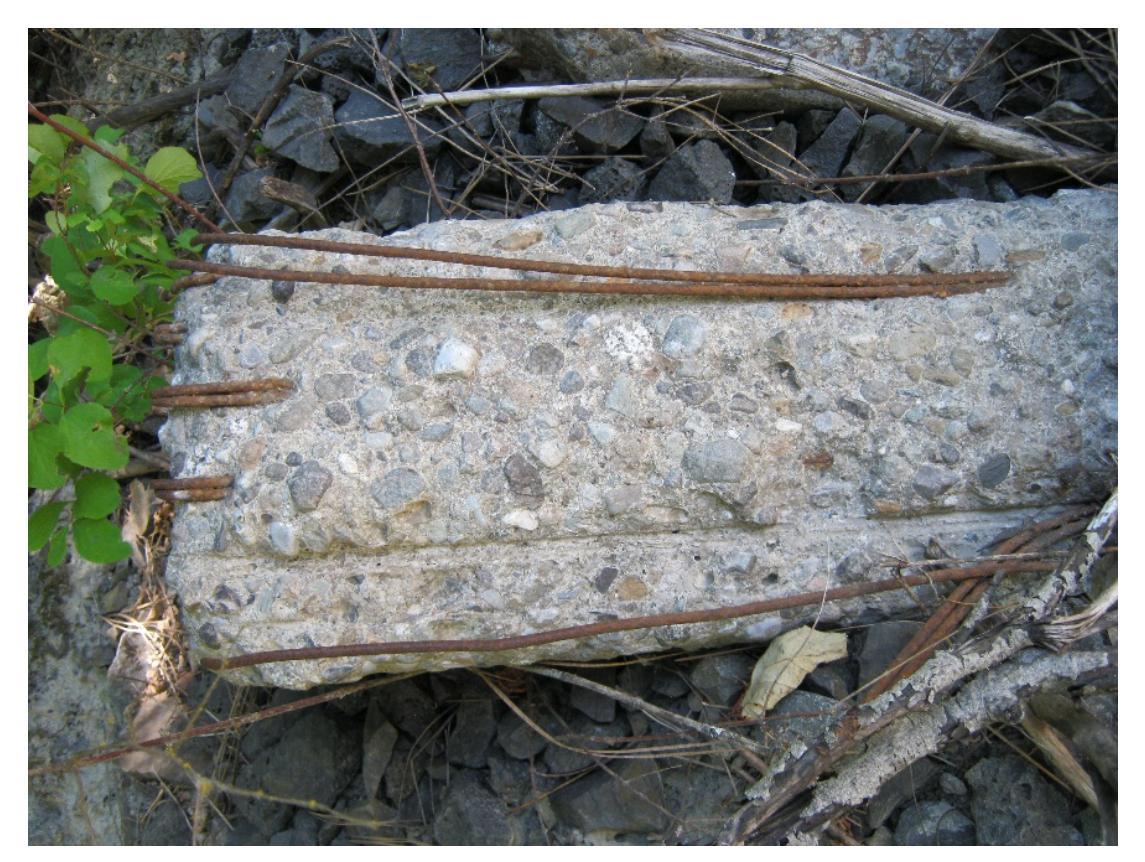
Figure C-5: Tie with abrasion removed from track, Crossing #1

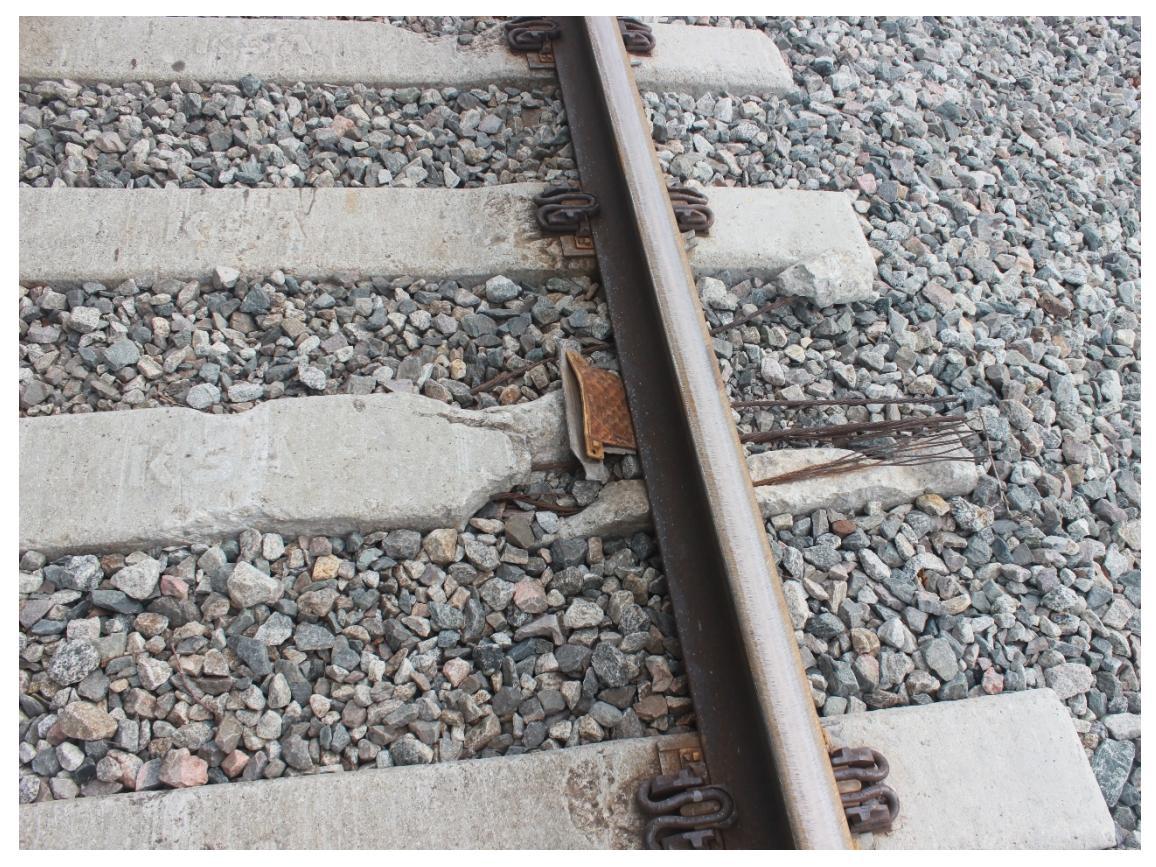
Figure C-15: Damaged tie from broken axle derailment, Crossing #3
