Federal Railroad Administration

DOT/FRA/ORD-19/38

Final Report October 2019

1. AGENCY USE ONLY (Leave blank)		2. REPORT DATE 3 October 2019		3. REPOR	3. REPORT TYPE AND DATES COVERED Technical Report April 2016 – August 2017	
4. TITLE AND SUBTITLE A Study of Environmental and Track Factors that Contribute to Abrasion Damage of Concrete Ties					5. FUNDING NUMBERS DTFR53-16-C-00009

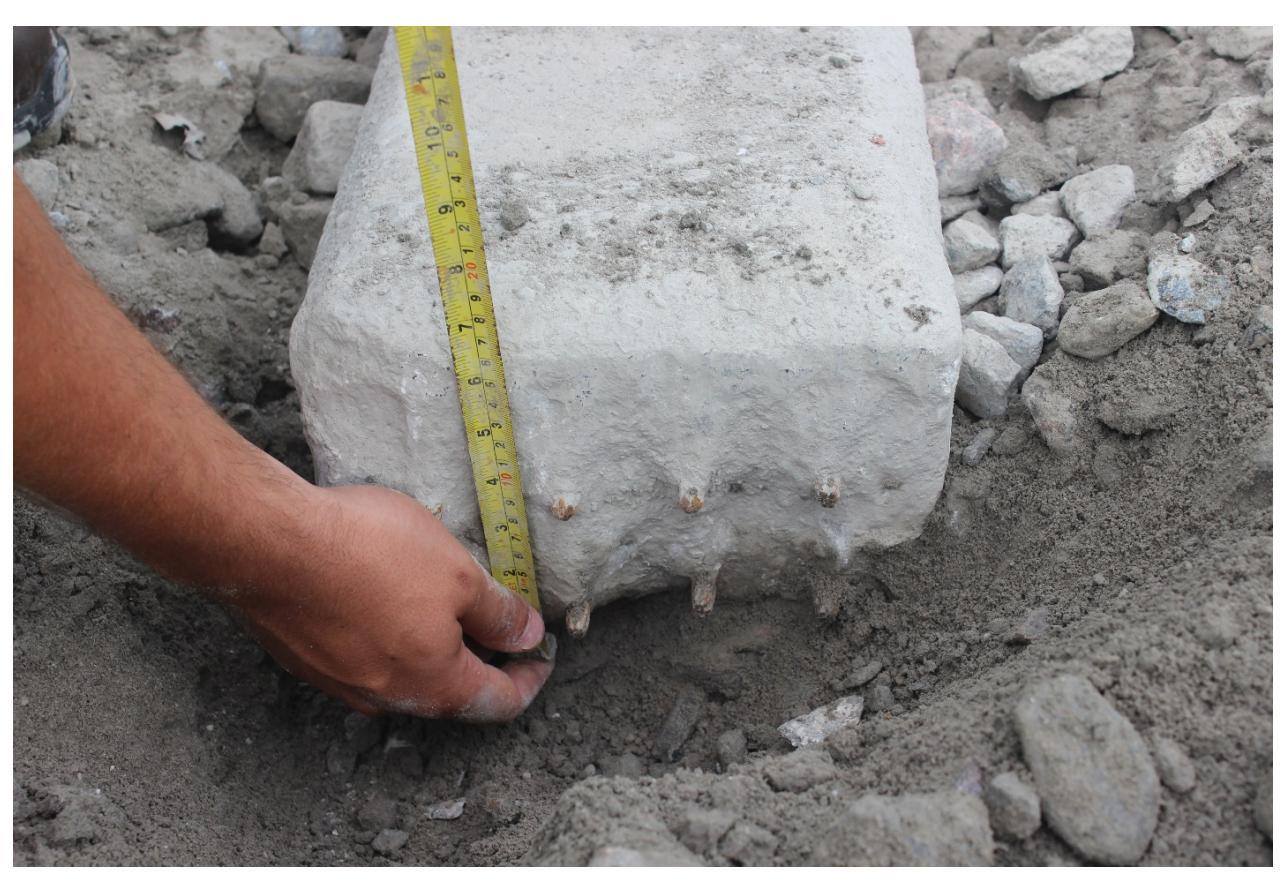
Figure C-17: One-inch abrasion on bottom of the tie. Crossing #3

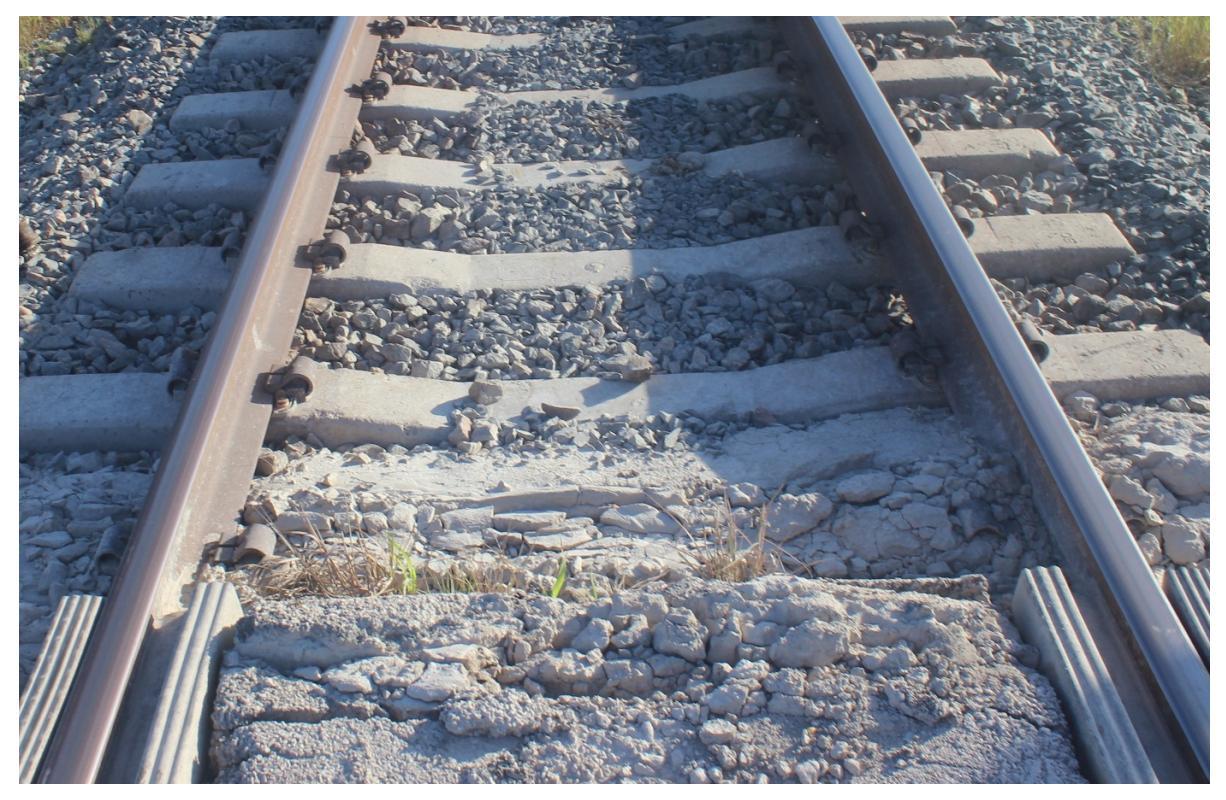
Gray mud was present in track on one end of the crossing. The surface grading on the end with gray mud was not as good as the opposite end, demonstrating how critical good drainage is to the long-term performance of railroad track structures. The railroad maintenance crew reported that the drainage pipes in the crossing require regular cleaning. Grass was growing in track indicating the presence of water, see Figure C-22. The asphalt crossing itself showed evidence of water intrusion, settling, and deterioration, as shown in Figure C-23. This is further evidence that the grading on site was not optimal.

Figure C-22: Excessive pumping and vegetation, Crossing #4

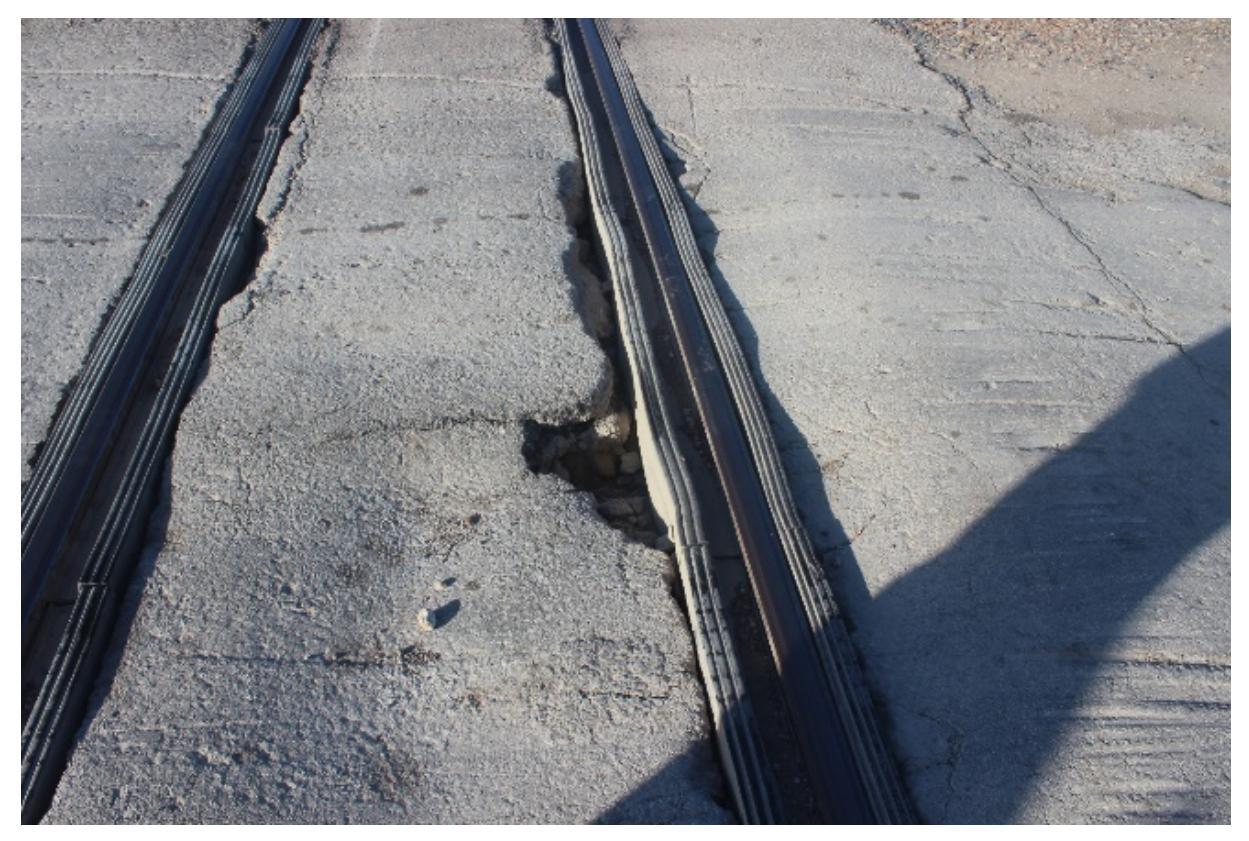
Figure C-23: Asphalt crossing defects, Crossing #4

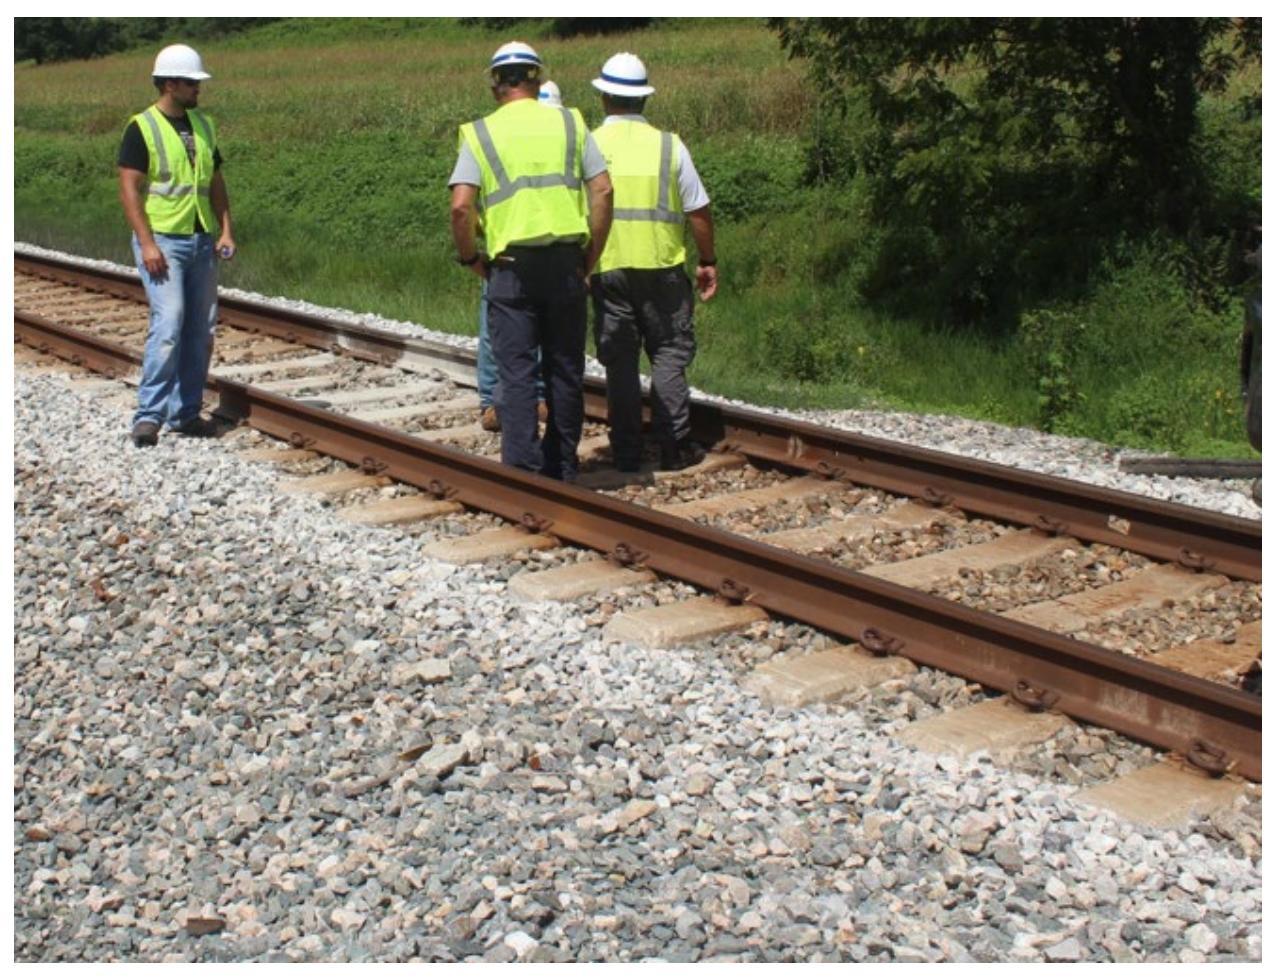
Ballast fouling was seen in track at four ties, as shown in Figure C-37. The ties were located next to a crossing with poor grading and drainage. There was severe center-binding cracking in the ties. There was a section of track with fines that were produced during pumping as shown in Figure C-38. It rained the day before the research team visited the site. Water was ponding in track, showing the poor drainage on-site. Fines were seen on the ballast shoulders, as shown in Figure C-39.

Figure C-37: Ballast fouling seen in track on four ties, Crossing #6

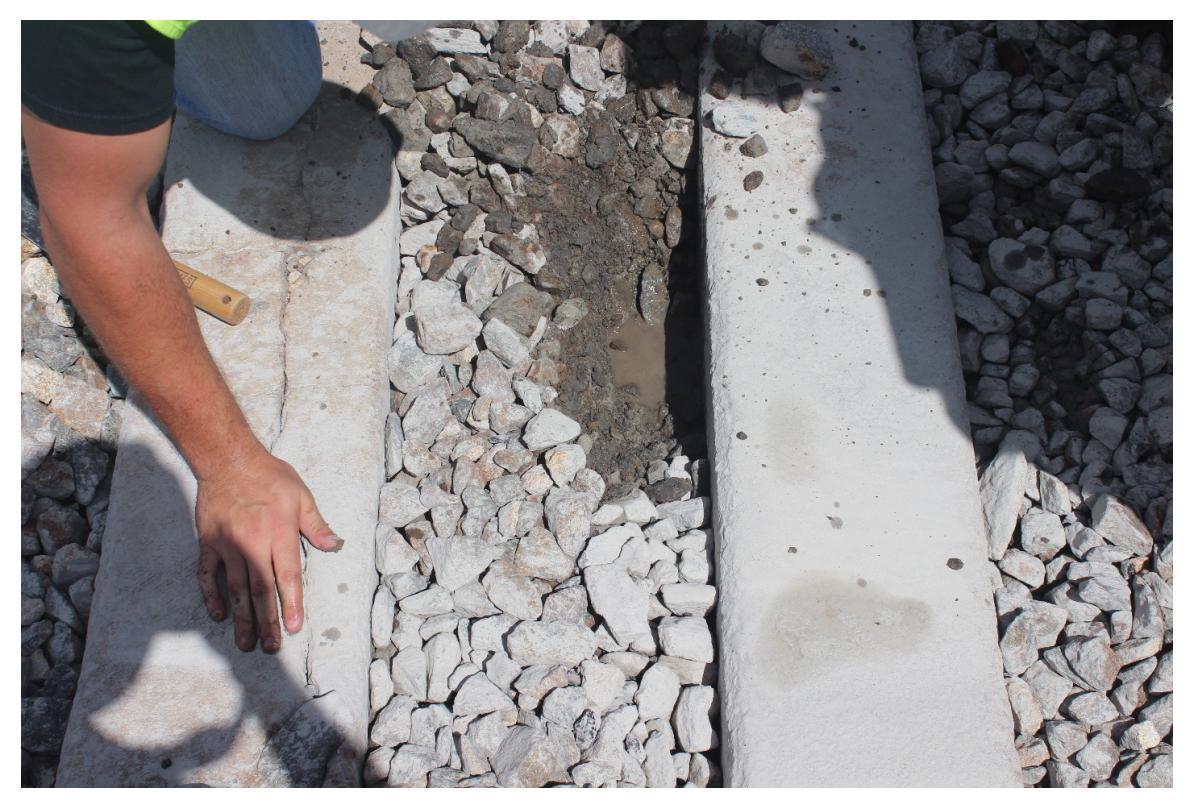
Figure C-38: Mud pumping adjacent to cracked tie, Crossing #6

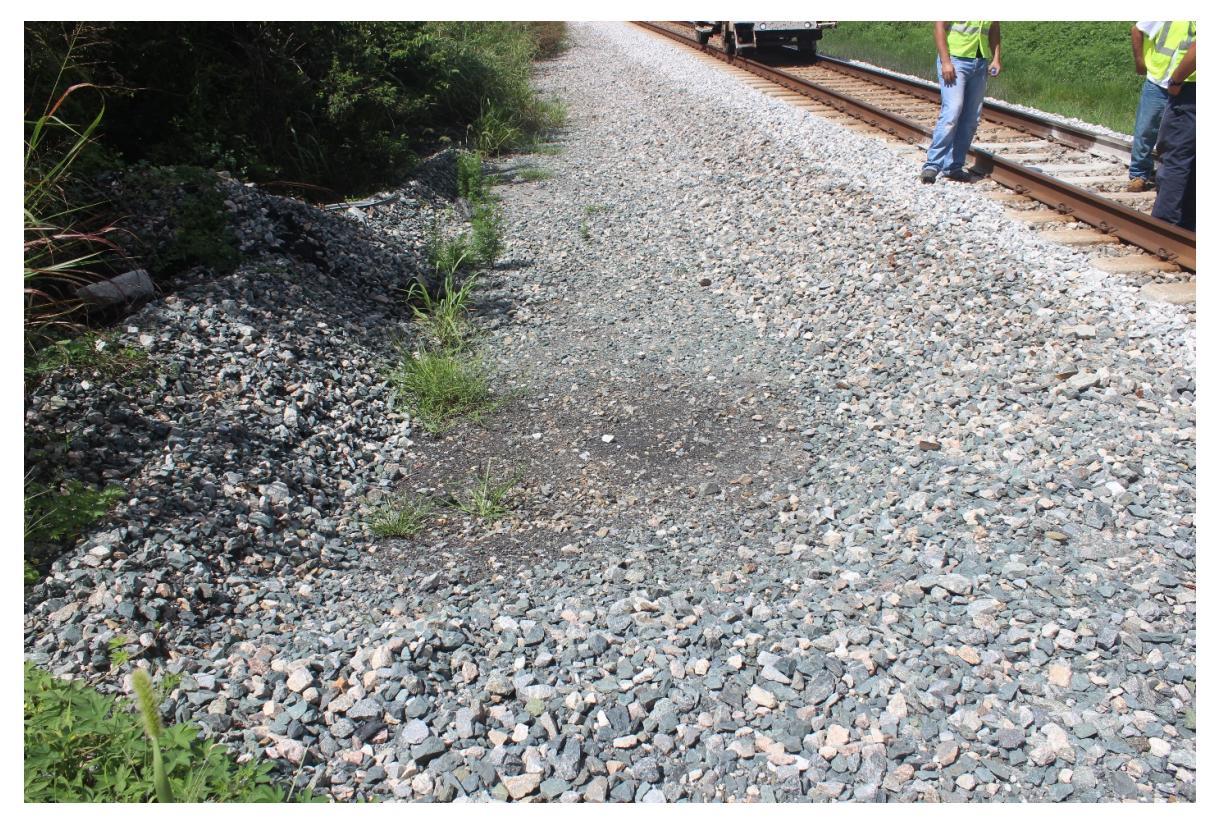
Figure C-39: Fines seen on the ballast shoulders, Crossing #6

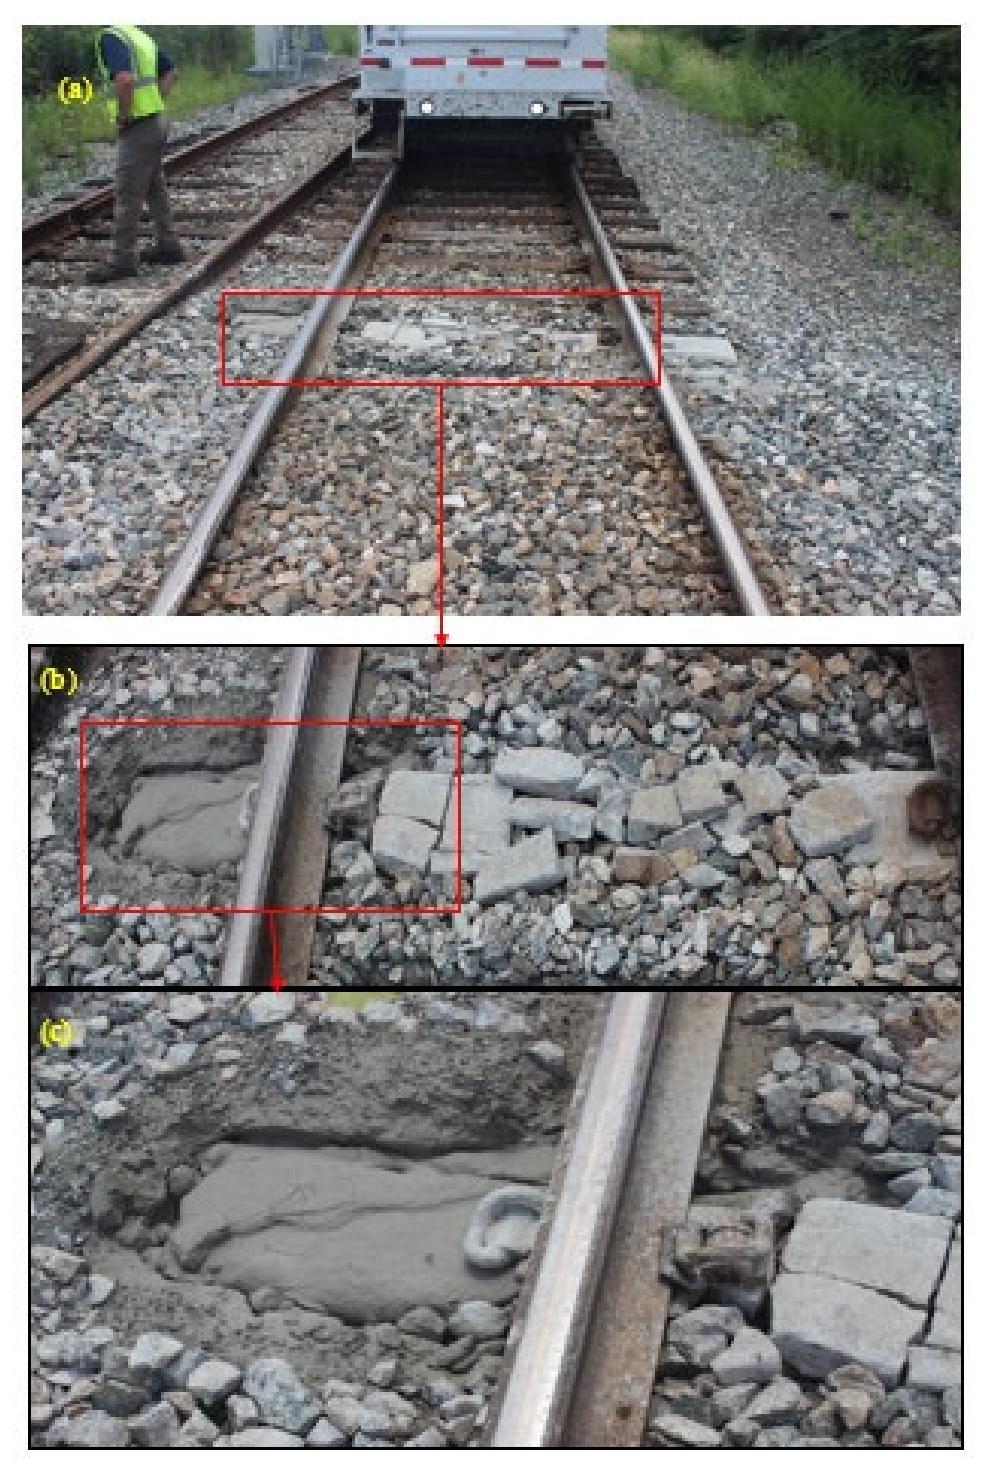
Figure C-53: Shattered tie in transition to wood, Crossing #9

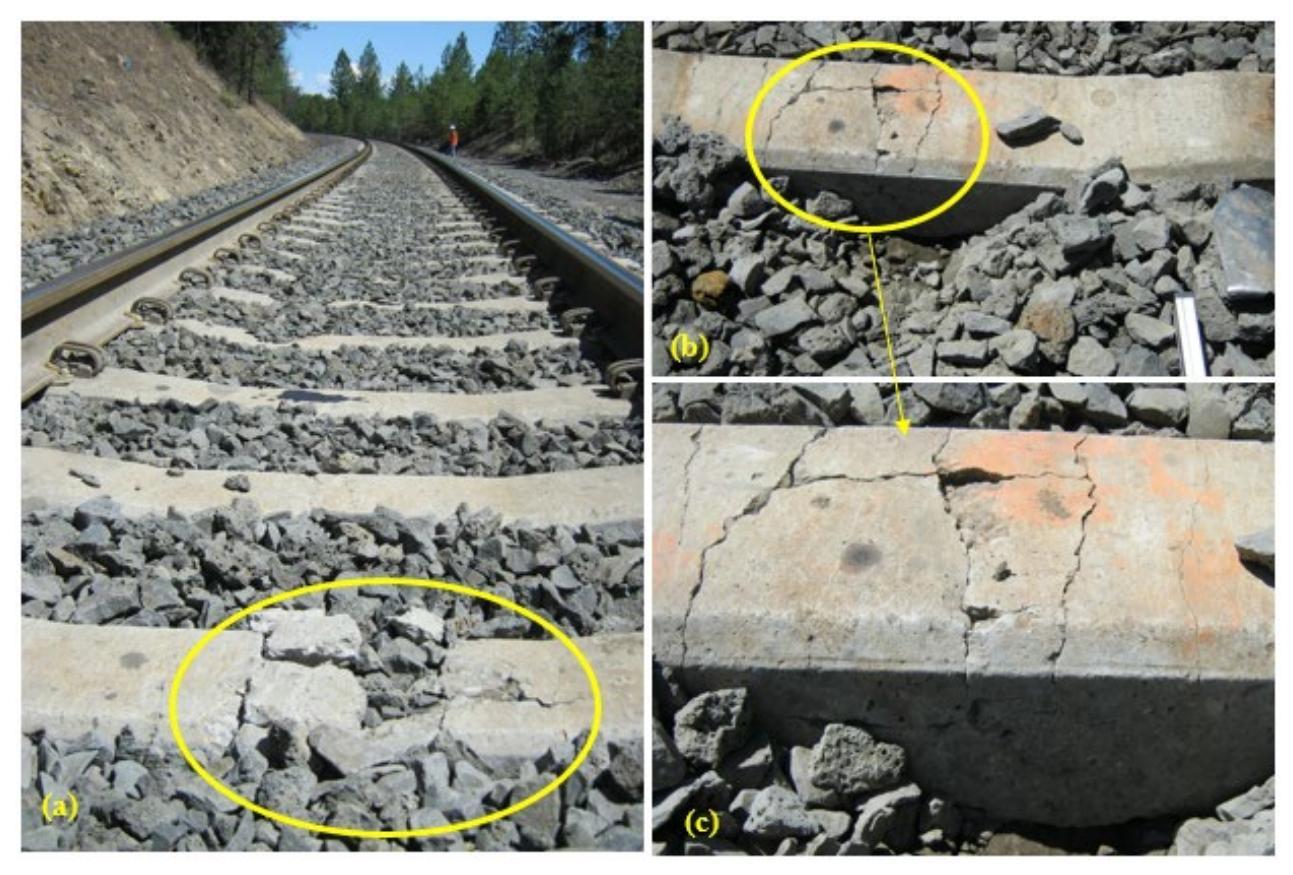
Figure D-3: Severe center binding cracking, Curve #1

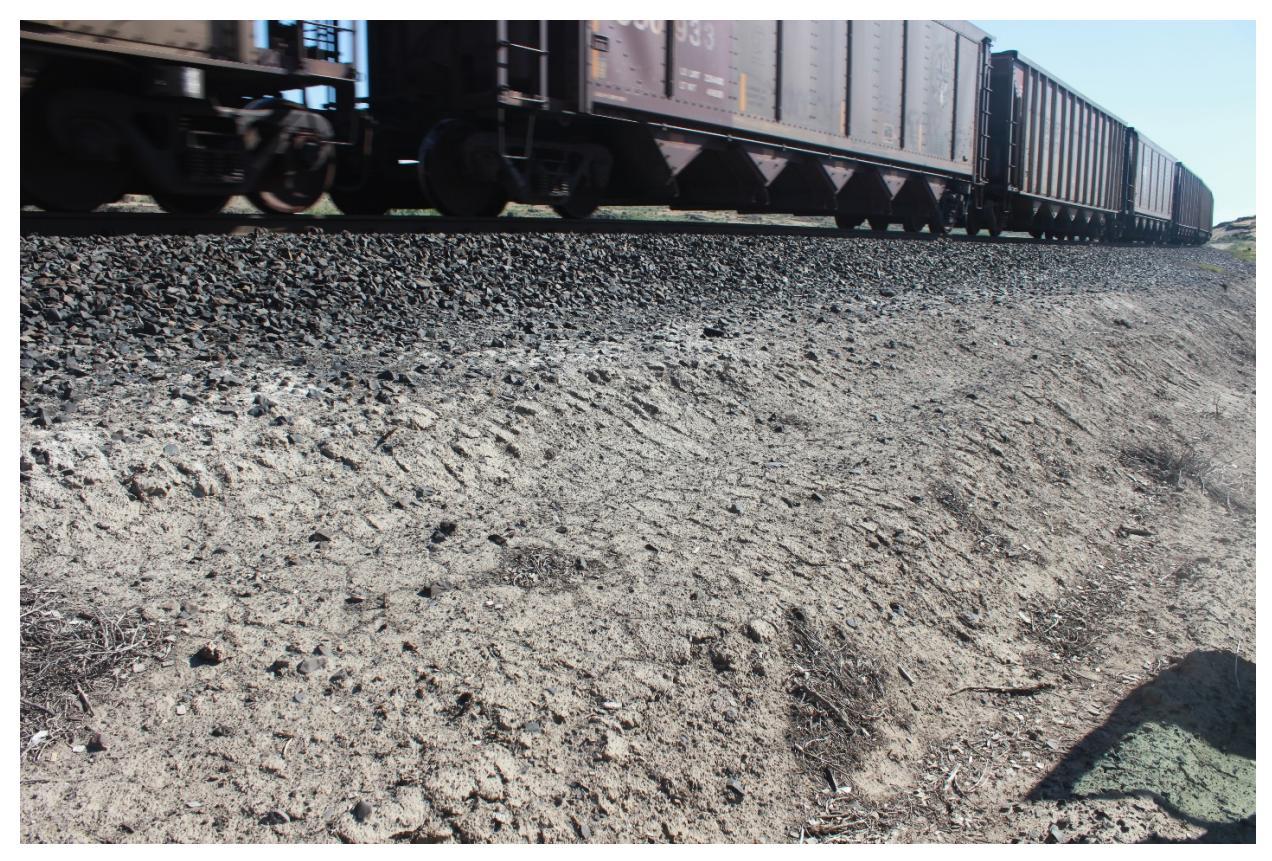
Figure D-12: Mud-flat cracking on track embankment, Curve #2

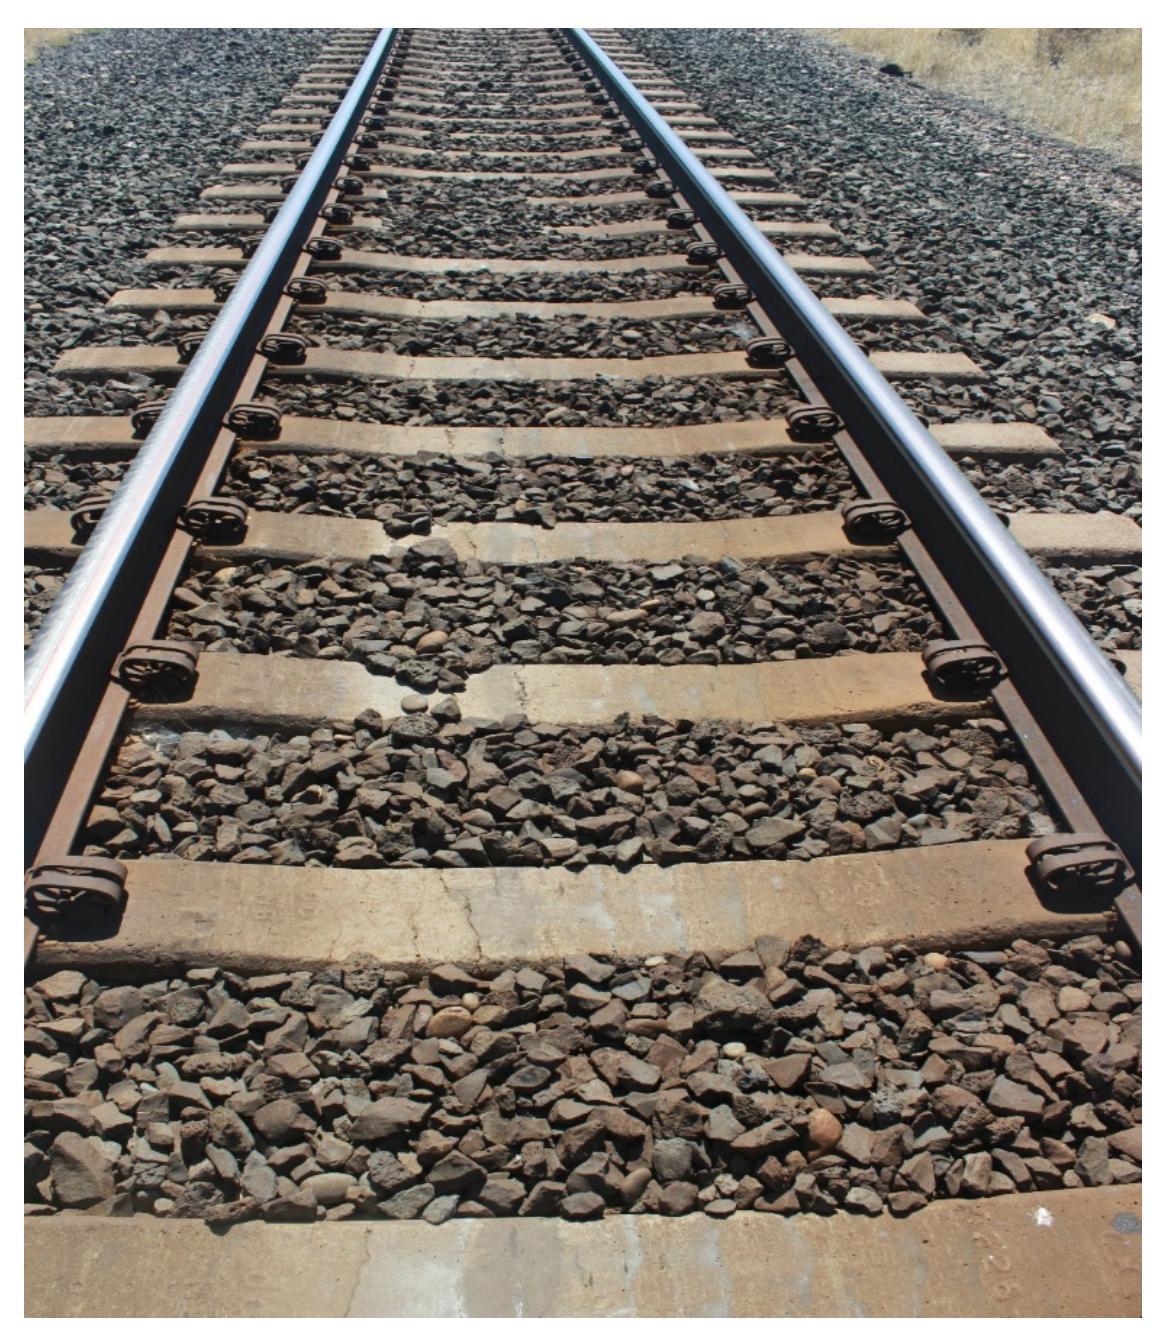
Figure D-16: Center-binding cracking, Curve #3

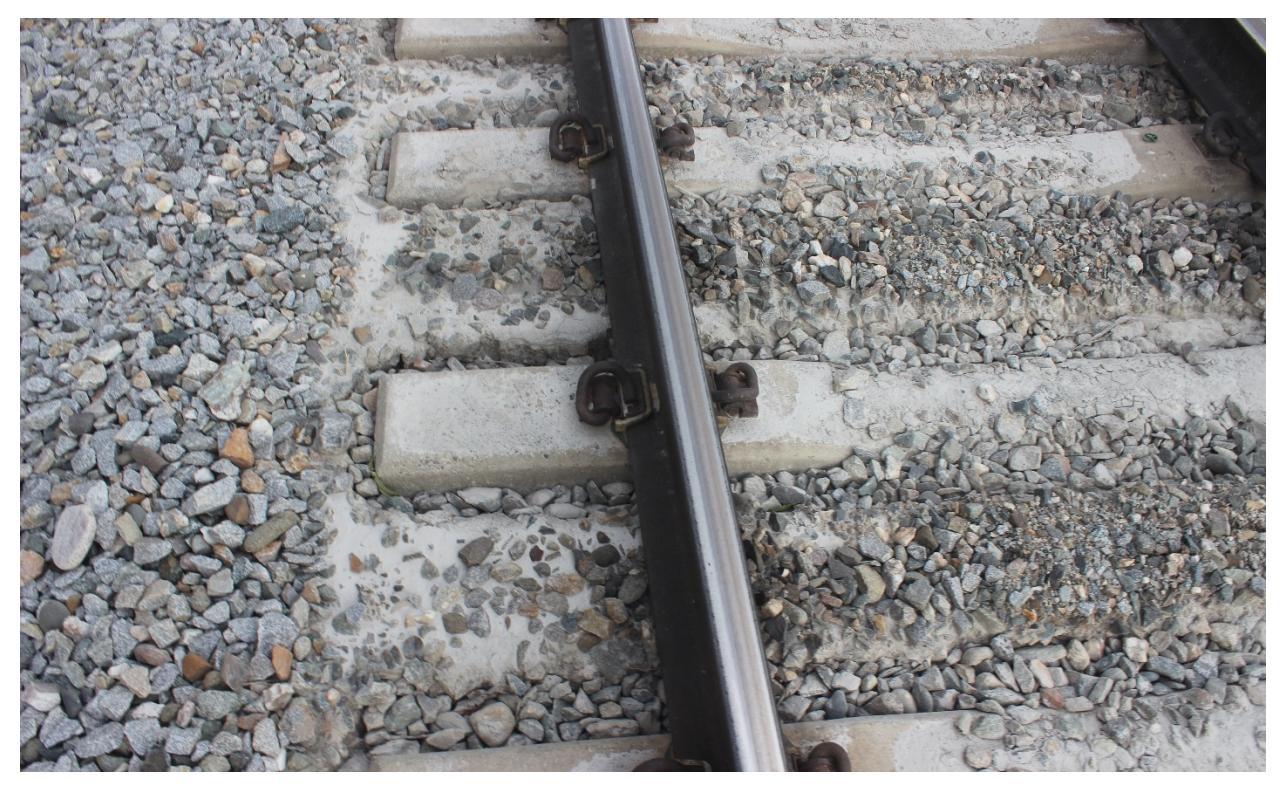
Figure D-23: Pumping seen in track, Curve #5

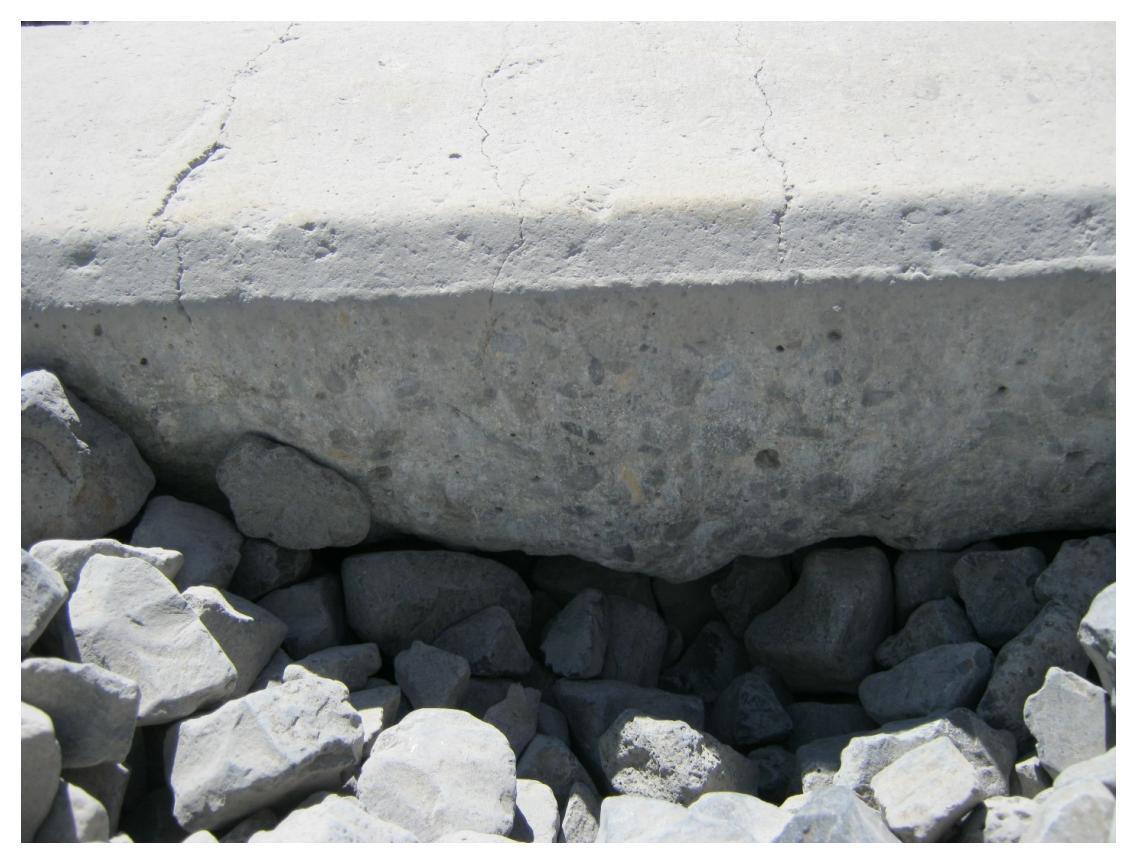
Figure E-7: Center binding cracking and tie rounding, Tangent #2

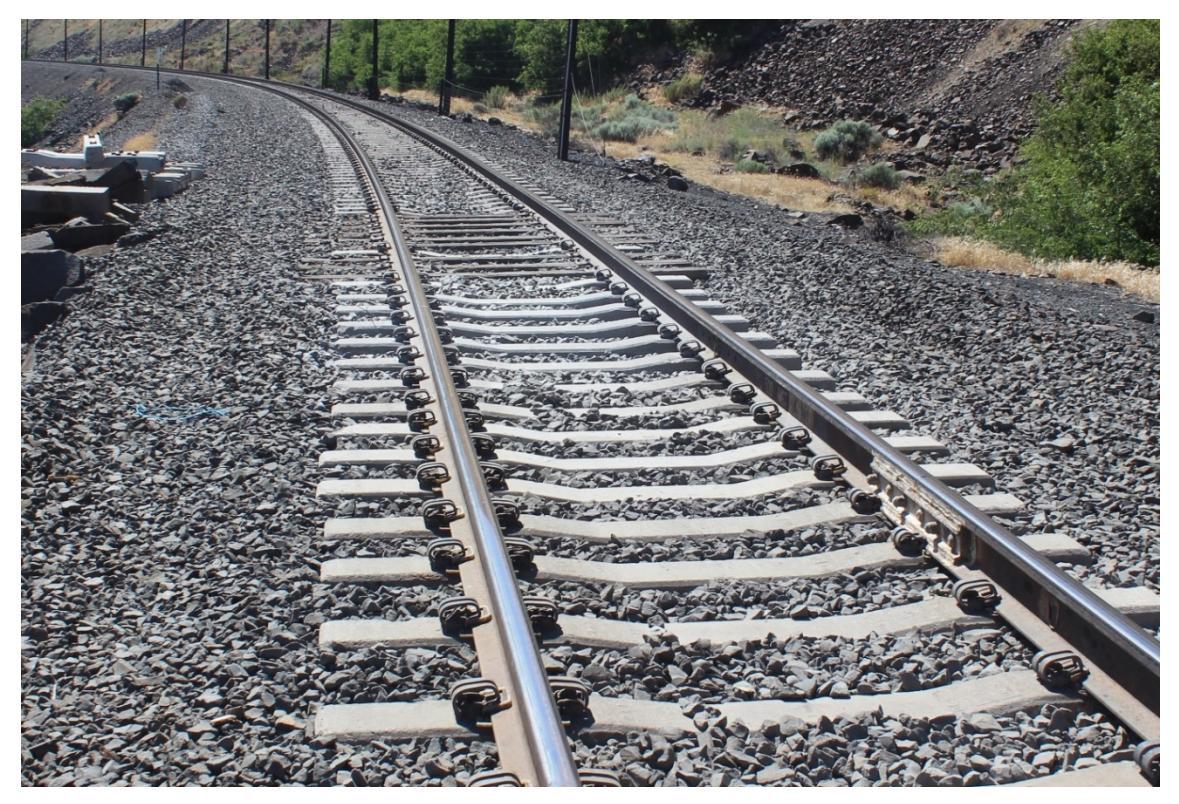
Figure E-8: Pumping on the concrete ties next to wooden ties, Tangent #2

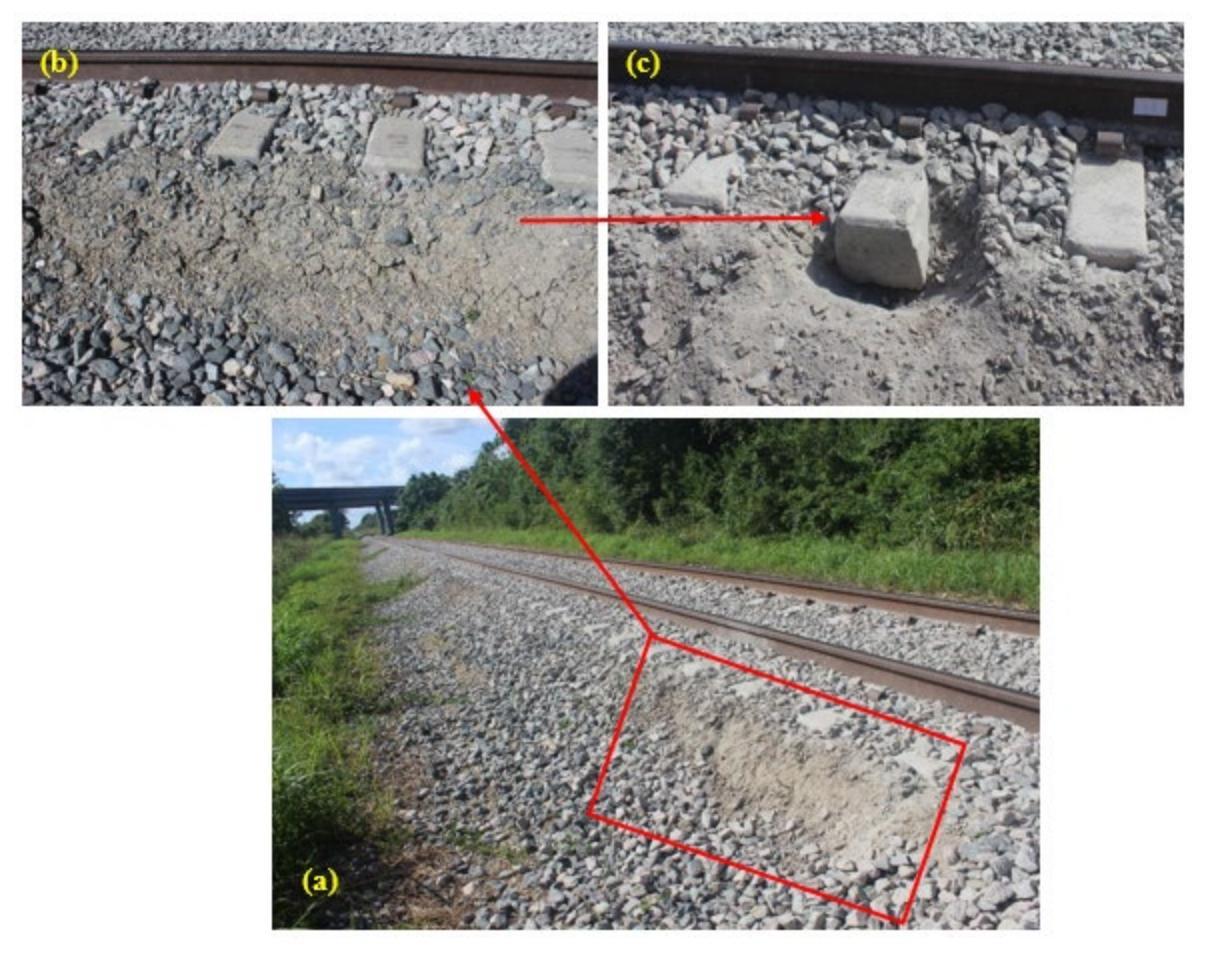
Figure E-11: Pumping on the sides of the track, Tangent #3

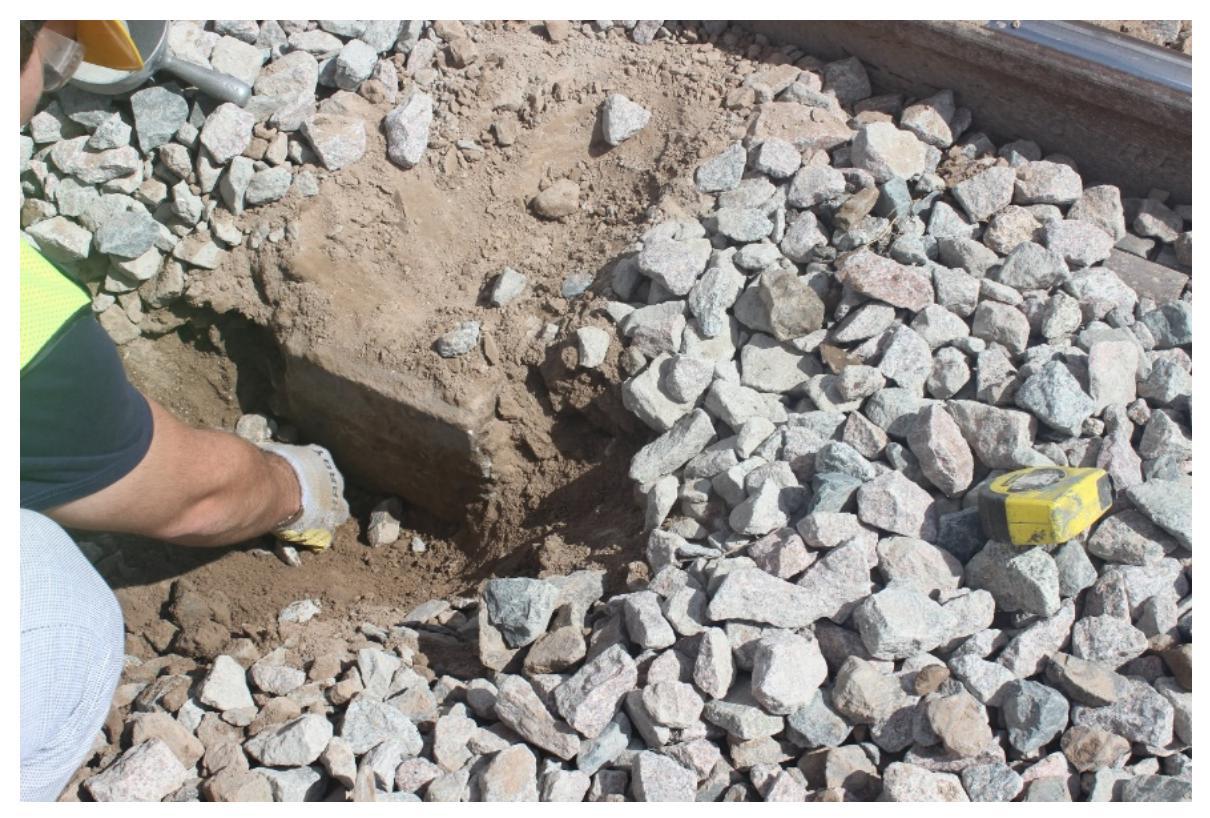
Figure E-16: Pumping due to the insufficient ballast layer thickness, Tangent #4

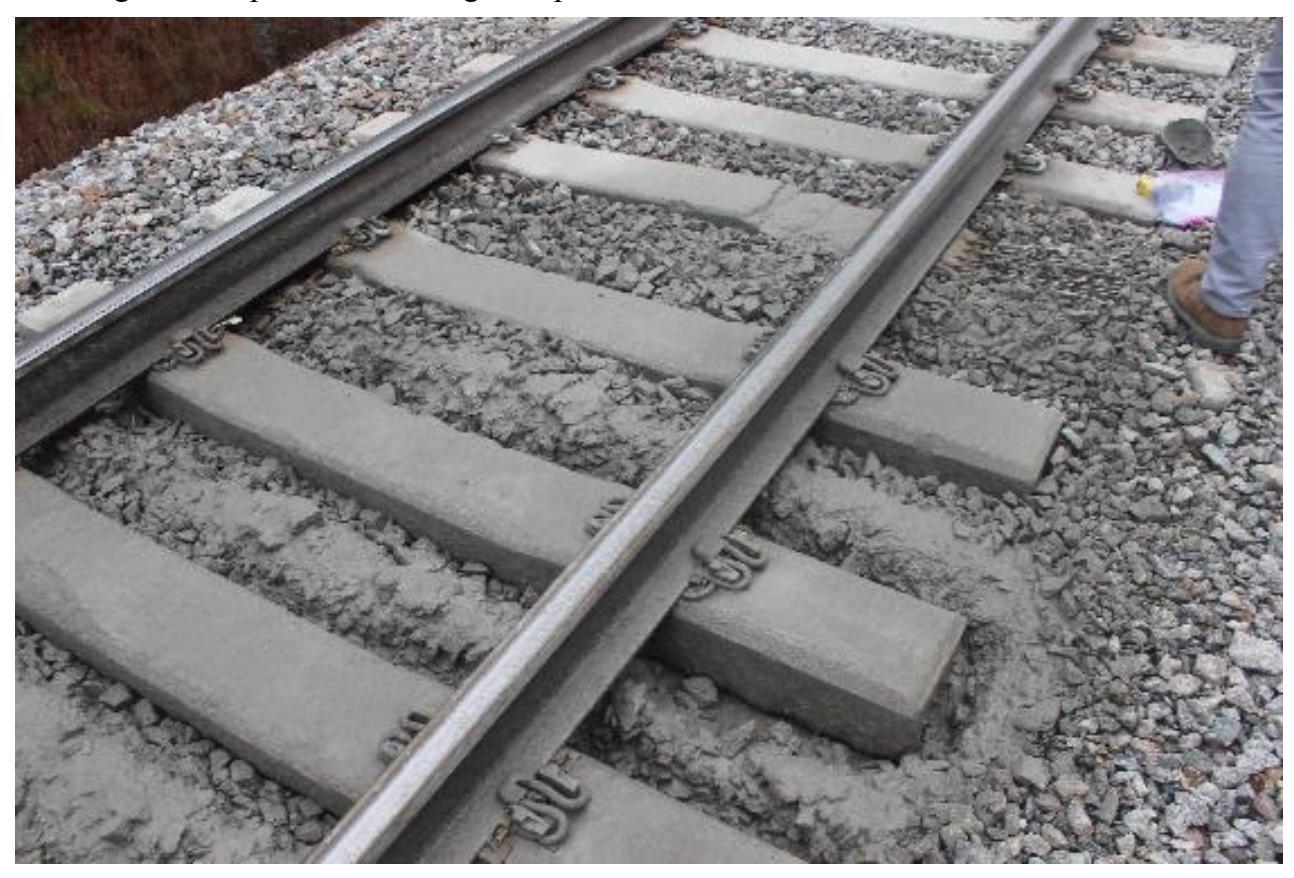
Figure E-23: Mud spot in track, Tangent #6

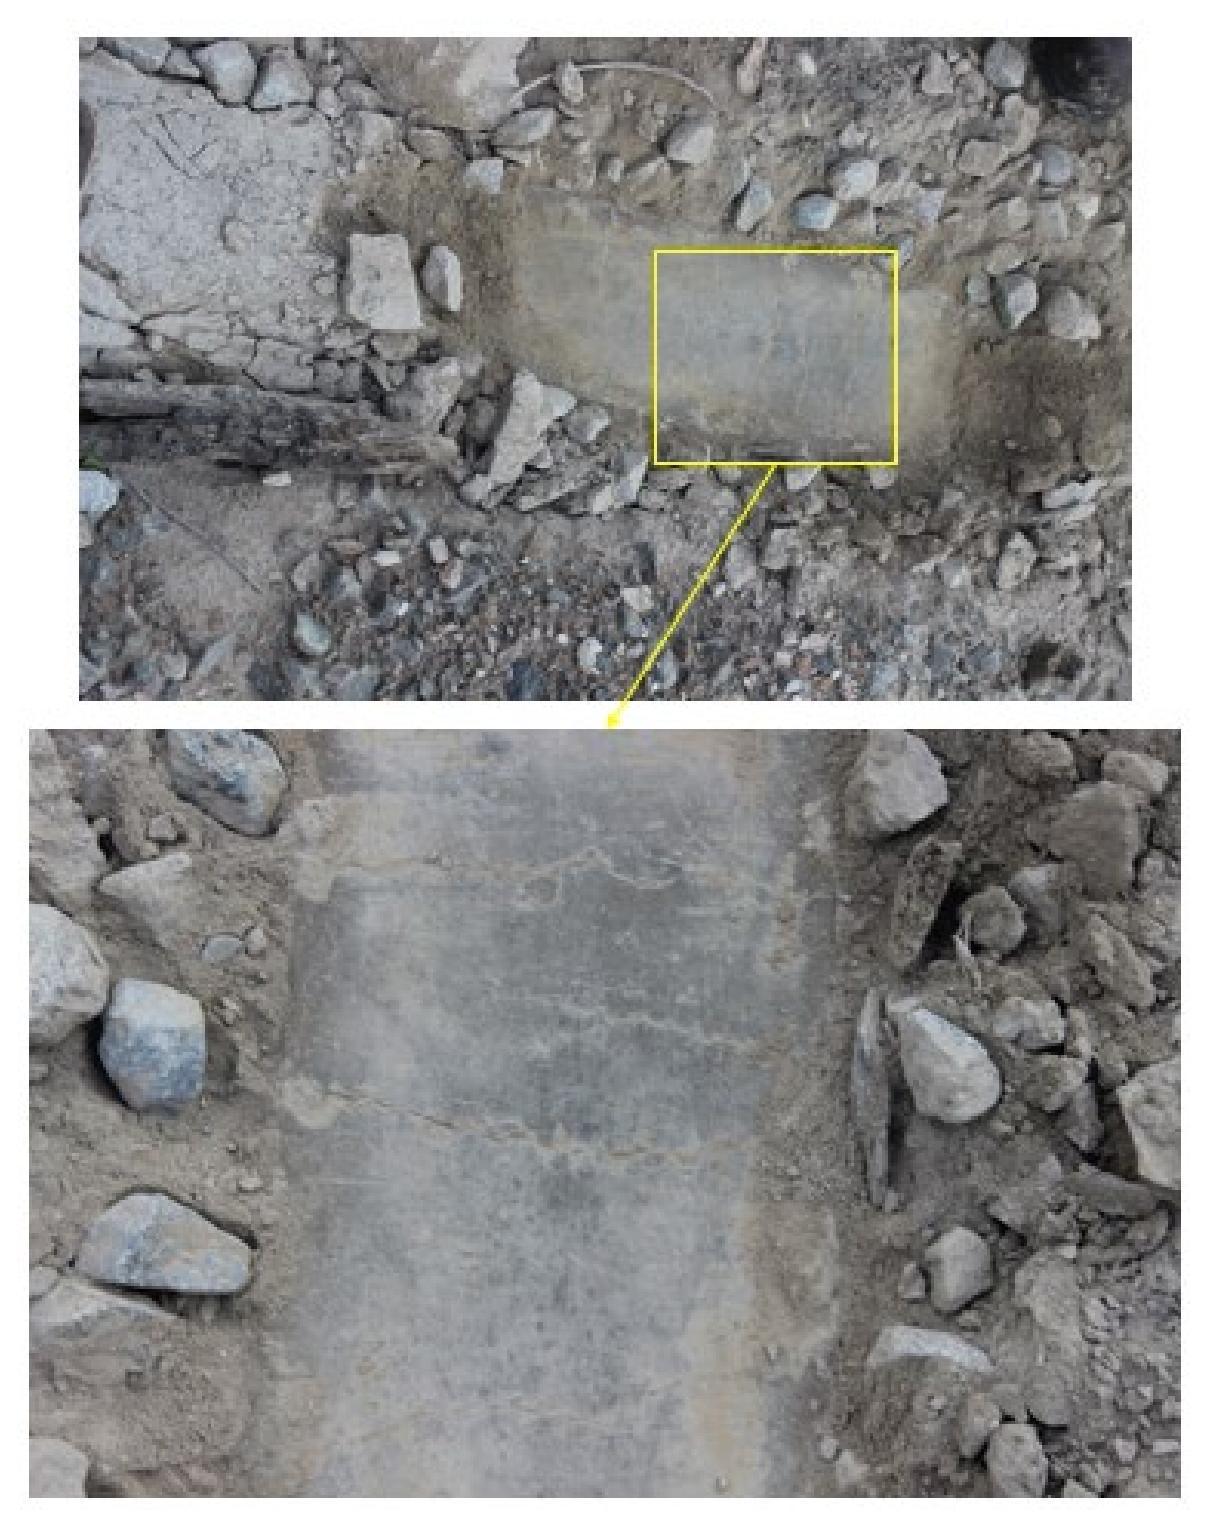
Figure E-34: Tie cracking, Tangent #7

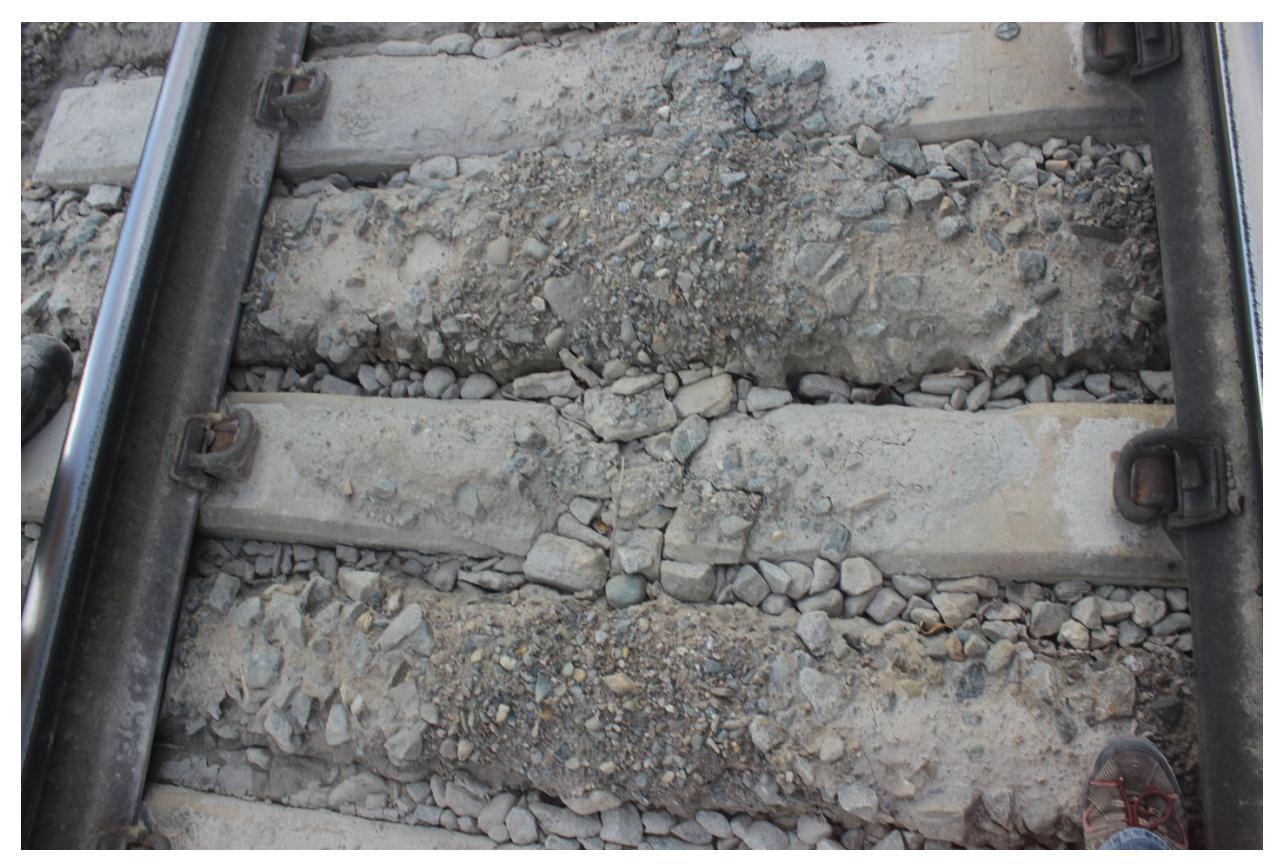
Figure E-35: Shattered tie, Tangent #7

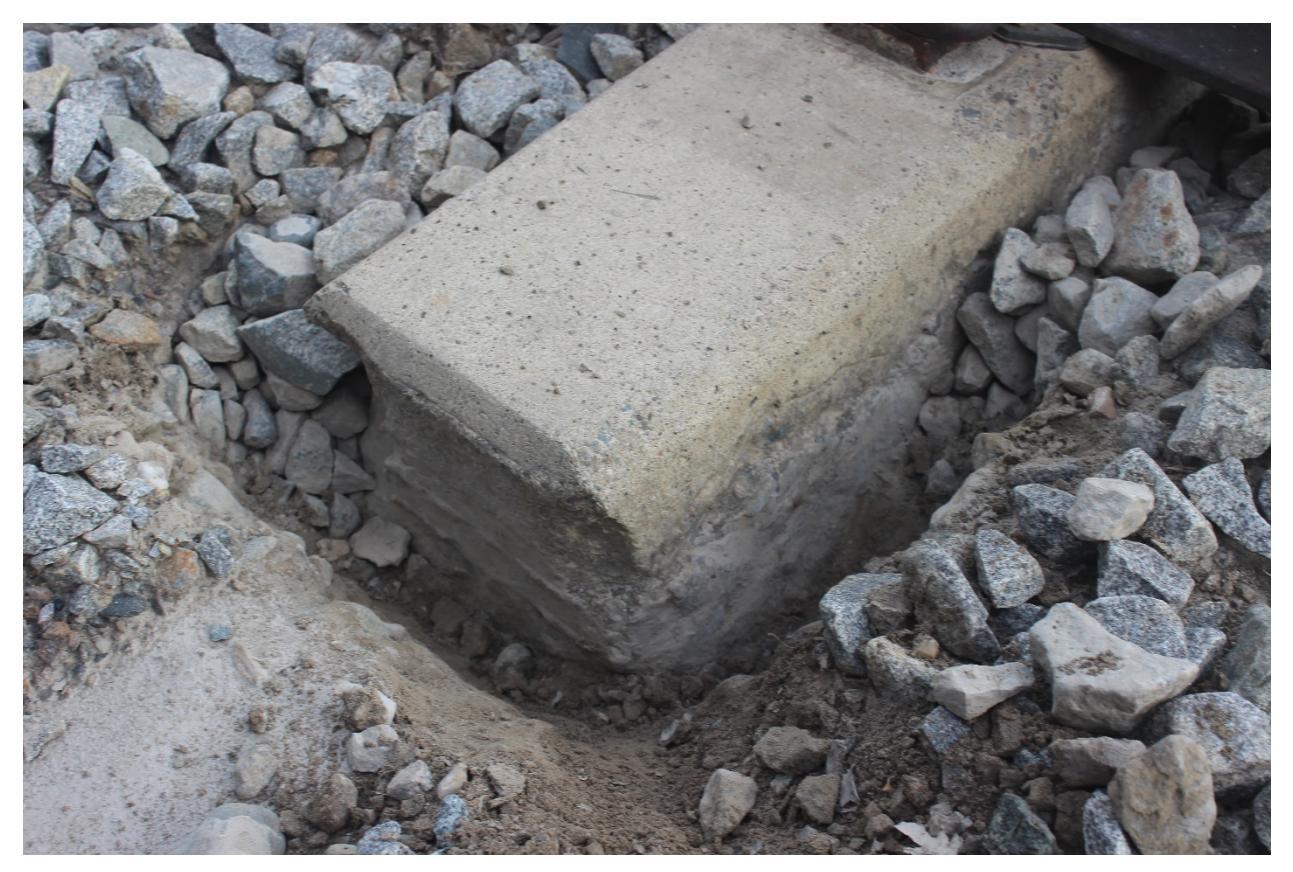
Figure E-40: Tie end wear, Tangent #7
