Federal Railroad Administration

DOT/FRA/ORD-19/38

Final Report October 2019

1. AGENCY USE ONLY (Leave blank)		2. REPORT DATE 3 October 2019		3. REPOR	3. REPORT TYPE AND DATES COVERED Technical Report April 2016 – August 2017	
4. TITLE AND SUBTITLE A Study of Environmental and Track Factors that Contribute to Abrasion Damage of Concrete Ties					5. FUNDING NUMBERS DTFR53-16-C-00009

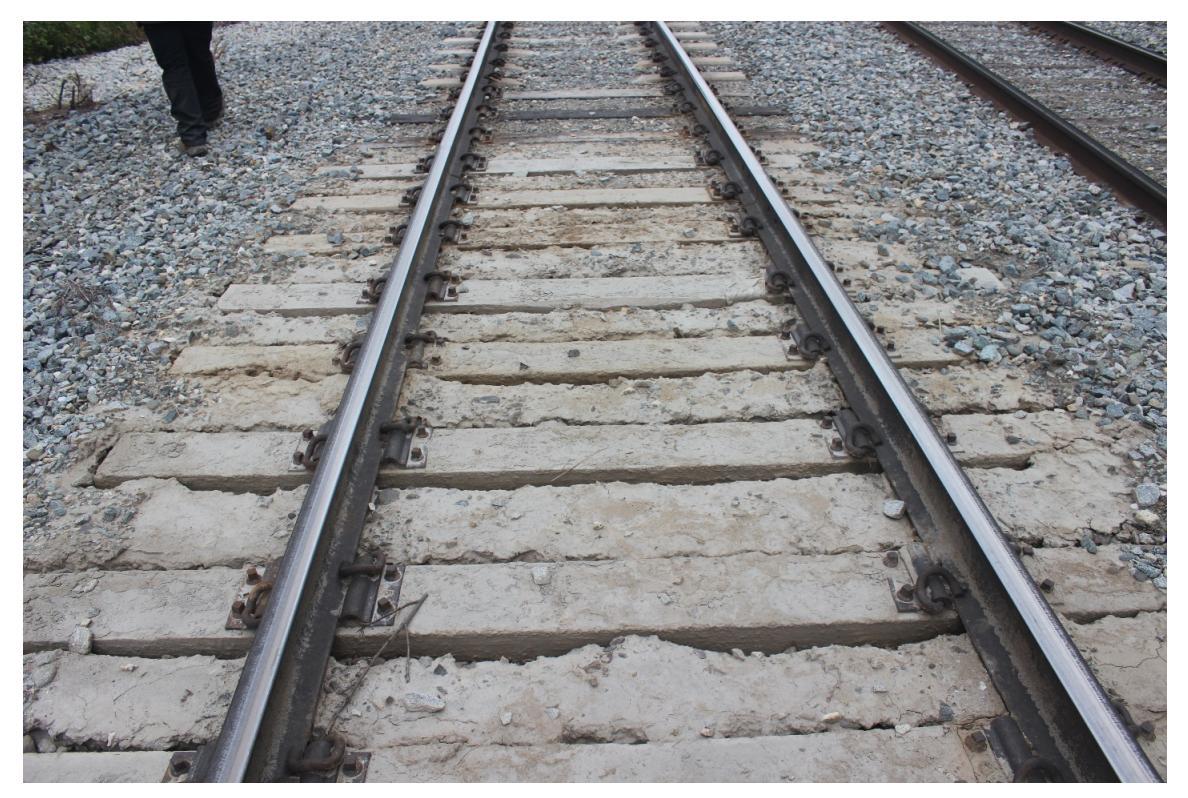
Figure E-46: Mud pumping, Tangent #9

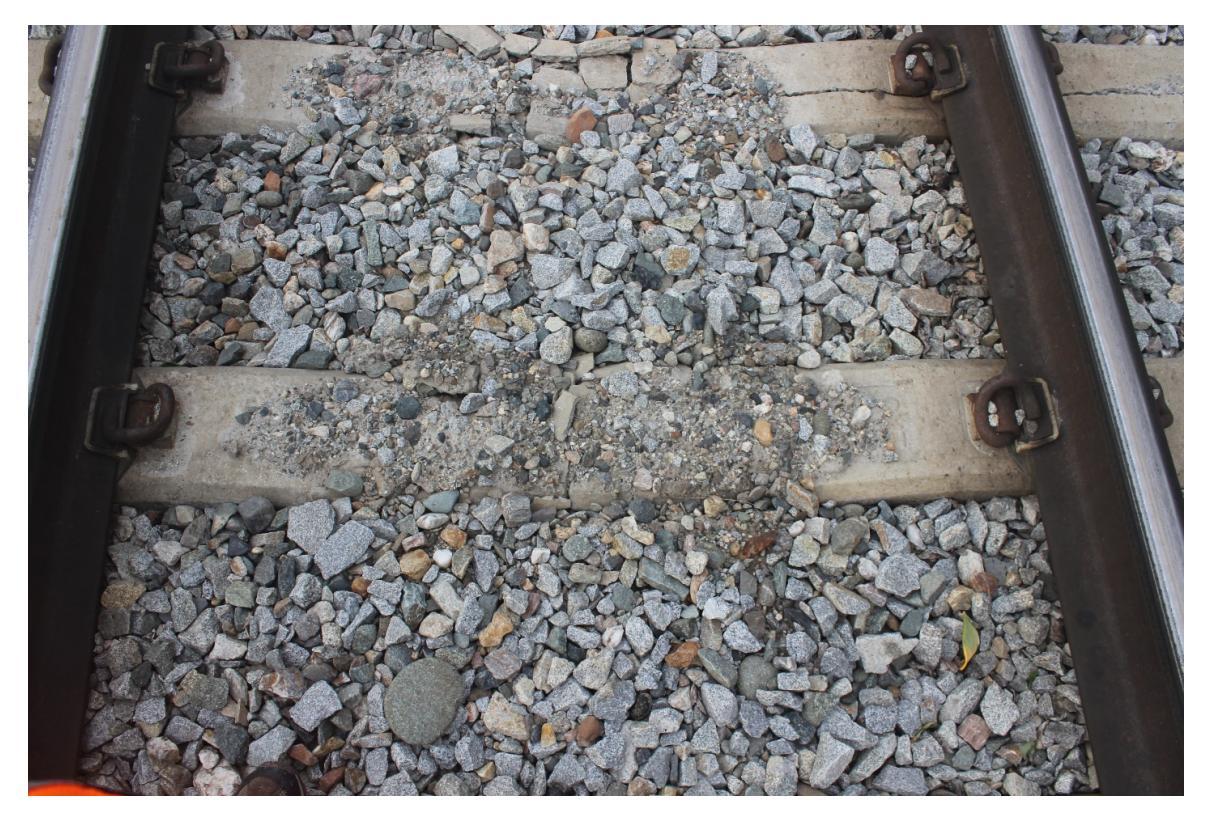
Figure E-47: Damaged ties, Tangent #9

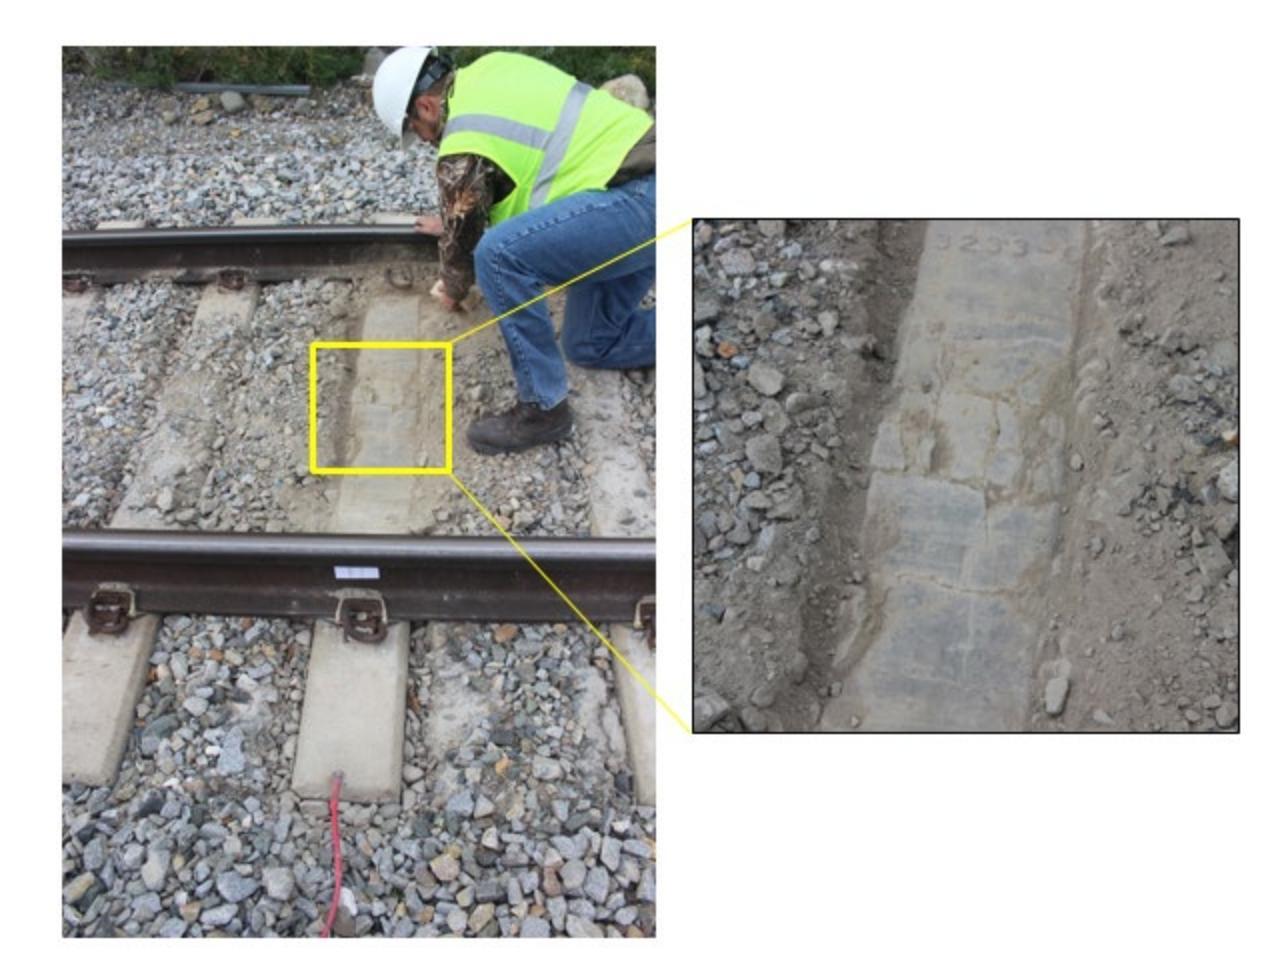
Figure E-48: Tie center binding cracks, Tangent #9

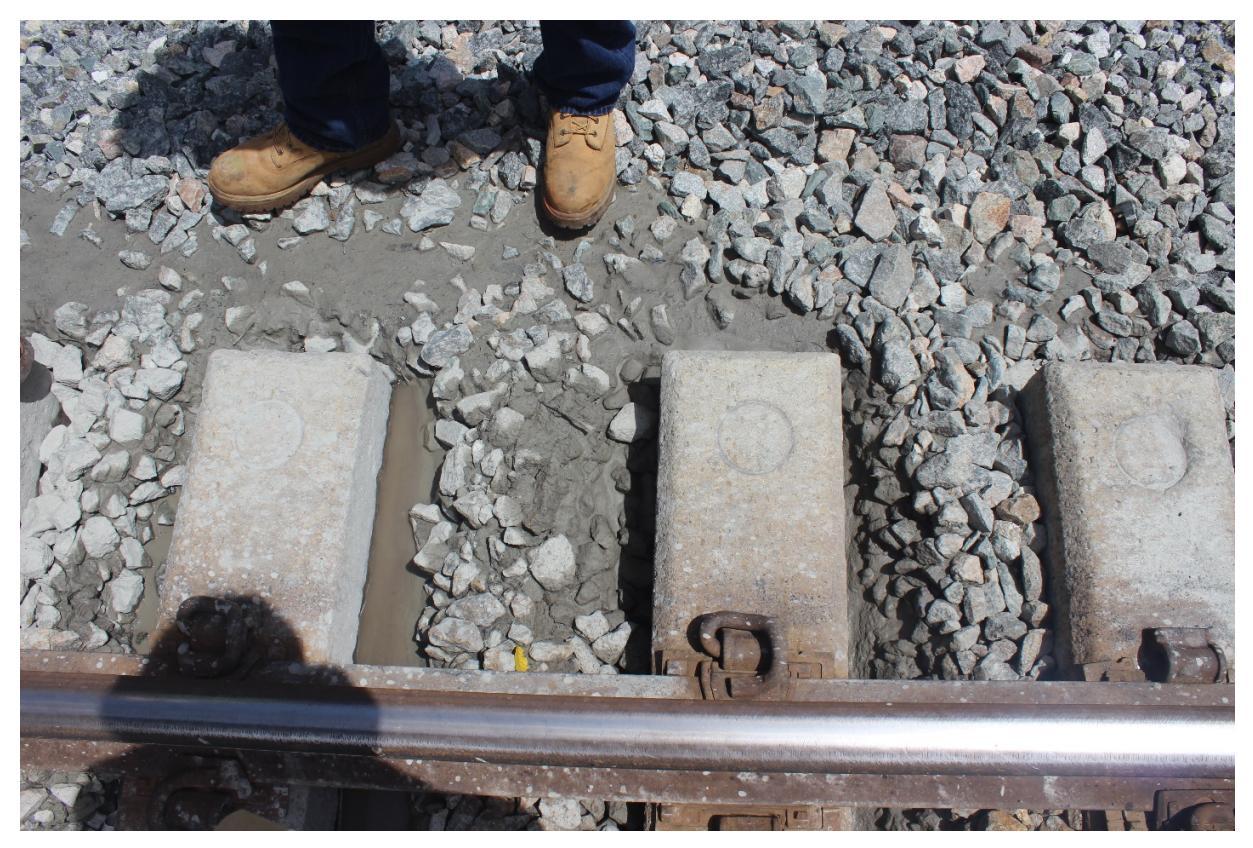
Figure E-54: Fine particles and water in track, Tangent #10

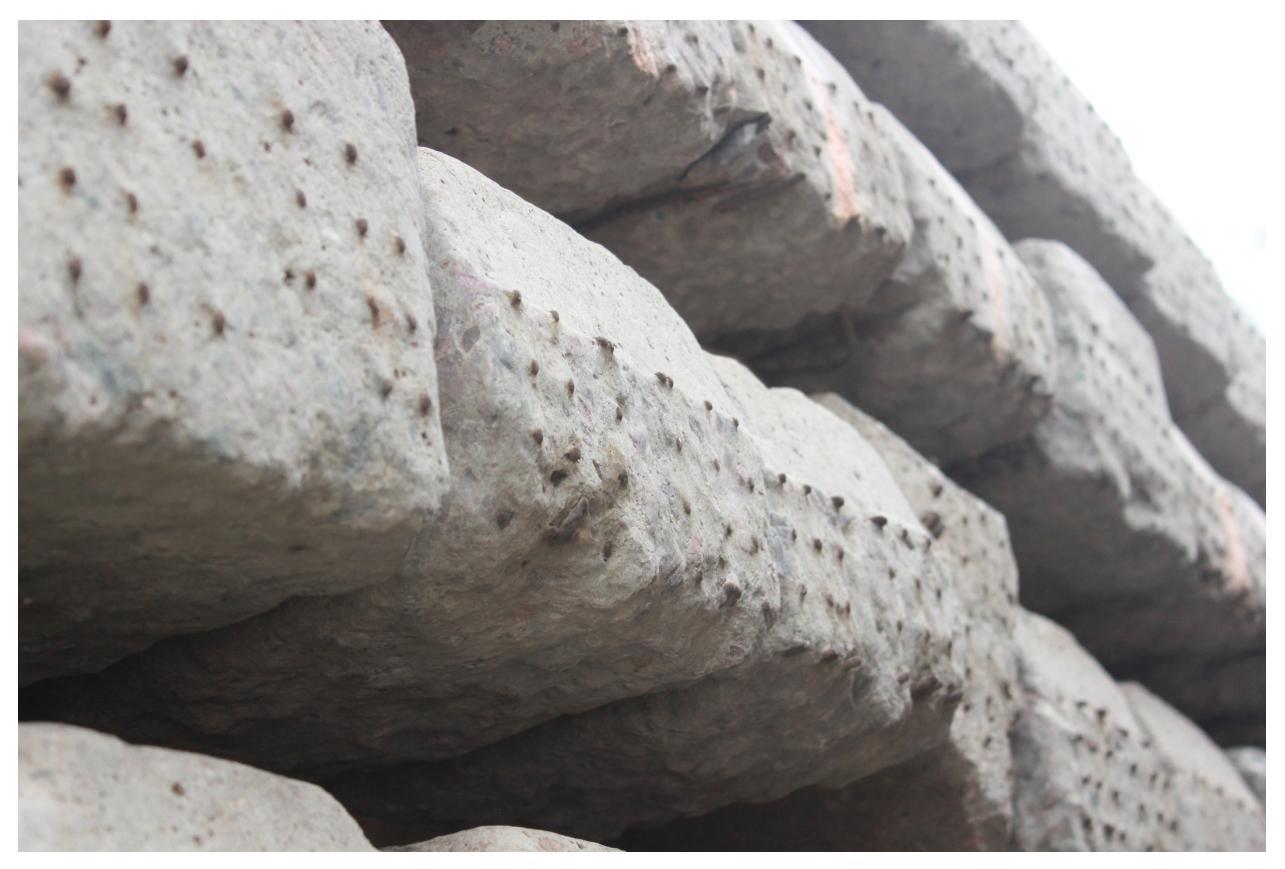
Figure F-5: Tie ends with minor-to-moderate bottom abrasion damage, Boneyard #1

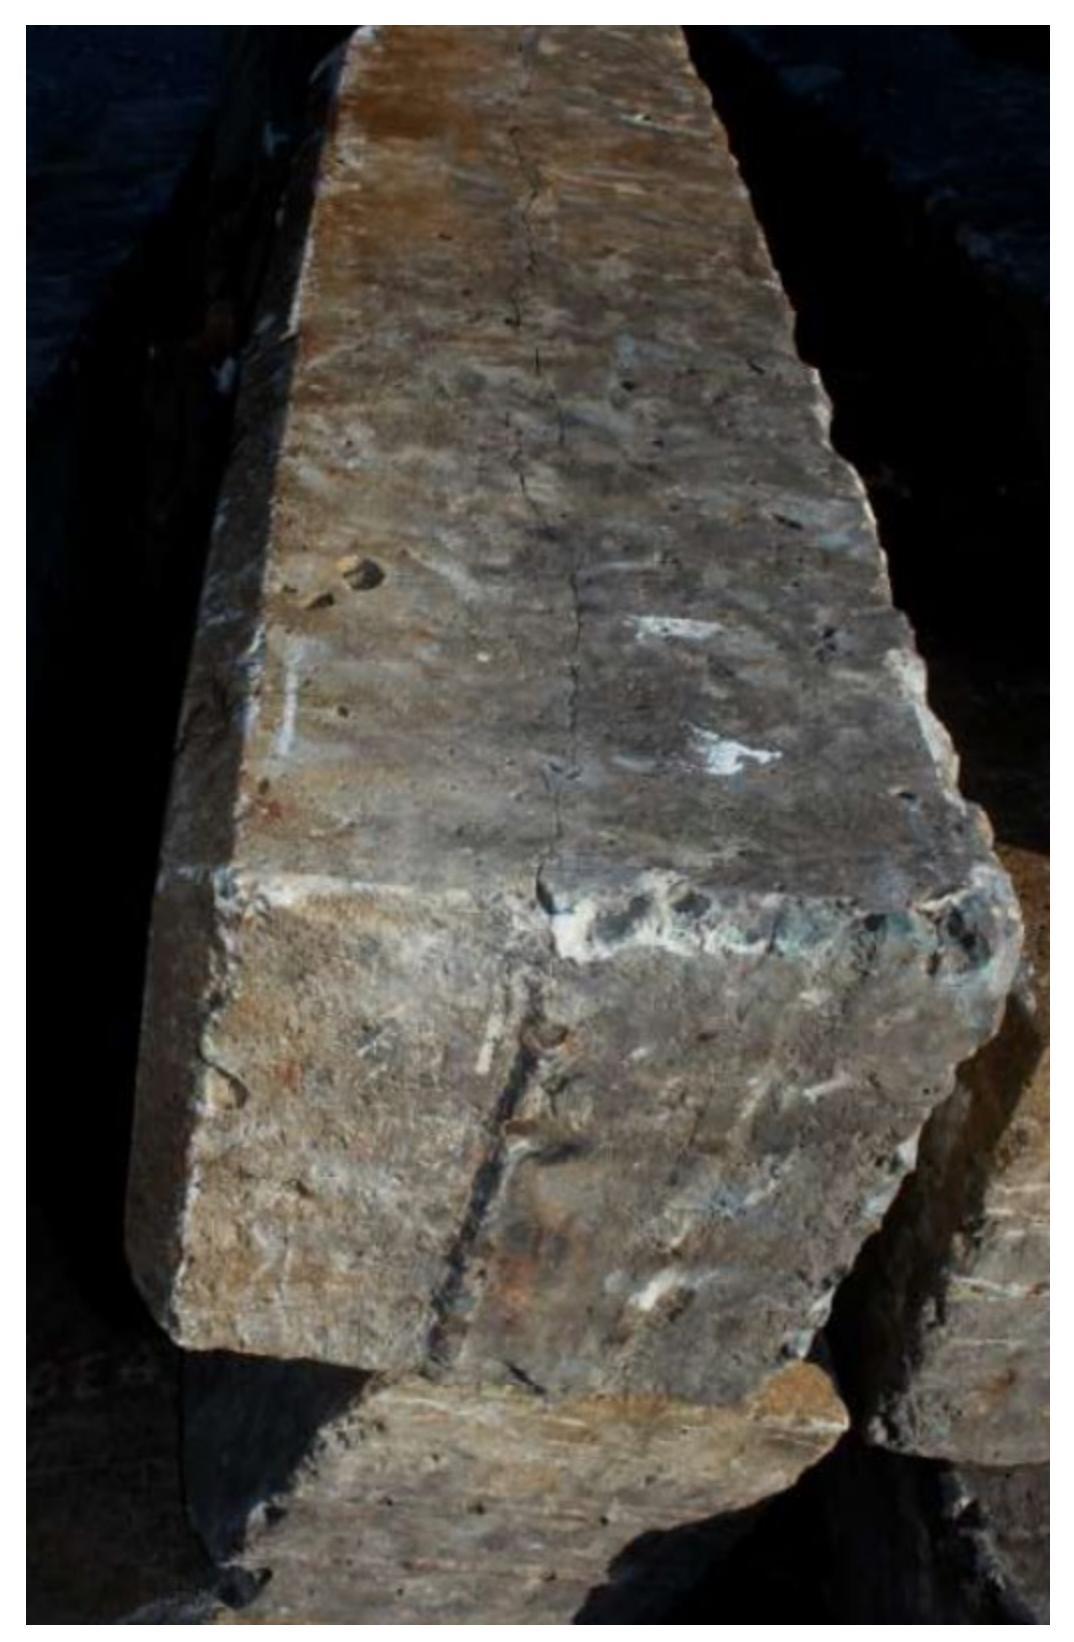
Figure F-9: Longitudinal splitting cracking seen in tie in stack 1, Boneyard #2

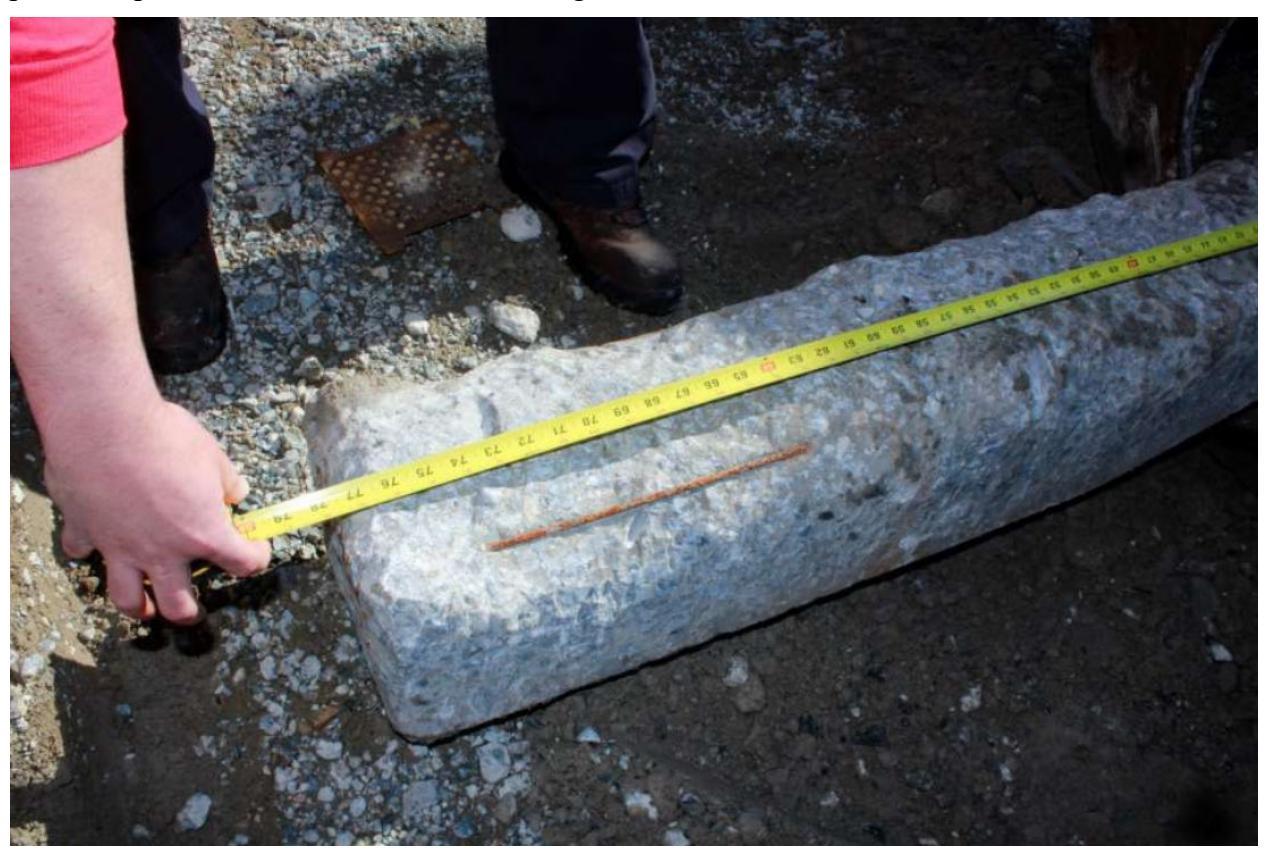
Figure F-10: Tie with severe abrasion wear in stack 2, Boneyard #2

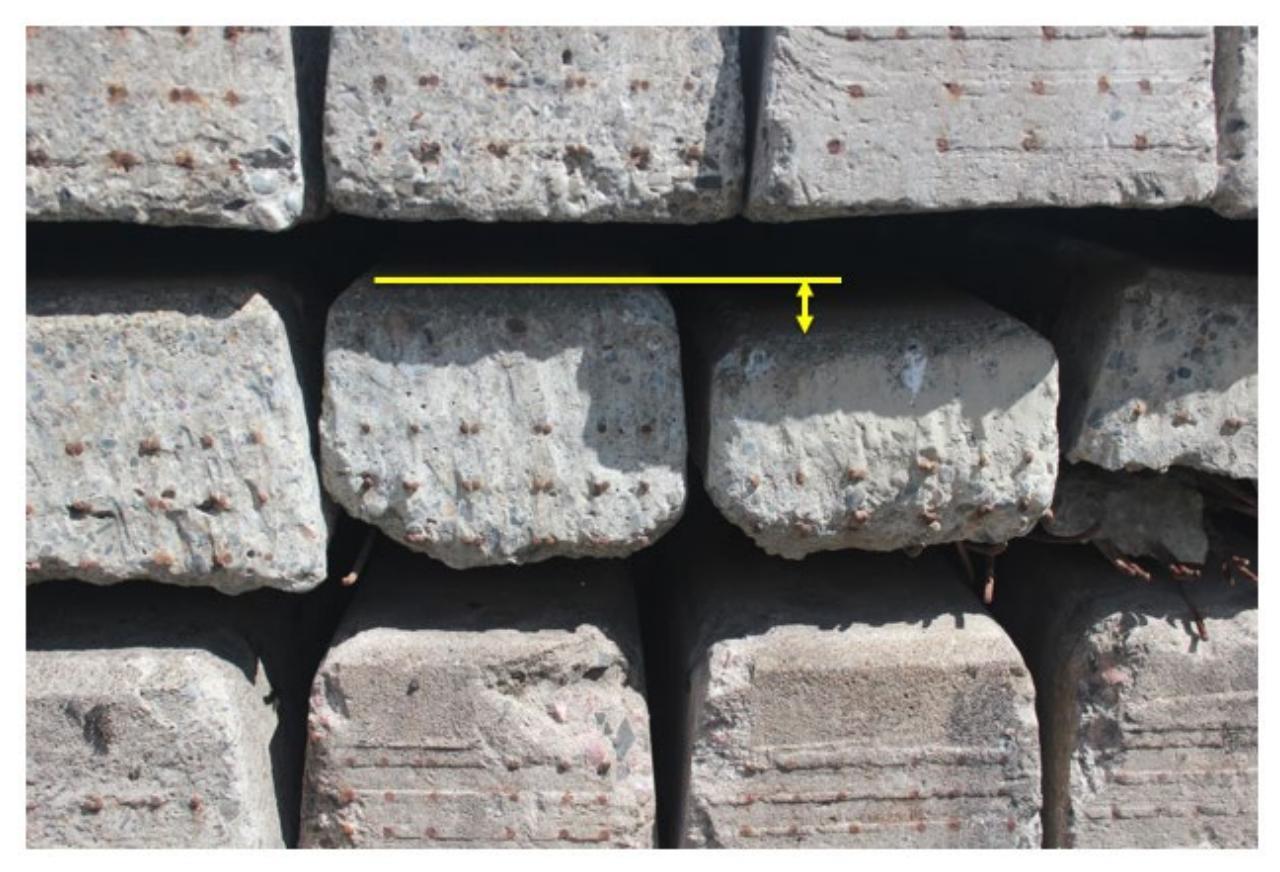
Figure F-13: Rounding of tie bottom corners seen in some ties, Boneyard #3
