Federal Railroad Administration

[FRA Emergency Order No. 24; Docket No. FRA-2005-22796, Notice No. 1]

Emergency Order Requiring Special Handling, Instruction and Testing of Railroad Operating Rules Pertaining to Hand-Operated Main Track Switches

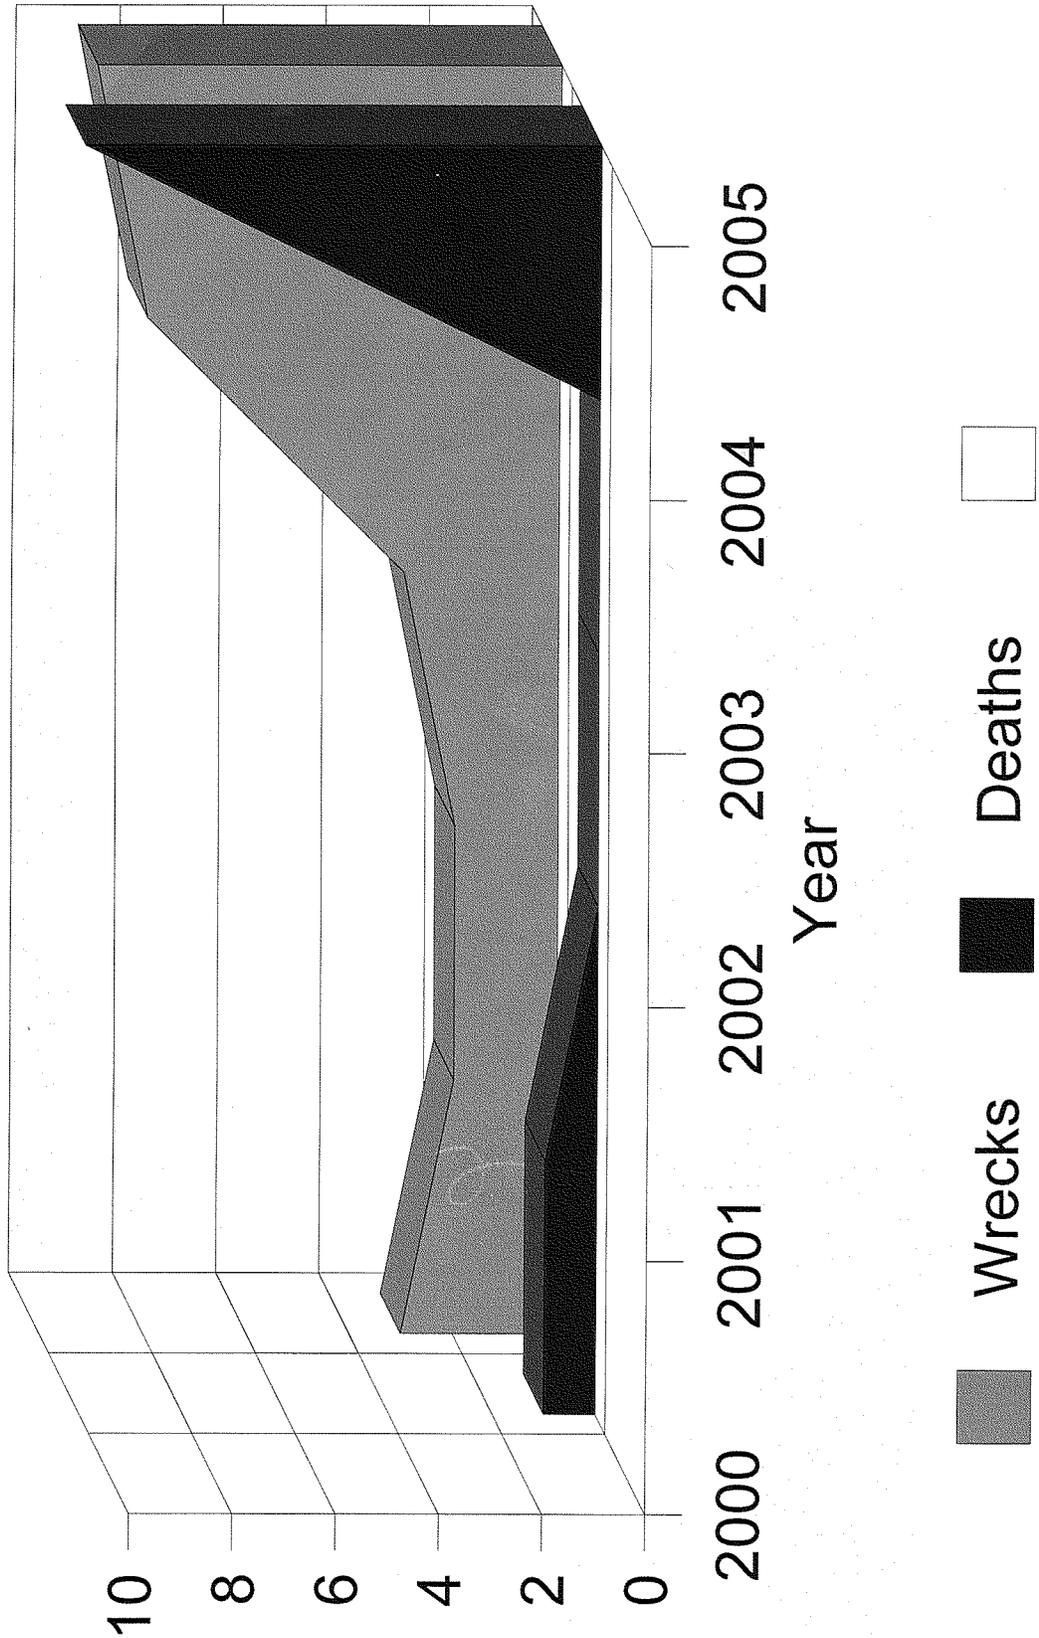
Wrecks & Deaths

In comparison, in 2004 there was a sharp increase in the frequency and severity of collisions resulting from improperly lined main track switches as shown on the attached charts. In 2004, there were a total of eight accidents resulting in eight injuries to railroad employees. The increase in the number of accidents and injuries did not go unnoticed by the industry as some railroads amended their operating rules to address this issue.

Finding and Order: Collisions, deaths and injuries resulting from improperly lined main track switches began in 2004 to rise very sharply as shown on the attached charts. FRA's issuance of a Safety Advisory in early January 2005, recommending practices designed to prevent such events, led to a nearly six month respite. The sharply rising and accelerating trend of collisions, deaths and injuries resulting from improperly lined main track switches, which the Safety Advisory abated only temporarily, constitutes an emergency situation involving a hazard of death or personal injury which FRA must act to stop.
