Federal Railroad Administration Office of Safety Headquarters Assigned Accident Investigation Report HQ-2006-36

CSX Transportation (CSX) Ozark, Alabama May 25, 2006

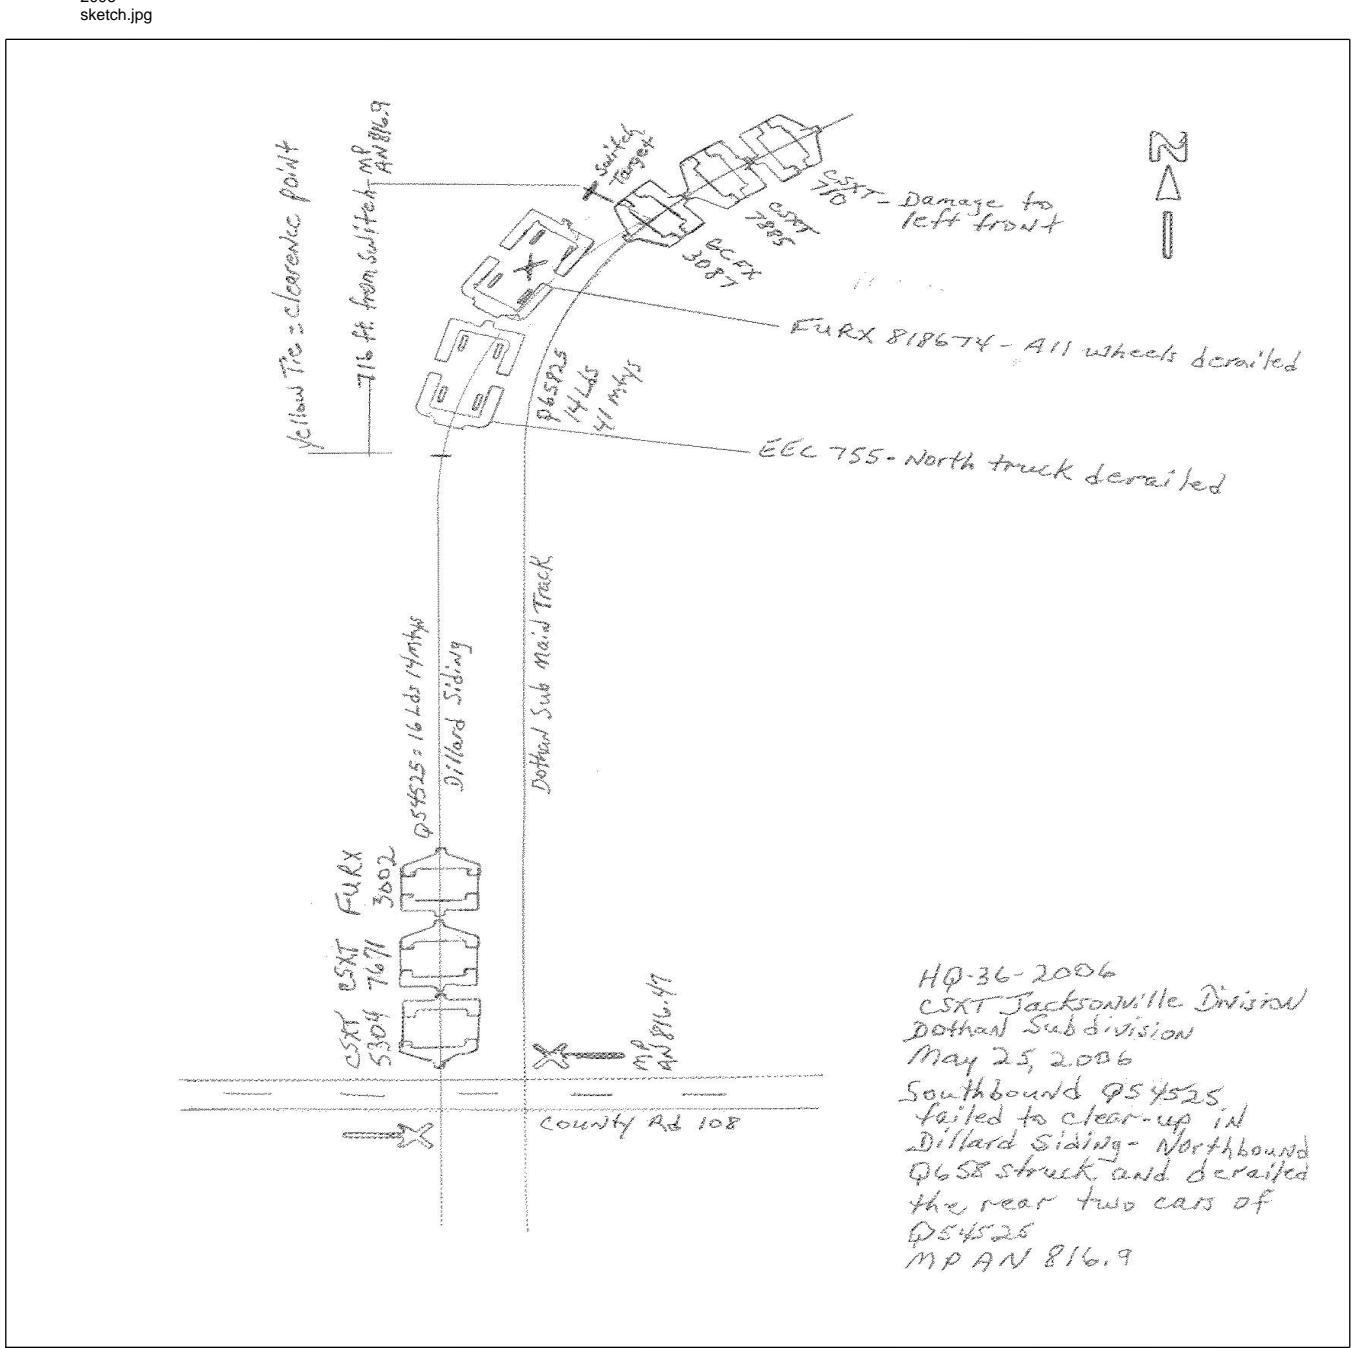
108. DRAW A SKETCH OF ACCIDENT AREA INCLUDING ALL TRACKS, SIGNALS, SWITCHES, STRUCTURES, OBJECTS, ETC., INVOLVED. HQ-36-2006

The train dispatcher issued a DTC order to northbound Train Q65825. Train Q65825 was operating on the main track on the Dothan Subdivision at a recorded speed of 39 miles per hour (mph) when locomotive CSXT 710 side swiped the last two cars of Train Q54525 that were fouling the main track on Dillard Siding MP AN 816.9.

Lead Locomotive CSXT 710 impacted the north (rear) set of trucks on the second rear car EEC 755, derailing the north end of that car. It also impacted the rear car, FURX 818674, derailing all wheels. These were the last two cars of Train Q54525. The left front of Locomotive CSXT 710 was damaged, but no other cars or locomotives were derailed.
