Federal Railroad Administration Office of Safety Headquarters Assigned Accident Investigation Report HQ-2005-75

Burlington Northern Santa Fe (BNSF) Mesler, Missouri September 7, 2005

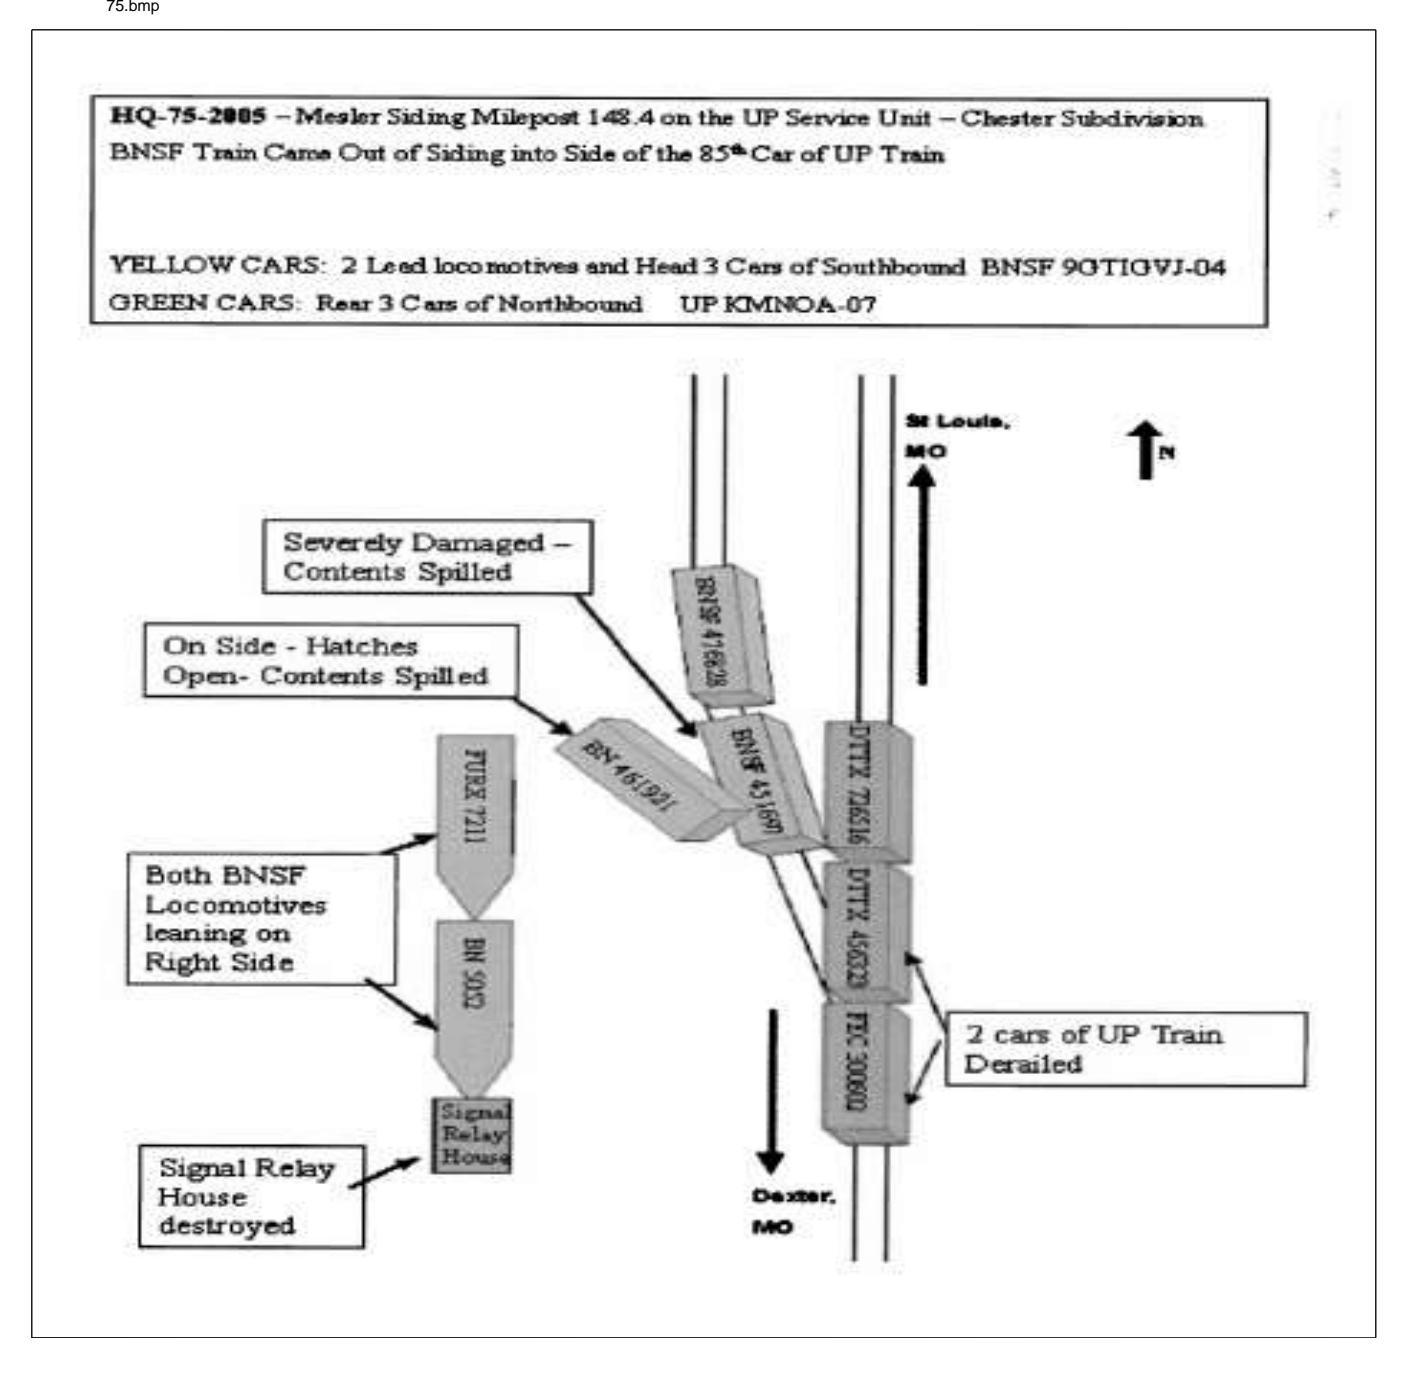
108. DRAW A SKETCH OF ACCIDENT AREA INCLUDING ALL TRACKS, SIGNALS, SWITCHES, STRUCTURES, OBJECTS, ETC., INVOLVED. 75.bmp

On September 7, 2005 at 12:30 p.m. CST southbound BNSF Railway Company (BNSF) freight Train Symbol G-TIAGAT9-04A proceeded by a red absolute signal and out the south end of Mesler Siding, striking stopped Union Pacific Railroad Company (UP) freight Train Symbol KMNOA 07 occupying the main track. The side-collision accident occurred near Mesler, Missouri, on the UP St. Louis Service Unit, Chester Subdivision, at milepost 148.4.

The 11 mph impact resulted in derailing 2 cars of the UP freight train and the 2 lead locomotives and head 3 cars of the BNSF freight train. There were no injuries to any crew members. Monetary damages to the BNSF equipment totaled \$129,975. The monetary damages incurred by the UP were \$10,318 to equipment and \$516,000 to track and signal.
